# STREAM BIOLOGICAL CONDITIONS ENVIRONMENTAL AUDITOR REPORT

<b>Stream ID:</b> S-KL41	<b>Crossing Start Date:</b> 10/10/2023	<b>Crossing Completion Date:</b> 10/21/2023
<b>Milepost:</b> 267	<b>Pre-Con Assessment Date:</b> 09/30/2023	<b>Post-Con Assessment Date:</b> 10/21/2023
<b>Station:</b> 14105+32	<b>Stream Classification:</b> Perennial (Perennial, Intermittent, Ephemeral)	<b>Bankfull Width (ft.):</b> 12
<b>County:</b> Franklin	<b>303(d) Impairment Listing:</b> Not Impaired	<b>Riffle:Pool Complexes Present?</b> No

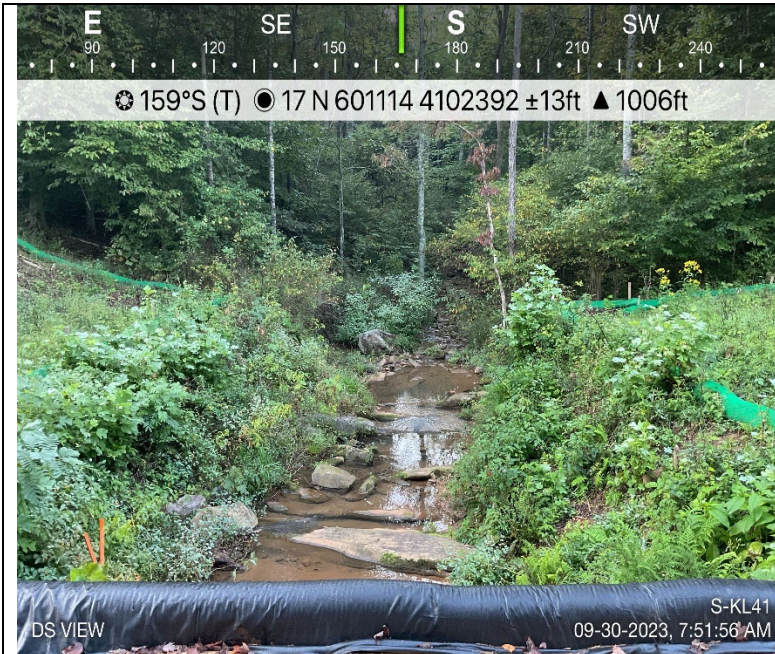
**Photo Description:** Downstream view of permitted impact area during pre-construction assessment.

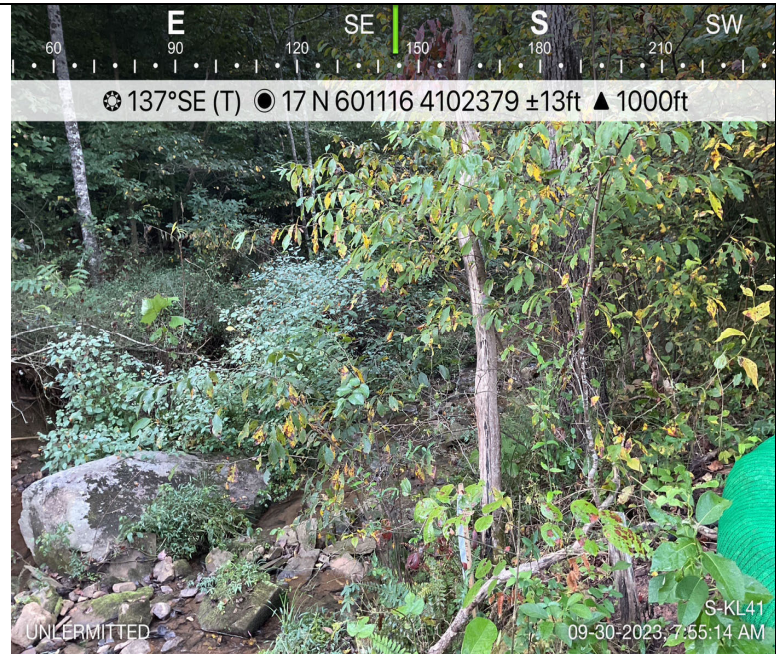
**Photo Description:** Conditions of the downstream area outside the ROW during pre-construction assessment.

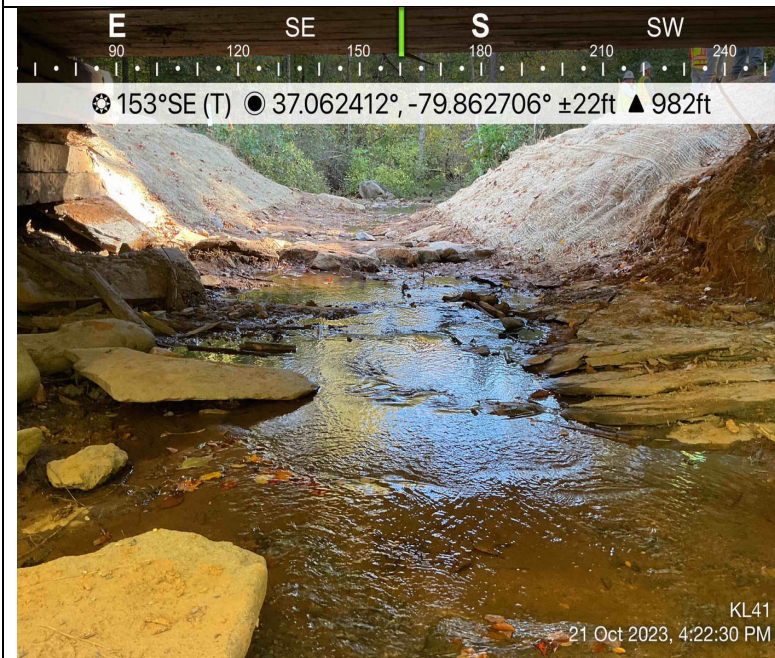
**Photo Description:** Downstream view of permitted impact area during post-construction assessment.

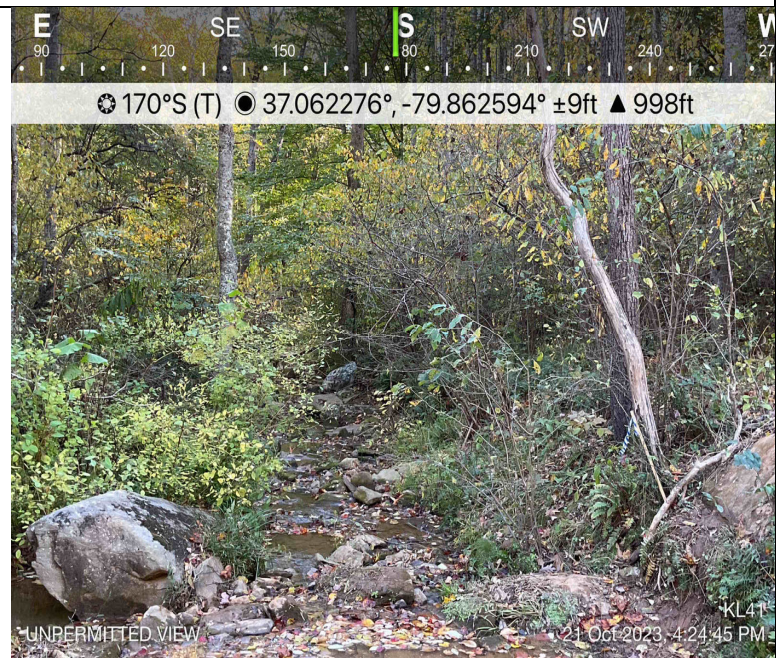
**Photo Description:** Conditions of the downstream area outside the ROW during post-construction assessment.

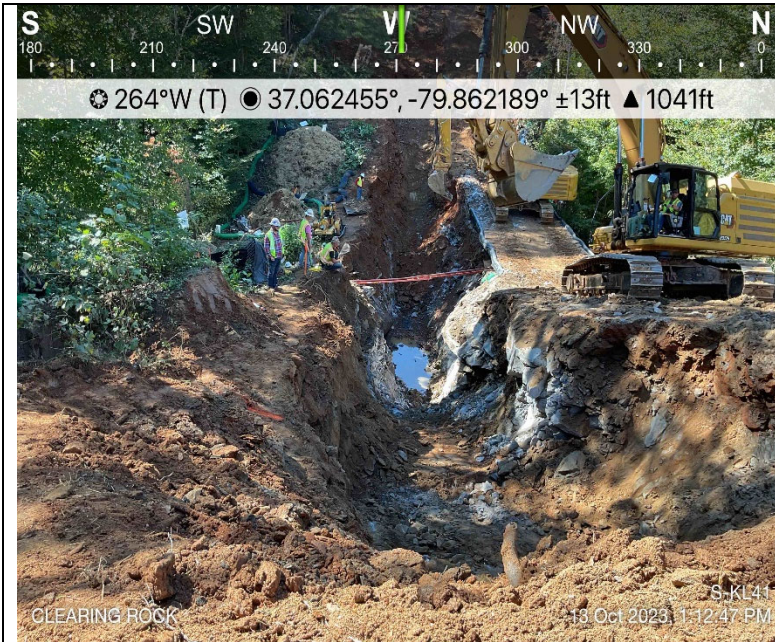
**Photo Description:** Rock excavation of trench. Dam and pump functional and hoses conveyed across trench via extension ladder.

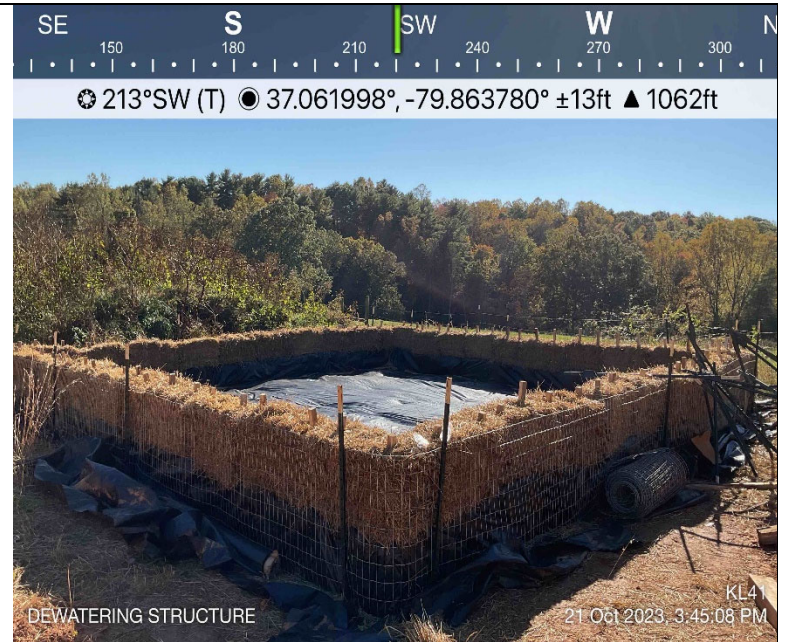
**Photo Description:** Dewatering structure installed and available for use throughout crossing activity.

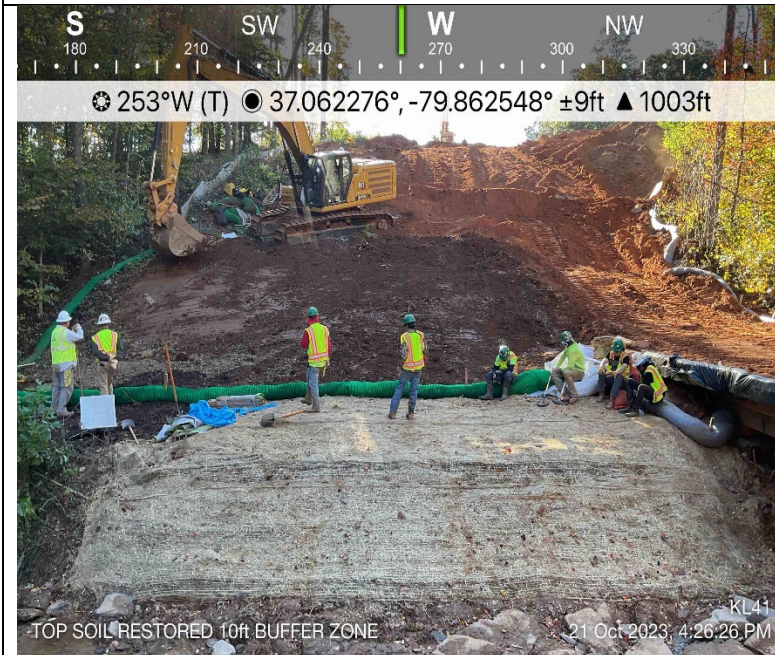
**Photo Description:** Restoration of the topsoil adjacent to the stream. Seed and stabilization matting installed along streambanks.

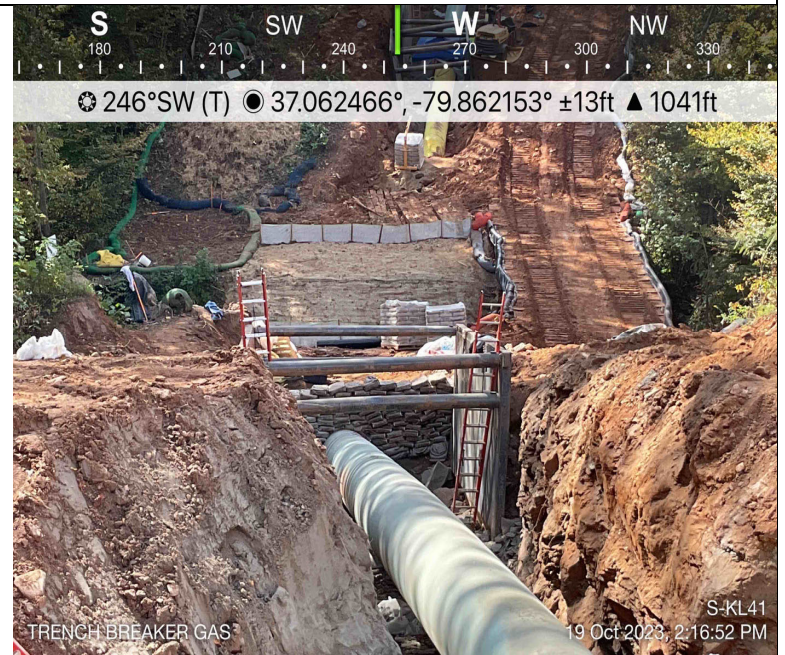
Item #9: Due to site specific safety concerns, the trench breakers will not be placed at 25-feet from the top-of-bank but instead will be installed 50-feet from the top-of-bank. -V. Smith

**Photo Description:** Trench breaker in GAS.
