STREAM BIOLOGICAL CONDITIONS ENVIRONMENTAL AUDITOR REPORT

Stream ID: S-KL43	Crossing Start Date: 09/06/2023	Crossing Completion Date: 09/16/2023
Milepost: 215	Pre-Con Assessment Date: 09/02/2023	Post-Con Assessment Date: 09/16/2023
Station: 11360+54	Stream Classification: Perennial (Perennial, Intermittent, Ephemeral)	Bankfull Width (ft.): 10
County: Giles	303(d) Impairment Listing: Not Impaired	Riffle:Pool Complexes Present? No

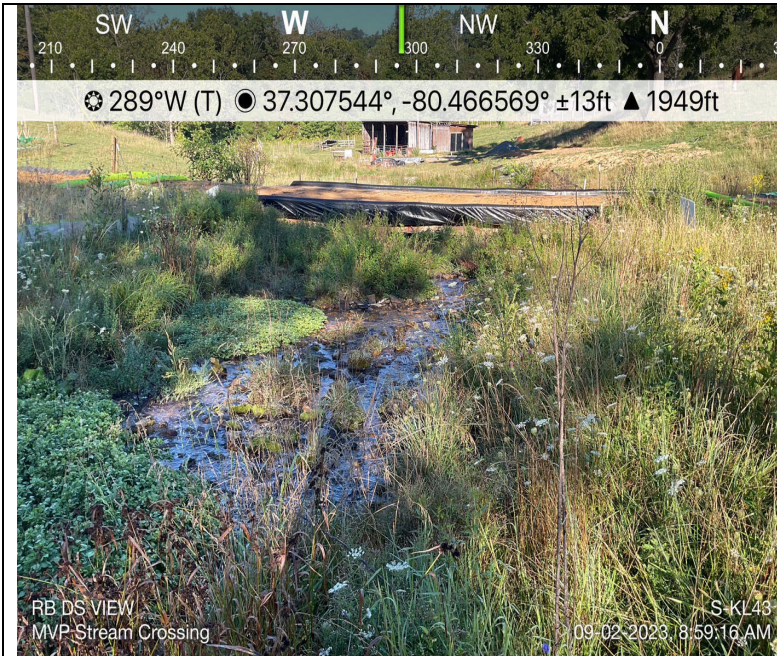
Photo Description: Downstream view of permitted impact area during pre-construction assessment.

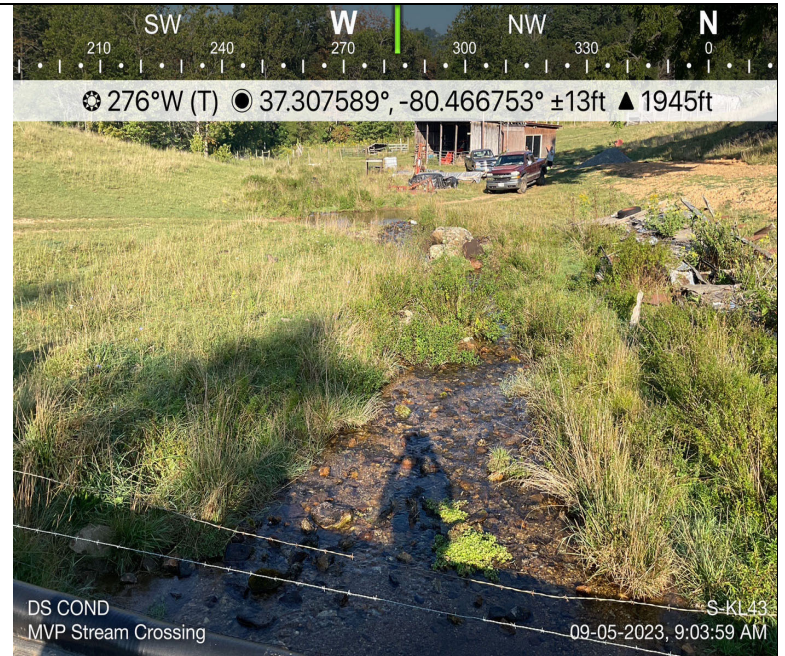
Photo Description: Conditions of the downstream area outside the ROW during pre-construction assessment.

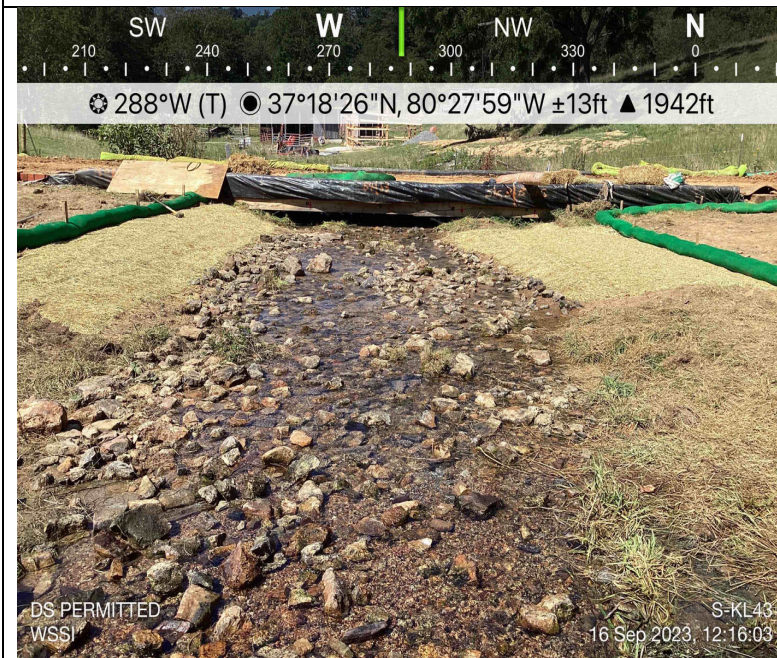
Photo Description: Downstream view of permitted impact area during post-construction assessment.

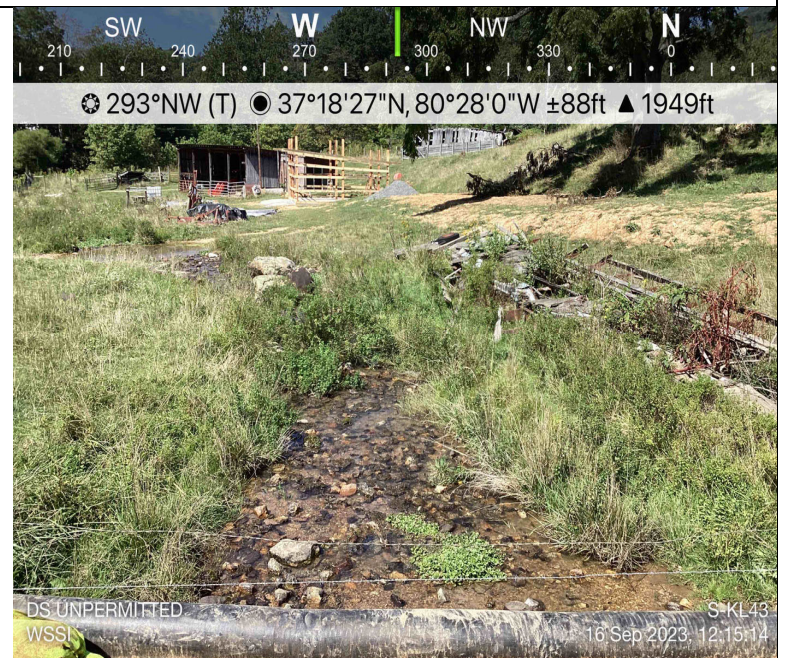
Photo Description: Conditions of the downstream area outside the ROW during post-construction assessment.

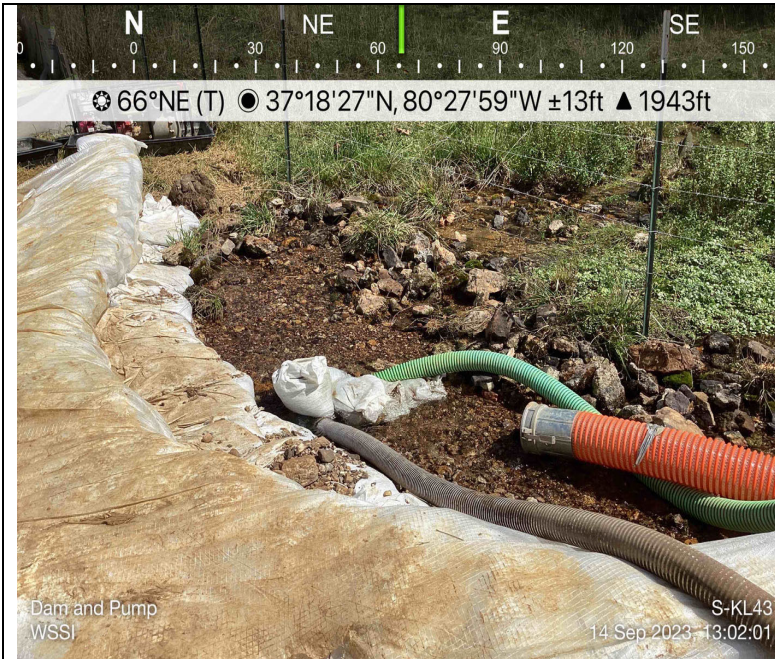
Dam and Pump
WSSI

Photo Description: Dam and pump.

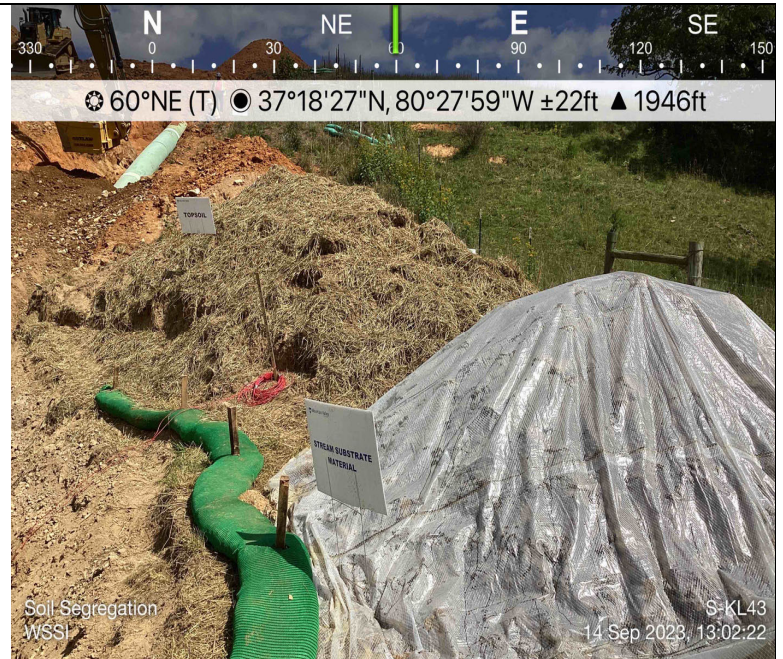
Soil Segregation
WSSI

Photo Description: Soil and substrate segregation.

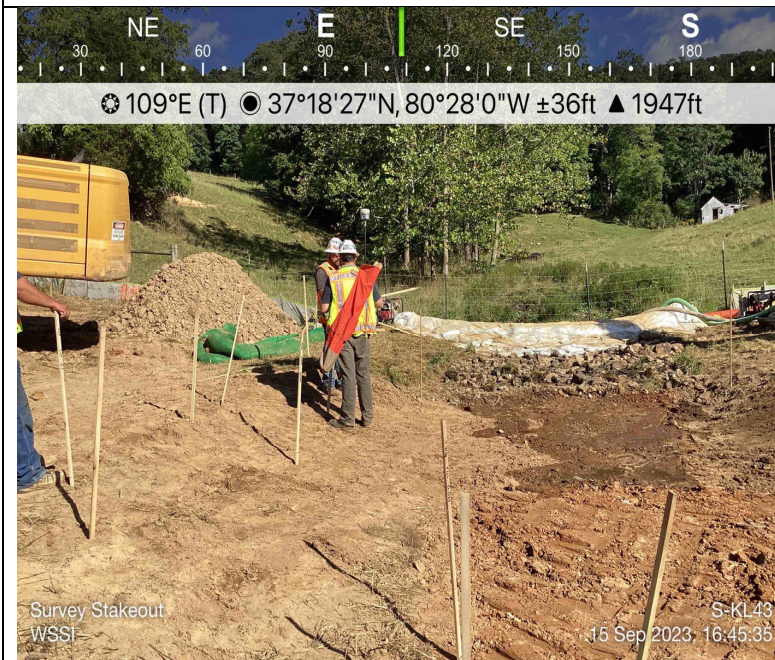
Survey Stakeout
WSSI

Photo Description: Survey stakeout complete.

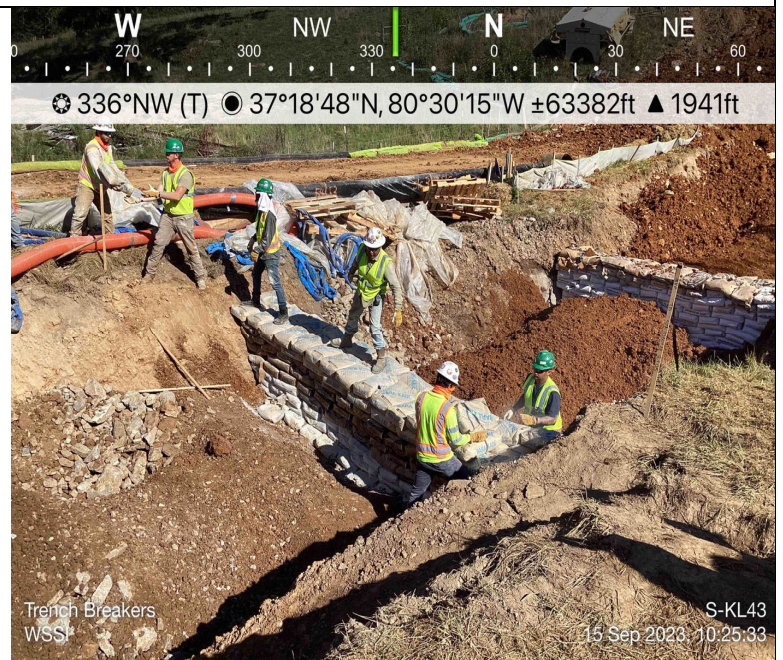
Trench Breakers
WSSI

Photo Description: Trench breakers installed.
