STREAM BIOLOGICAL CONDITIONS ENVIRONMENTAL AUDITOR REPORT

Stream ID: S-KL43	Activity Start Date: 10/10/2023	Activity Completion Date: 10/10/2023
Milepost: 215	Pre-Con Assessment Date: 10/09/2023	Post-Con Assessment Date: 10/10/2023
Station: 11360+54	Stream Classification: Perennial (Perennial, Intermittent, Ephemeral)	Bankfull Width (ft.): 10
County: Giles	303(d) Impairment Listing: Not Impaired	Riffle:Pool Complexes Present? No

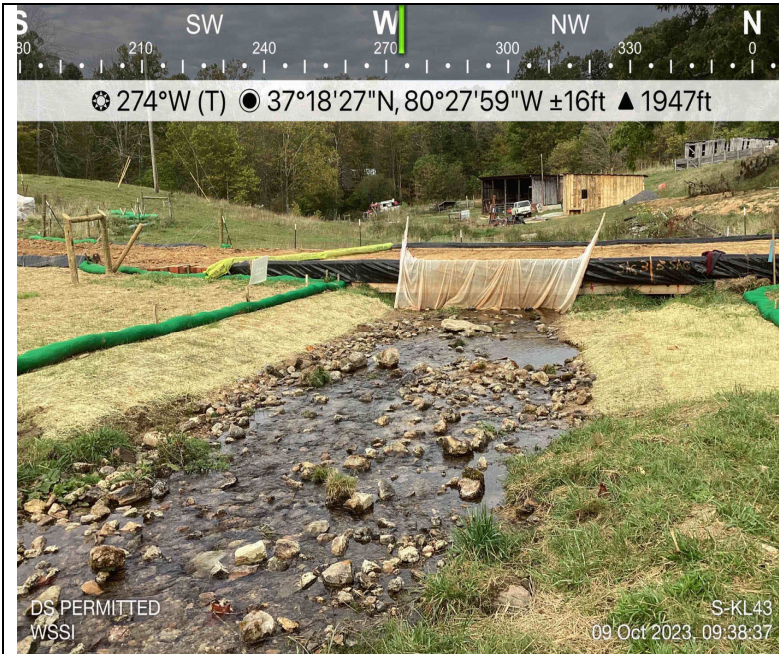
Photo Description: Downstream view of permitted impact area during pre-construction assessment.

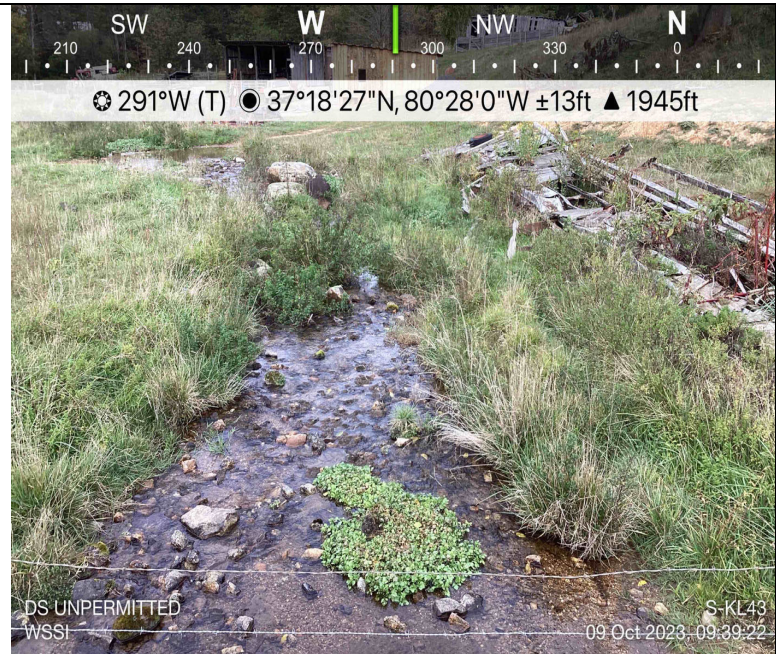
Photo Description: Conditions of the downstream area outside the ROW during pre-construction assessment.

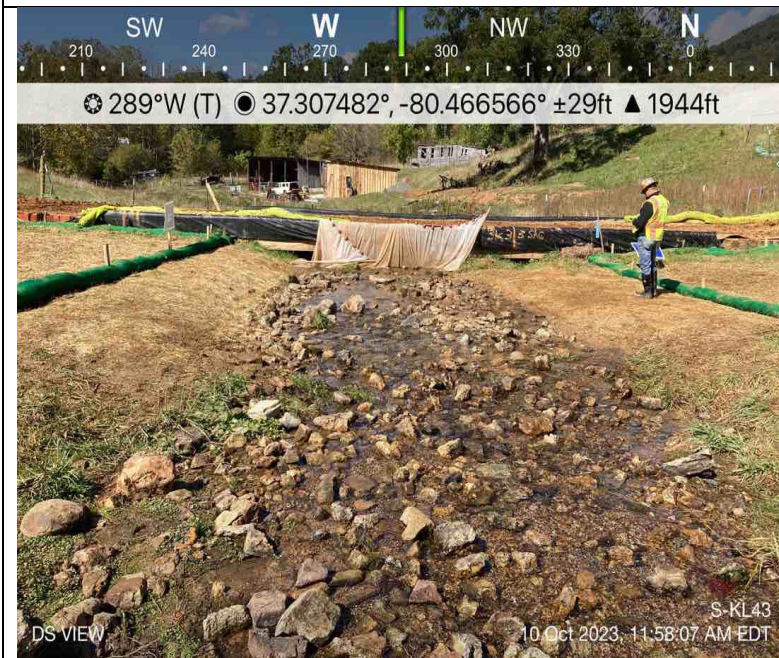
Photo Description: Downstream view of permitted impact area during post-construction assessment.

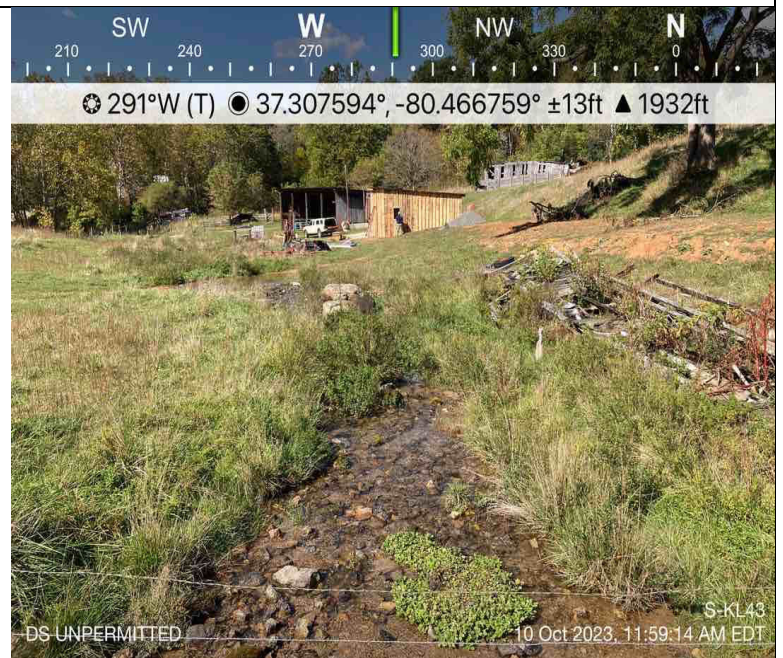
Photo Description: Conditions of the downstream area outside the ROW during post-construction assessment.

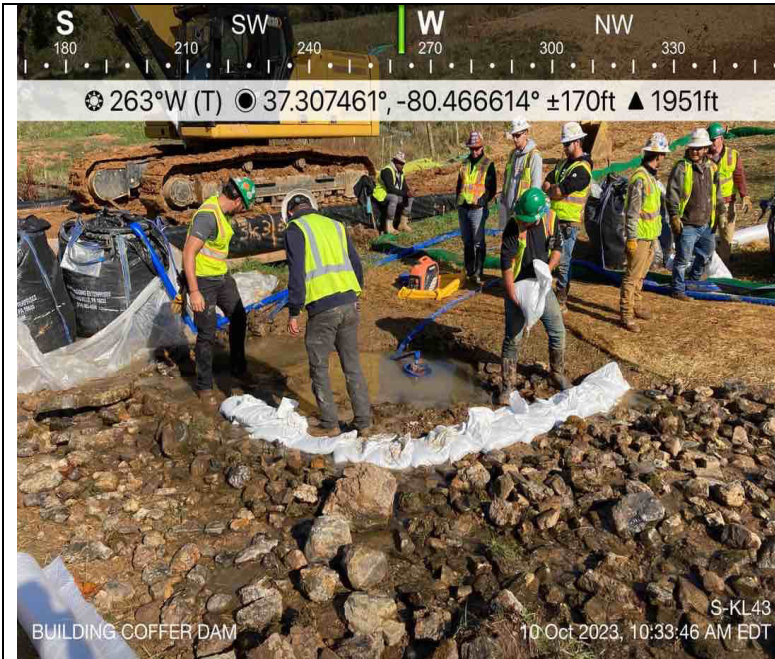
Photo Description: Cofferd dam inside of dammed area.

10/10/2023: Dam and pump around were installed and a cofferdam was installed around the subsidence issue. Substrate and topsoil were removed from within cofferdam and stockpiled separately. Additional subsoil was brought in and compacted in the remediate/remove the subsided area. Topsoil and substrate were then restored in the proper order, then the cofferdam and dam & pump around were removed to restore stream flow. Auditor post-construction assessment completed.

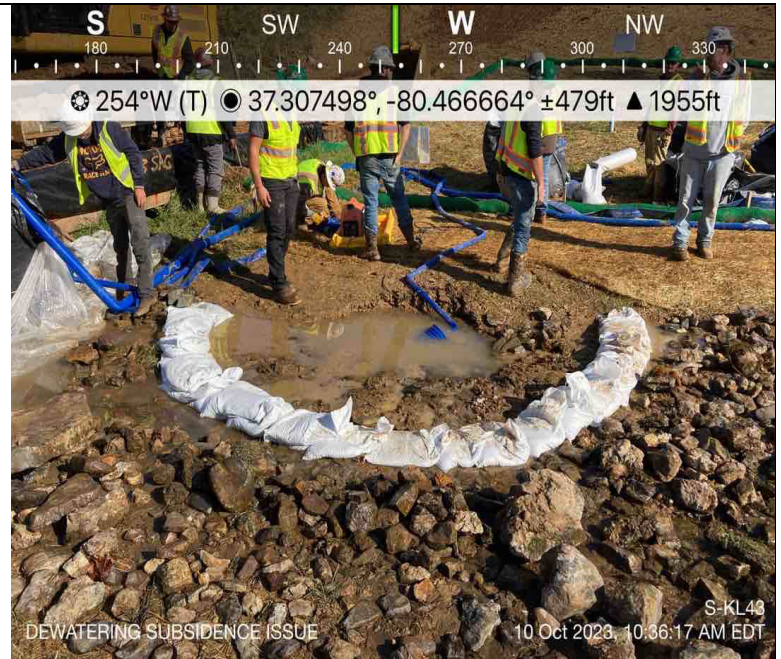
10/07/2023: A subsidence issue appeared near the toe of the right bank of the stream. The subsidence issue appears to be approximately 1.5ft deep and 3ft in diameter. Dam and pump around will be reestablished after fish relocation has been completed on Monday, 10/09/2023. After the fish relocation has been completed and the dam and pump around has been re-established, the necessary subsidence remediation will be made. The crew responsible for making repairs is currently sourcing the required material to do so. -A. Breeding

Photo Description: Subsidence issue area being dewatered prior to repairs.

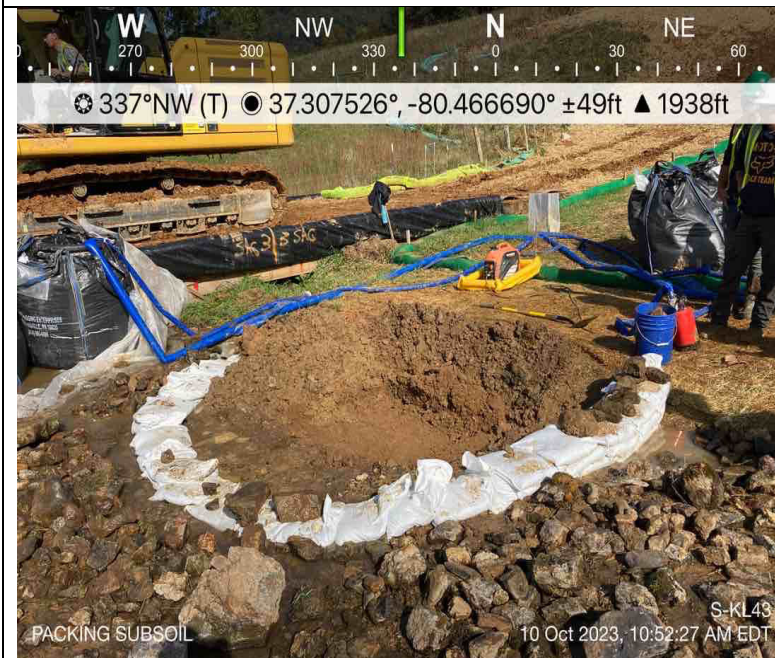
Photo Description: Subsoil compacted in subsidence.

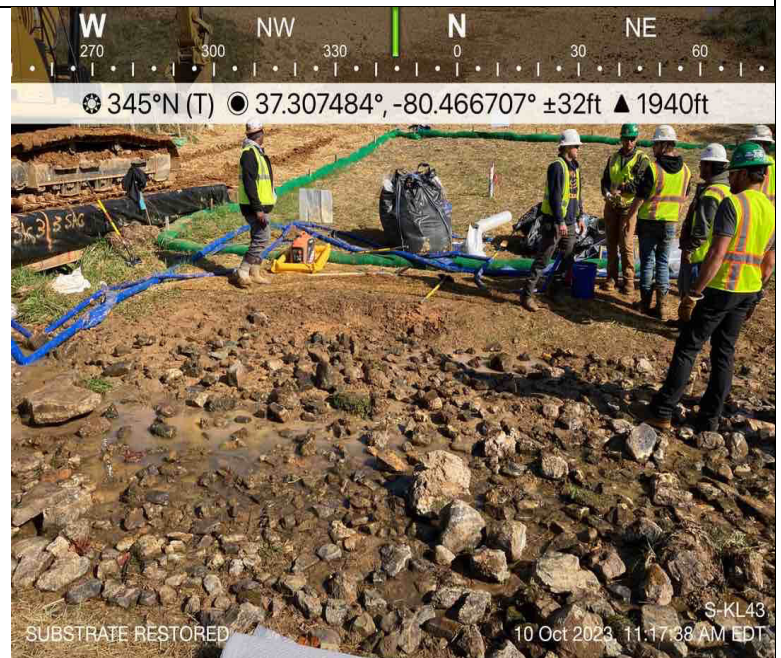
Photo Description: Substrate and stream restored. Cofferdam removed from around subsidence remediation area.
