# STREAM BIOLOGICAL CONDITIONS ENVIRONMENTAL AUDITOR REPORT

<b>Stream ID:</b> S-KL52	<b>Crossing Start Date:</b> 09/28/2023	<b>Crossing Completion Date:</b> 10/04/2023
<b>Milepost:</b> 268.3	<b>Pre-Con Assessment Date:</b> 09/24/2023	<b>Post-Con Assessment Date:</b> 10/06/2023
<b>Station:</b> 14176+09	<b>Stream Classification:</b> Ephemeral (Perennial, Intermittent, Ephemeral)	<b>Bankfull Width (ft.):</b> 1
<b>County:</b> Franklin	<b>303(d) Impairment Listing:</b> Not Impaired	<b>Riffle:Pool Complexes Present?</b> No

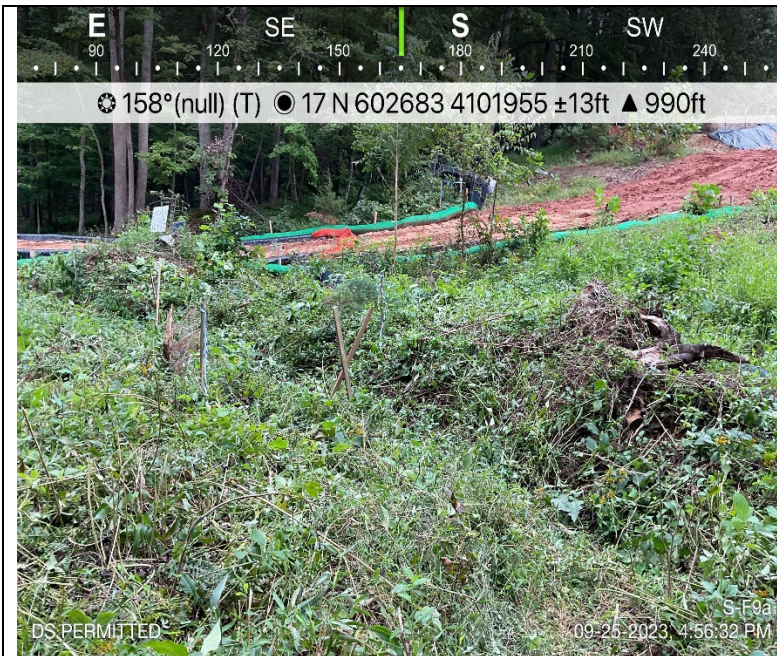
**Photo Description:** Downstream view of permitted impact area during pre-construction assessment.

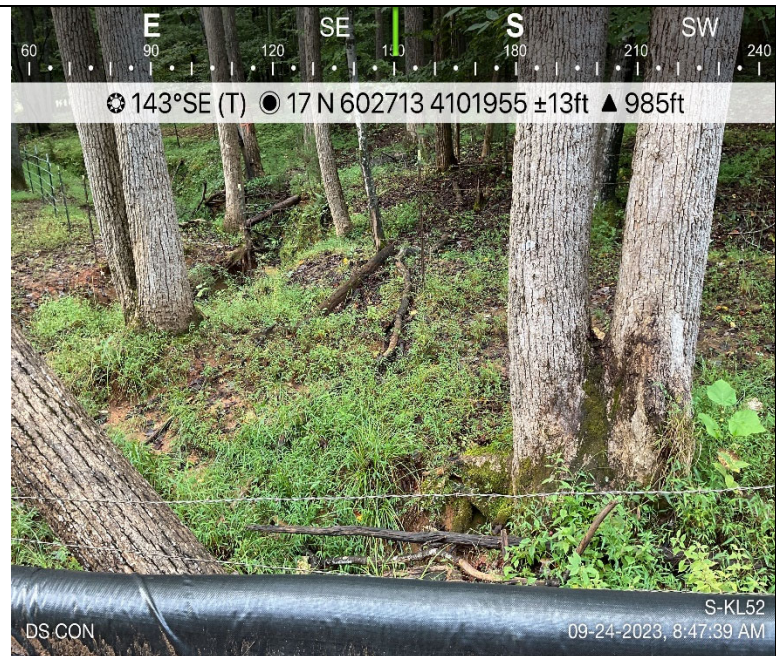
**Photo Description:** Conditions of the downstream area outside the ROW during pre-construction assessment.

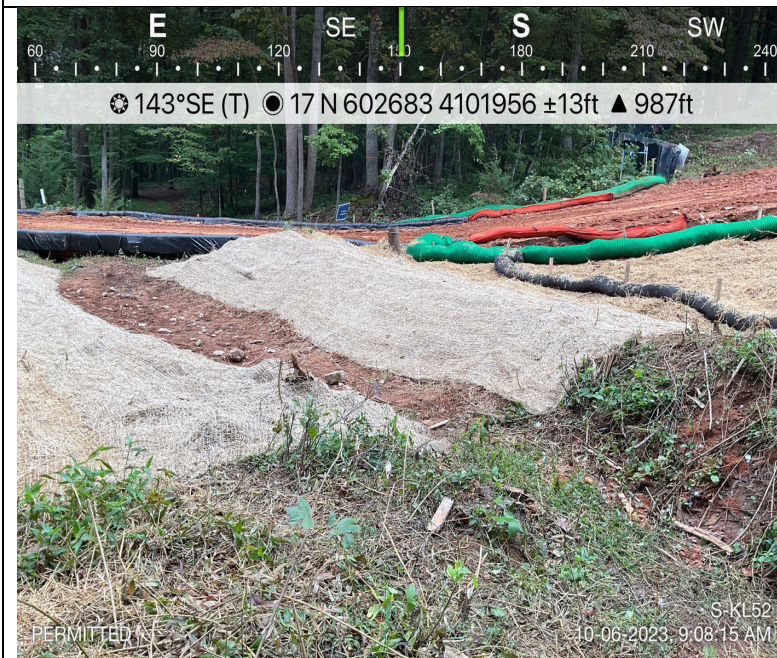
**Photo Description:** Downstream view of permitted impact area during post-construction assessment.

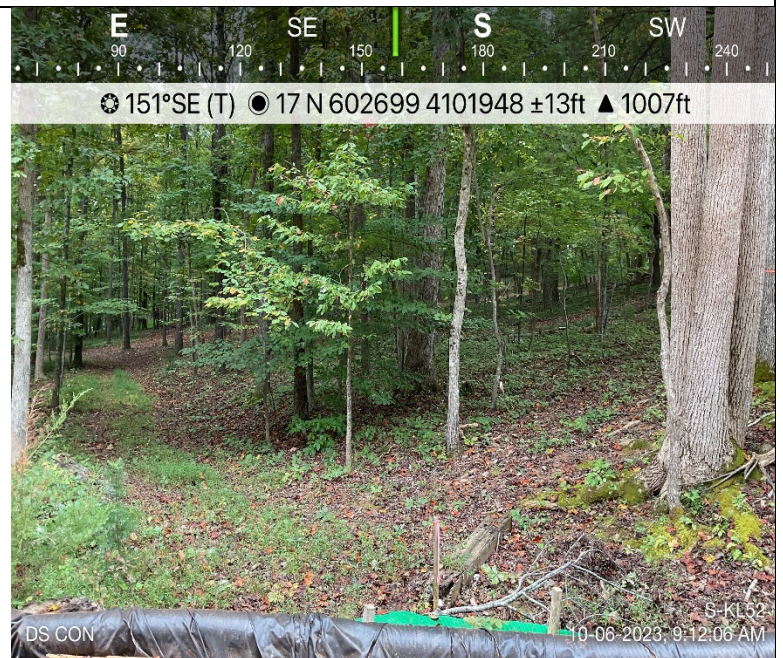
**Photo Description:** Conditions of the downstream area outside the ROW during post-construction assessment.

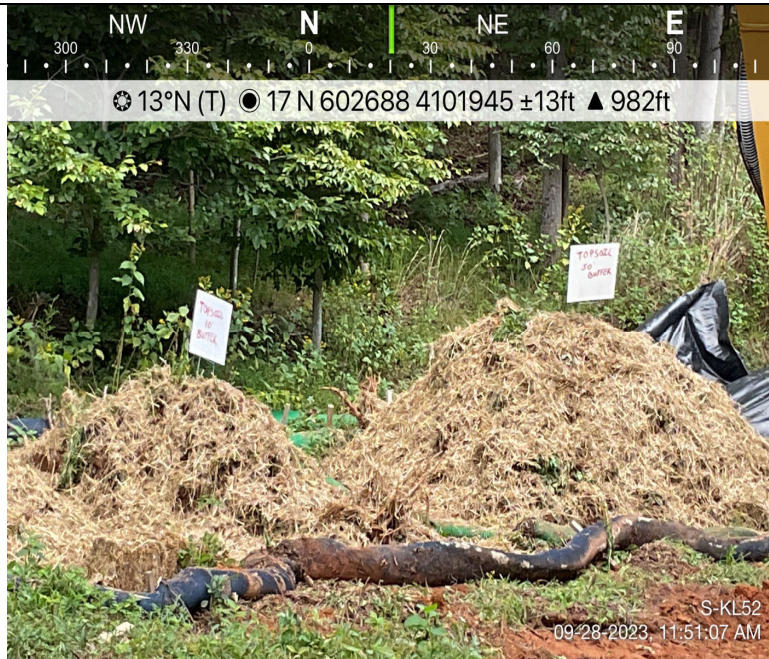
**Photo Description:** Topsoil stockpiles with stabilization.

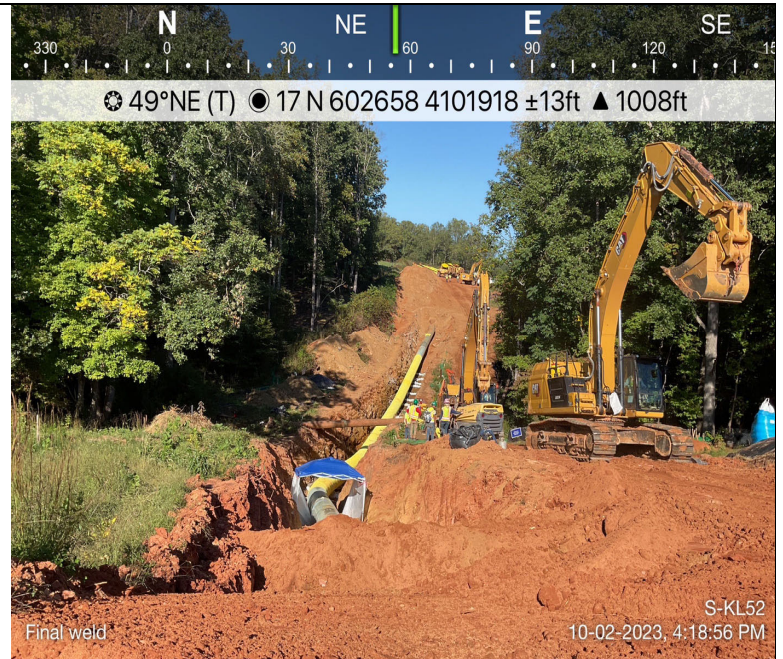
**Photo Description:** Trench excavated, and pipe lowered in.

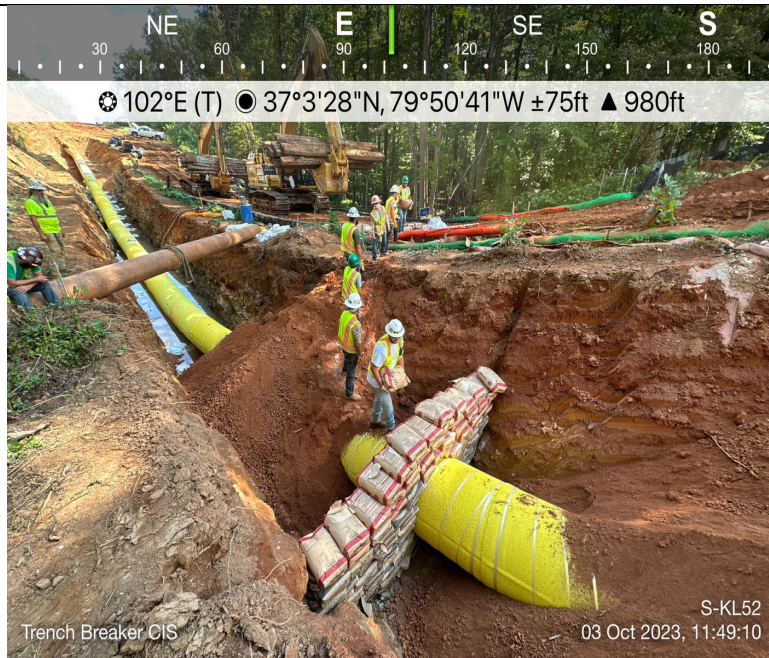
**Photo Description:** Trench breaker installation on coming in side of stream resource. Flume remained installed during crossing activities.

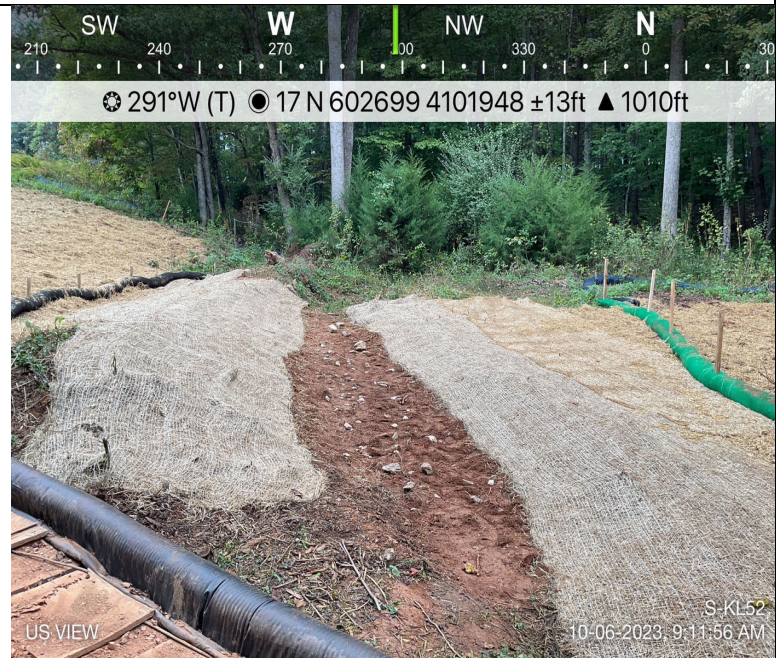
**Photo Description:** Restoration and stabilization of resource impact area.
