Stream Biological Conditions EA Report

Project Name	H-600 Pipeline Spread D	AFE	124300132	Spread	H-600 Pipeline Spread D
Contractor	Precision	Report #	334		
Environmental Auditor	Scott Wessel	Date/Time	10/31/2023 7:09 AM		
Stream ID	S-L35-2	Crossing Start Date	10/31/2023	Crossing Completion Date	11/6/2023
Milepost	124.92	Pre-Con Assessment Date	10/31/2023	Post-Con Assessment Date	11/6/2023
Station	6595+84	Bankfull Width (ft.)	4.0	Riffle:Pool Complexes Present?	No
State	WV	Stream Classification	Perennial		
County	Nicholas	303(d) Impairment Listing	No

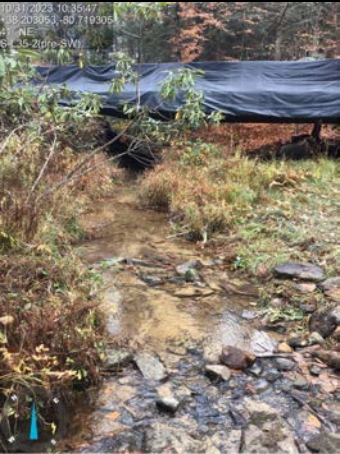
GPS Location	See coordinates in above photo.	GPS Location	See coordinates in above photo.
Description	Downstream view of permitted impact area during pre-construction assessment.	Description	Downstream view of unimpacted area during pre-construction assessment.

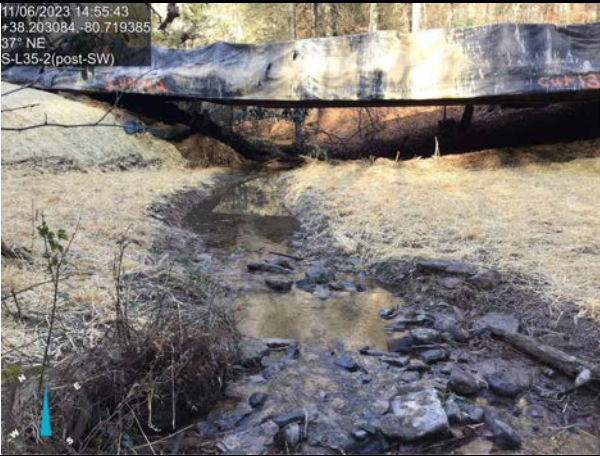
GPS Location	See coordinates in above photo.	GPS Location	See coordinates in above photo.
Description	Downstream view of permitted impact area during post-construction assessment.	Description	Downstream view of unimpacted area during post-construction assessment.

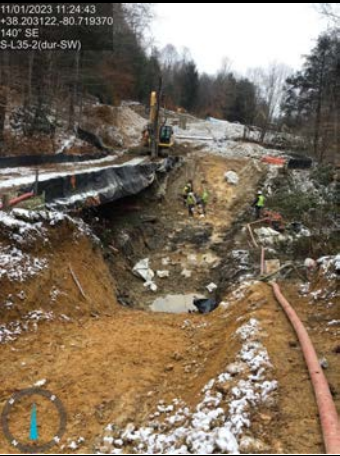
GPS Location	See coordinates in above photo.	GPS Location	See coordinates in above photo.
Description	Blasting crew on site drilling to set charges on the GAS of resource.	Description	Contractor removing spoils from ditch once blasting crew was done.
