Stream Biological Conditions EA Report

Project Name	H-600 Pipeline Spread D	AFE	124300132	Spread	H-600 Pipeline Spread D
Contractor	Precision	Report #	335		
Environmental Auditor	Scott Wessel	Date/Time	10/31/2023 8:20 AM		
Stream ID	S-L35-3	Crossing Start Date	10/31/2023	Crossing Completion Date	11/7/2023
Milepost	125.16	Pre-Con Assessment Date	10/31/2023	Post-Con Assessment Date	11/7/2023
Station	6608+41	Bankfull Width (ft.)	4.0	Riffle:Pool Complexes Present?	No
State	WV	Stream Classification	Perennial		
County	Nicholas	303(d) Impairment Listing	No

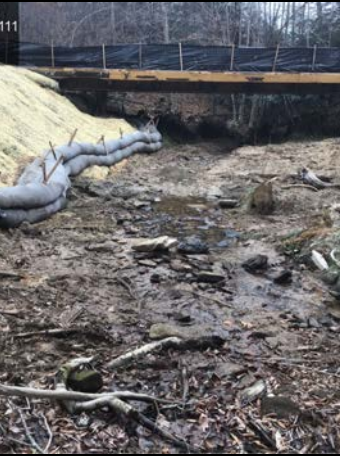
AFE	124300132	Date/Time	10/31/2023 8:20 AM	Report #	335				
Required Photos									
  <p>10/31/2023 10:11:22 +38.200292,-80.717049 315° NW S-L35-3(pre-SW)</p>		  <p>10/31/2023 13:14:20 +38.200396,-80.717203 355° N S-L35-3(pre-SW)</p>		GPS Location	See coordinates in above photo.				
Description	Downstream view of permitted impact area during pre-construction assessment.	Description	Downstream view of unimpacted area during pre-construction assessment.

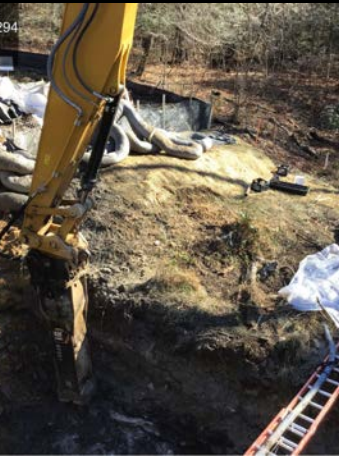
<p>11/07/2023 14:08:45 +38.200292,-80.717111 325° NW S-L35-3(post-SW)</p>		  <p>11/07/2023 14:14:00 +38.200404,-80.717256 348° N S-L35-3(post-SW)</p>		GPS Location	See coordinates in above photo
Description	Downstream view of permitted impact area during post-construction assessment.	Description	Downstream view of unimpacted area during post-construction assessment.	  <p>11/03/2023 10:46:50 +38.200163,-80.717305 024° NE S-L35-3(dur-SW)</p>
