Stream Biological Conditions EA Report

Project Name	H-600 Pipeline Spread D	AFE	124300132	Spread	H-600 Pipeline Spread D
Contractor	Precision	Report #	314		
Environmental Auditor	Scott Wessel	Date/Time	10/23/2023 8:06 PM		
Stream ID	S-L38	Crossing Start Date	10/24/2023	Crossing Completion Date	10/29/2023
Milepost	124.73	Pre-Con Assessment Date	10/23/2023	Post-Con Assessment Date	10/29/2023
Station	6585+84	Bankfull Width (ft.)	3.0	Riffle:Pool Complexes Present?	No
State	WV	Stream Classification	Perennial		
County	Nicholas	303(d) Impairment Listing	No

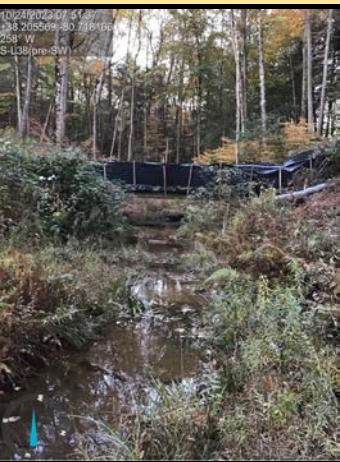
GPS Location	See GPS in above photo.
Description	Downstream view of permitted impact area during pre-construction assessment.	Description	Downstream view of unimpacted area during pre-construction assessment.

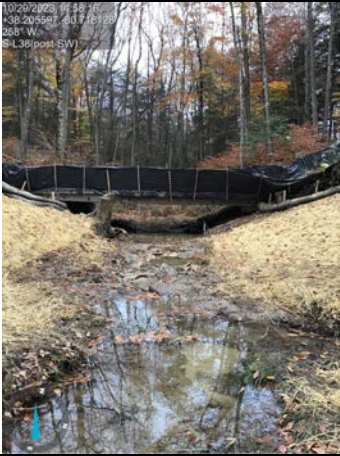
GPS Location	See GPS in above photo.	GPS Location	See GPS in above photo.	Description	Downstream view of permitted impact area during post-construction assessment.

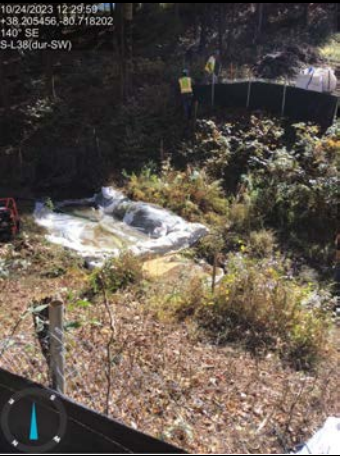
GPS Location	See GPS in above photo.
Description	Pump and dam being installed for stream S-L38.	Description	Large boulders and substrate material being segregated on the GAS of stream.

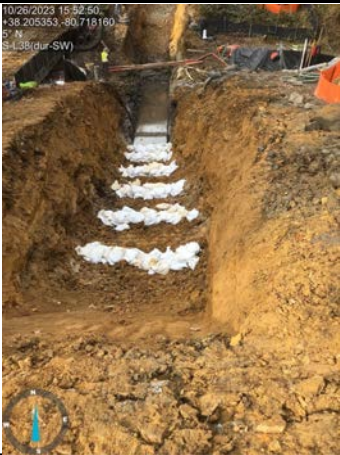
<p>10/26/2023 15:52:50 +38 205353 -80 718160 5° N S-L38(dur-SW)</p>

<p>10/27/2023 10:10:05 +38 205358 -80 718255 340° N S-L38(dur-SW)</p>		GPS Location	See GPS in above photo.	GPS Location	See GPS in above photo.
Description	Trench being lined with sandbags and dewatering operations.	Description	Pipe section being installed. Ditch water was being pumped out utilizing dewatering structure.

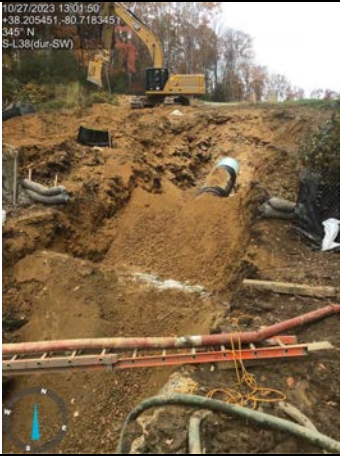
<p>10/27/2023 13:01:40 +38 205451 -80 718345 345° N S-L38(dur-SW)</p>

<p>10/27/2023 13:39:26 +38 205388 -80 718182 23° NE S-L38(dur-SW)</p>		GPS Location	See GS in above photo.	GPS Location	See GPS in above photo.
Description	Pipe being padded on the CIS after breakers were installed.	Description	Breaker being installed on the CIS of resource.

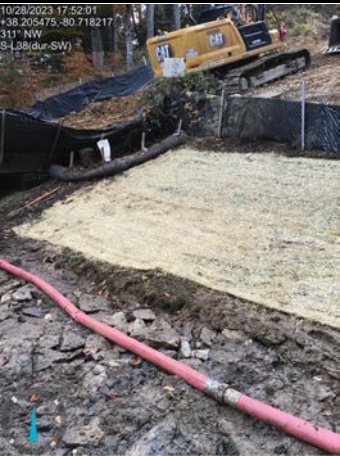
<p>10/28/2023 17:52:01 +38 205475 -80 718217 311° NW S-L38(dur-SW)</p>

Description	Erosion control blanket and super silt fence installed on the CIS of S-L38.	Description	Pump and dam being removed once S-L38 was completed.
