STREAM BIOLOGICAL CONDITIONS ENVIRONMENTAL AUDITOR REPORT

Stream ID: S-MM15	Crossing Start Date: 09/27/2023	Crossing Completion Date: 10/06/2023
Milepost: 228.5	Pre-Con Assessment Date: 09/26/2023	Post-Con Assessment Date: 10/09/2023
Station: 12076+95	Stream Classification: Intermittent (Perennial, Intermittent, Ephemeral)	Bankfull Width (ft.): 6
County: Montgomery	303(d) Impairment Listing: Not Impaired	Riffle:Pool Complexes Present? No

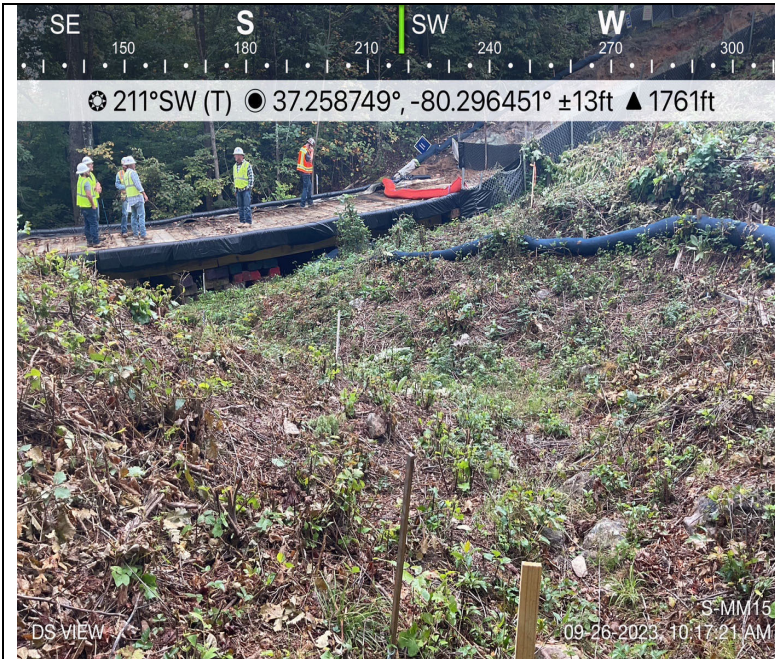
Photo Description: Downstream view of permitted impact area during pre-construction assessment.

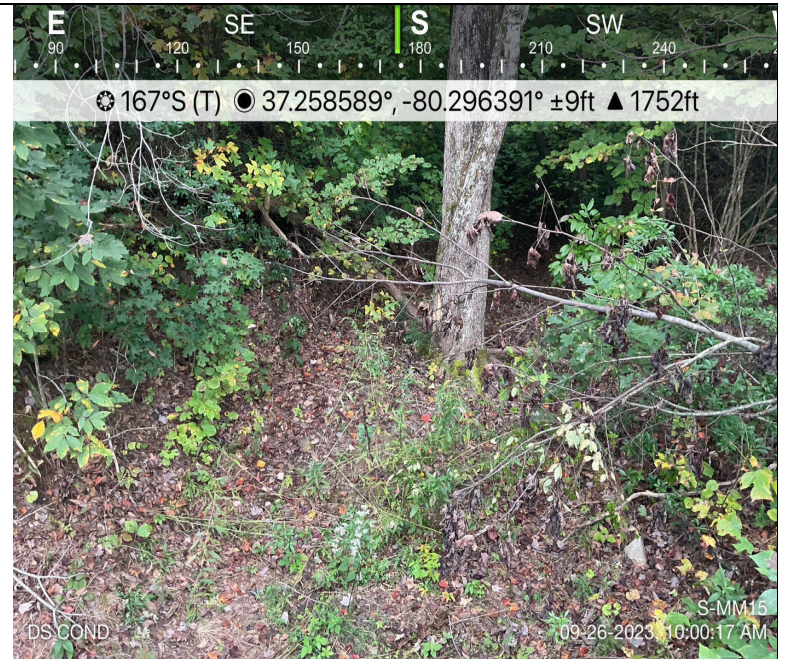
Photo Description: Conditions of the downstream area outside the ROW during pre-construction assessment.

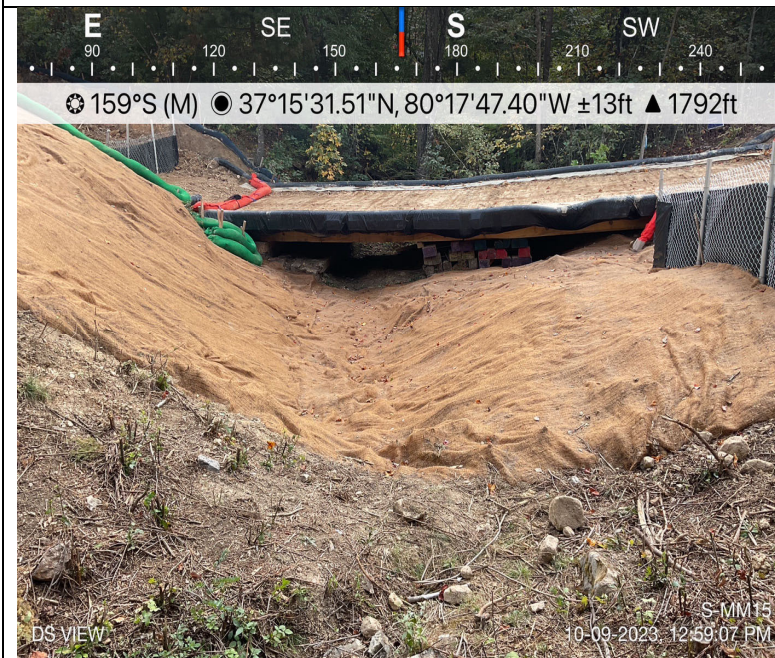
Photo Description: Downstream view of permitted impact area during post-construction assessment.

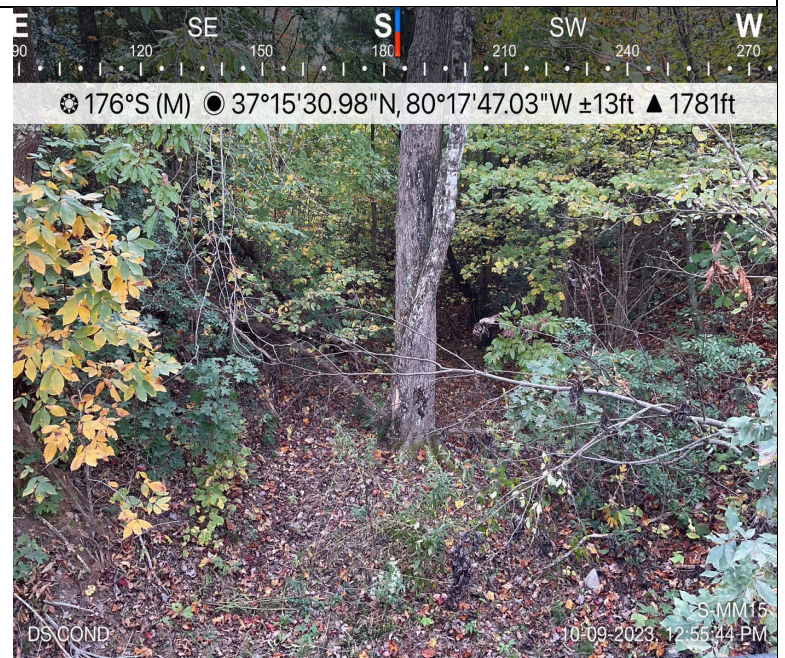
Photo Description: Conditions of the downstream area outside the ROW during post-construction assessment.

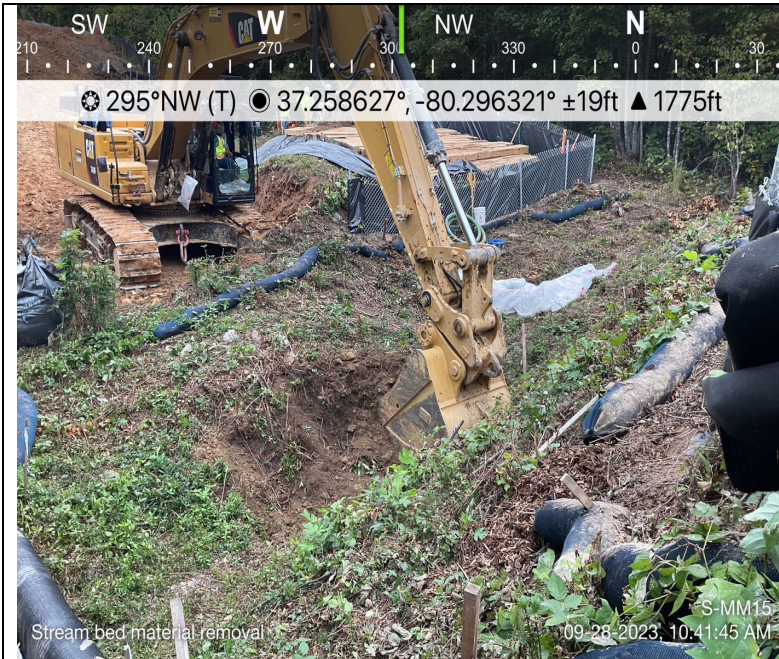
Photo Description: Stream bed topsoil removal.

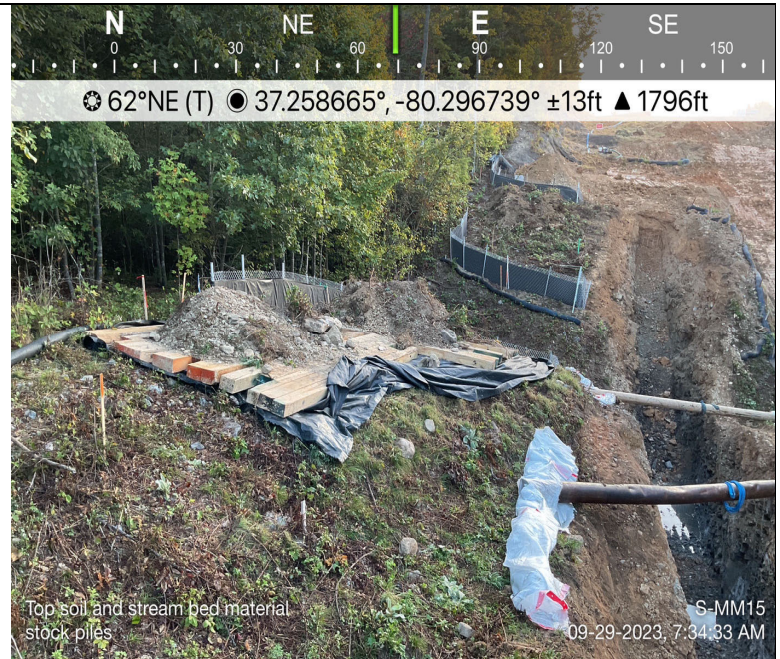
Photo Description: Segregated topsoil piles.

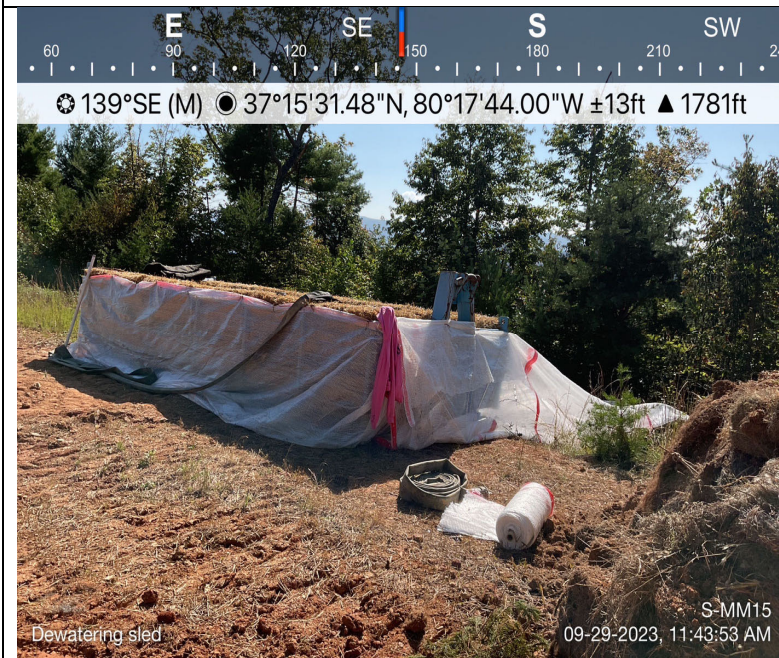
Photo Description: Dewatering sled.

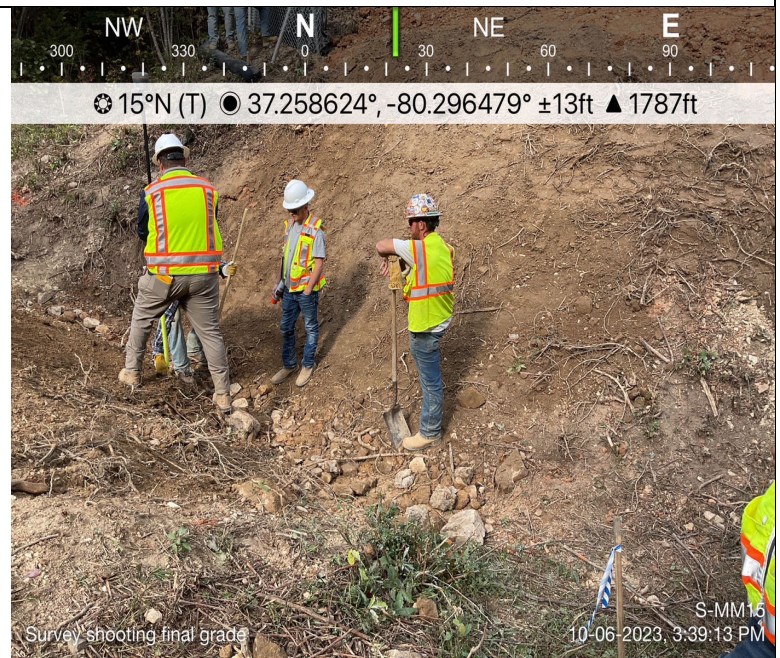
Photo Description: Final grade survey shots.
