STREAM BIOLOGICAL CONDITIONS ENVIRONMENTAL AUDITOR REPORT

Stream ID: S-MM18	Crossing Start Date: 10/16/2023	Crossing Completion Date: 10/26/2023
Milepost: 213.7	Pre-Con Assessment Date: 10/06/2023	Post-Con Assessment Date: 10/26/2023
Station: 11292+80	Stream Classification: Ephemeral (Perennial, Intermittent, Ephemeral)	Bankfull Width (ft.): 5
County: Giles	303(d) Impairment Listing: Not Impaired	Riffle:Pool Complexes Present? No

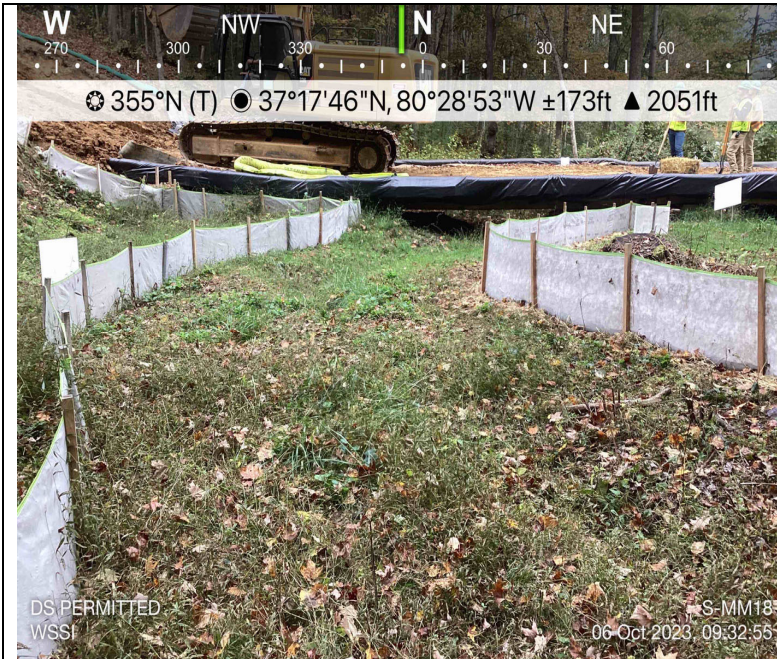
Photo Description: Downstream view of permitted impact area during pre-construction assessment.

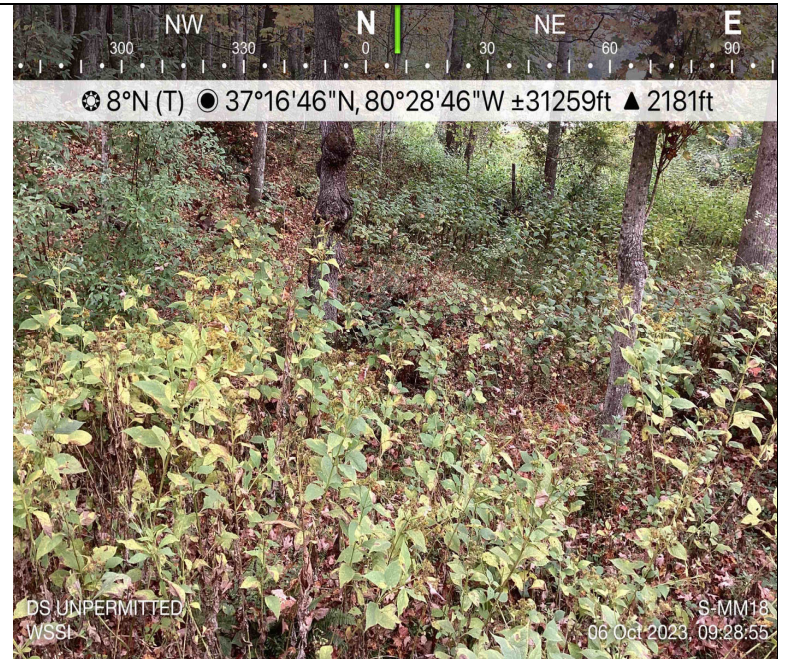
Photo Description: Conditions of the downstream area outside the ROW during pre-construction assessment.

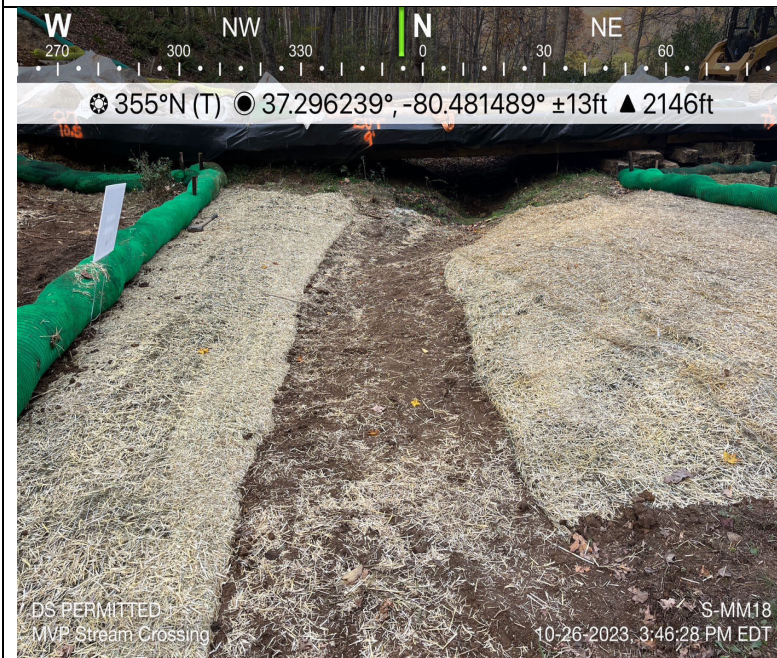
Photo Description: Downstream view of permitted impact area during post-construction assessment.

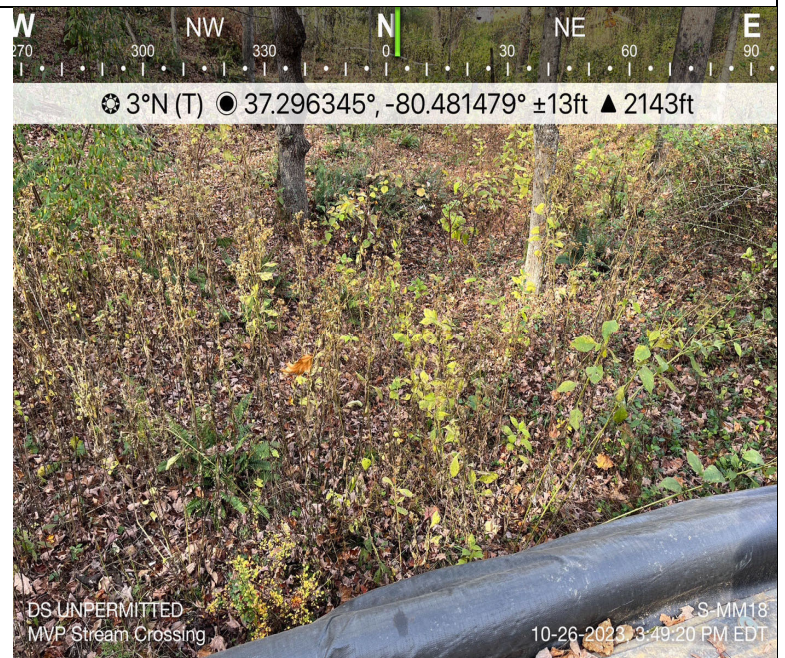
Photo Description: Conditions of the downstream area outside the ROW during post-construction assessment.

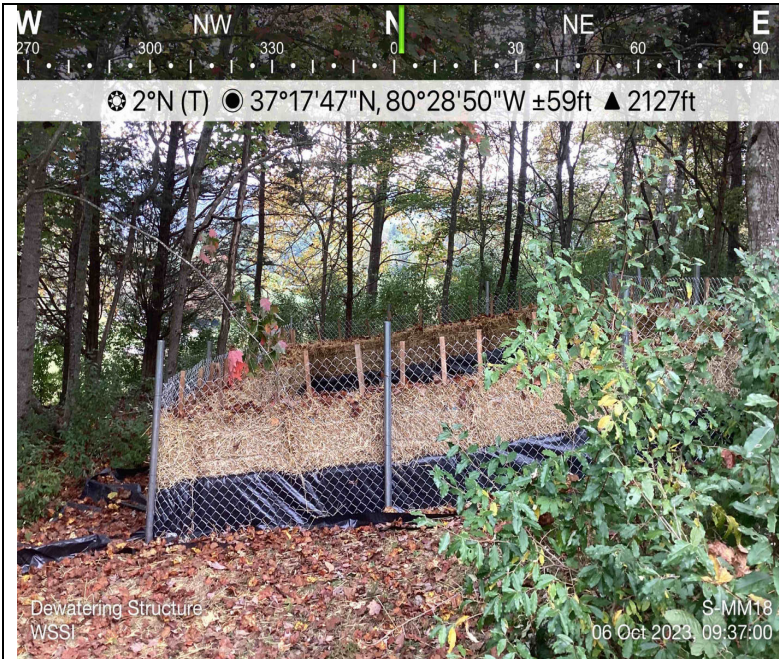
Photo Description: Dewatering structure located off of the LOD with project permissions.

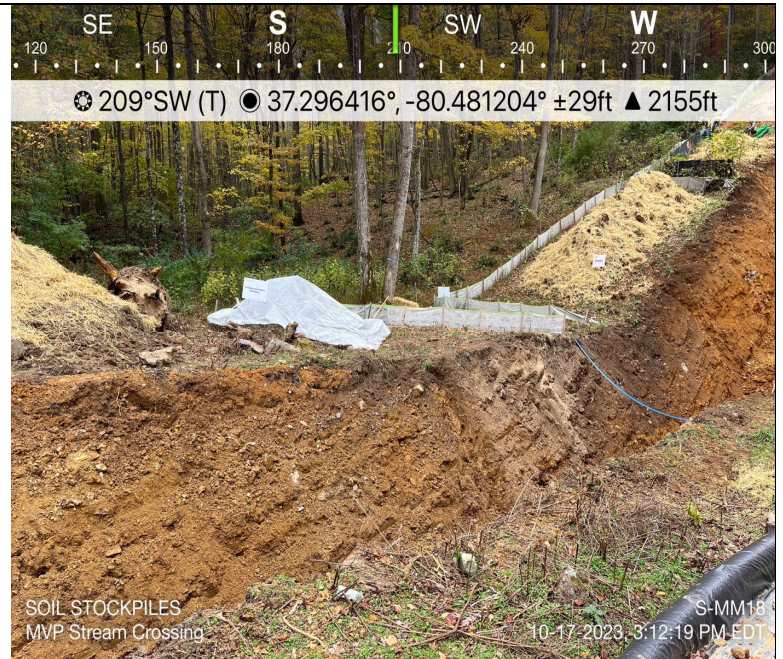
Photo Description: Topsoil and stream substrate stockpiles. Dam and pump installed for conveyance for stream flow, if needed.

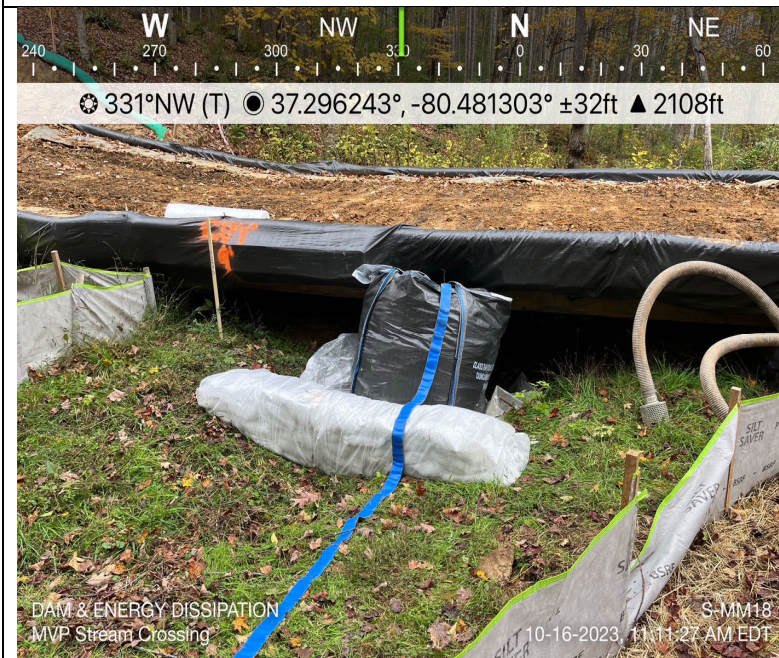
Photo Description: Dam and energy dissipation bag.

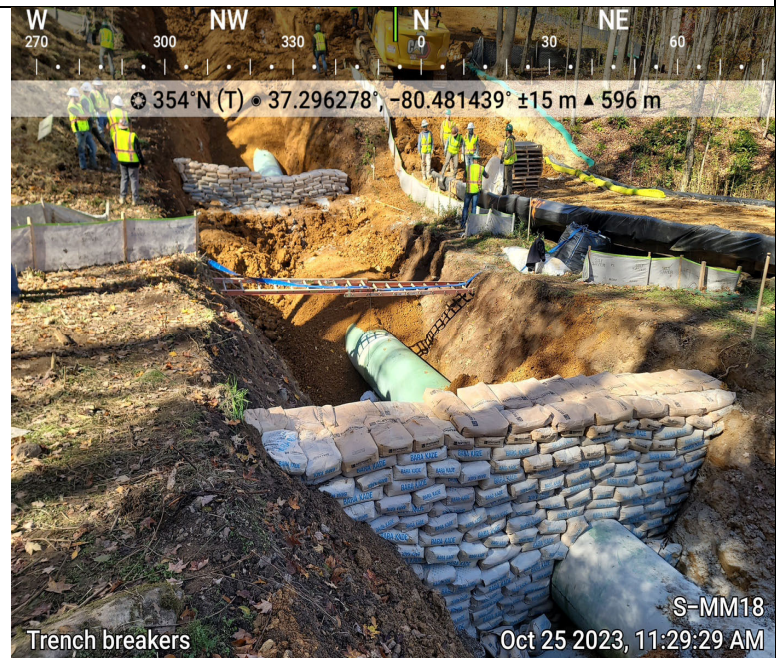
Photo Description: Trench breakers installed over the pipe.
