STREAM BIOLOGICAL CONDITIONS ENVIRONMENTAL AUDITOR REPORT

Version 2.3

Stream ID: S-MM42	Crossing Start Date: 09/28/2023	Crossing Completion Date: 09/29/2023
Milepost: 260.6	Pre-Con Assessment Date: 09/24/2023	Post-Con Assessment Date: 10/02/2023
Station: 13770+40	Stream Classification: Ephemeral (Perennial, Intermittent, Ephemeral)	Bankfull Width (ft.): 2
County: Franklin	303(d) Impairment Listing: Not Impaired	Riffle:Pool Complexes Present? No

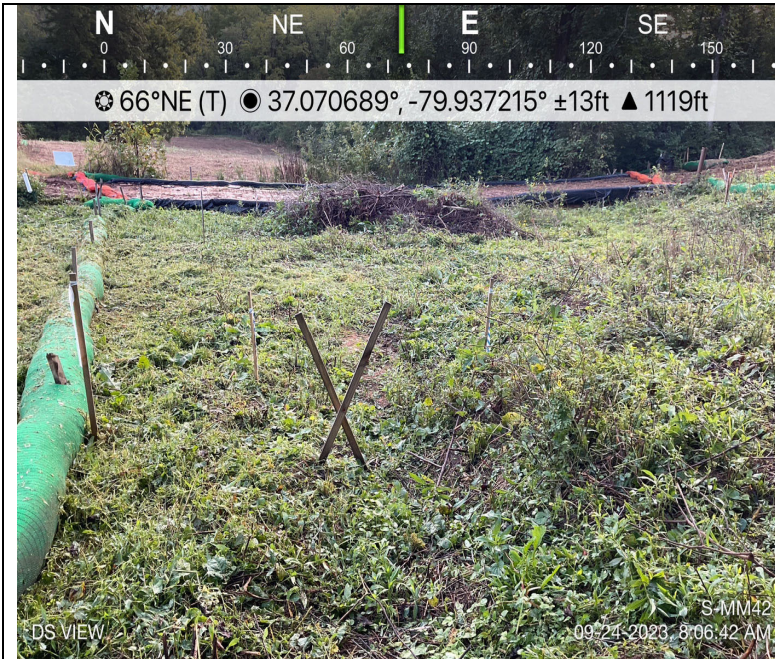
Photo Description: Downstream view of permitted impact area during pre-construction assessment.

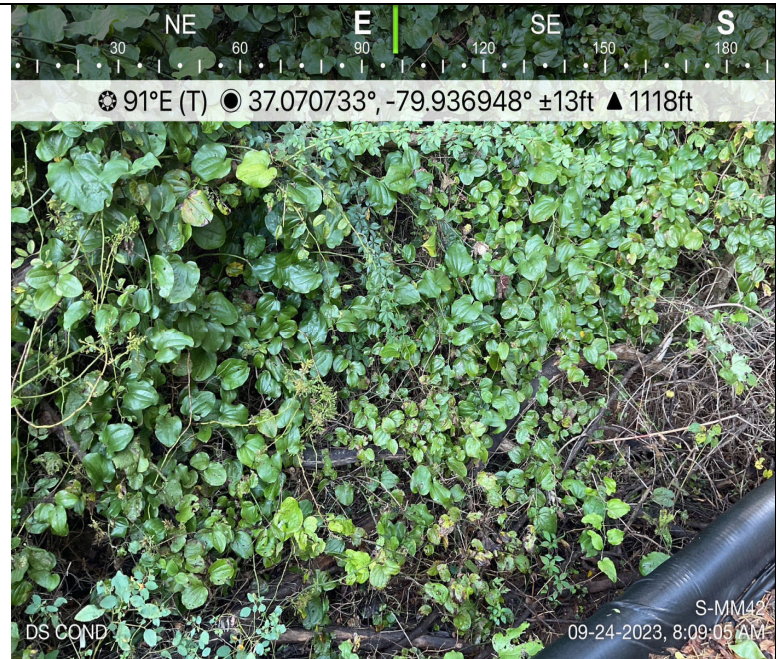
Photo Description: Conditions of the downstream area outside the ROW during pre-construction assessment.

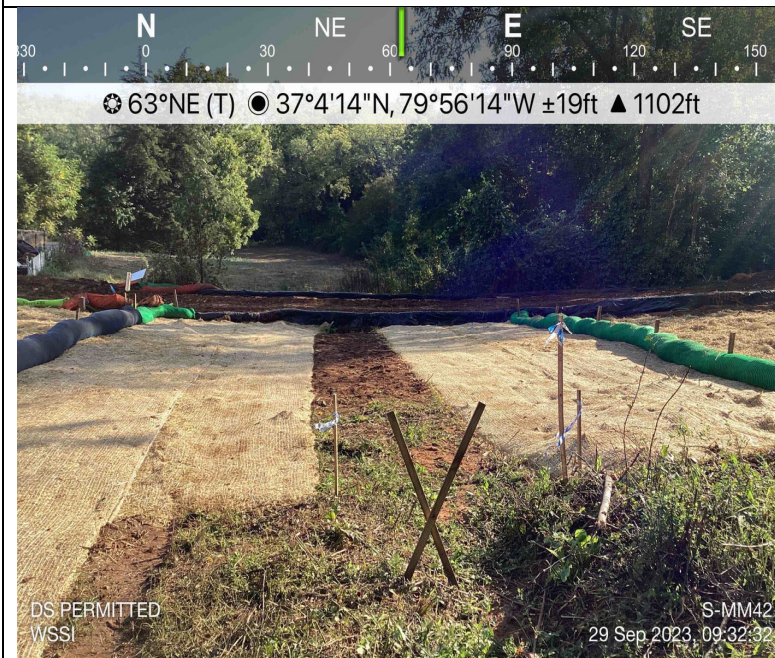
Photo Description: Downstream view of permitted impact area during post-construction assessment.

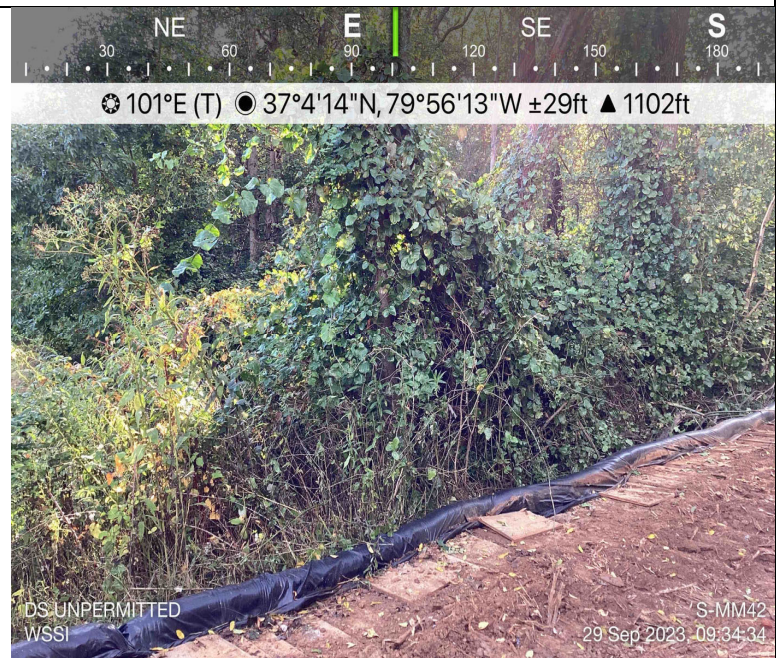
Photo Description: Conditions of the downstream area outside the ROW during post-construction assessment.

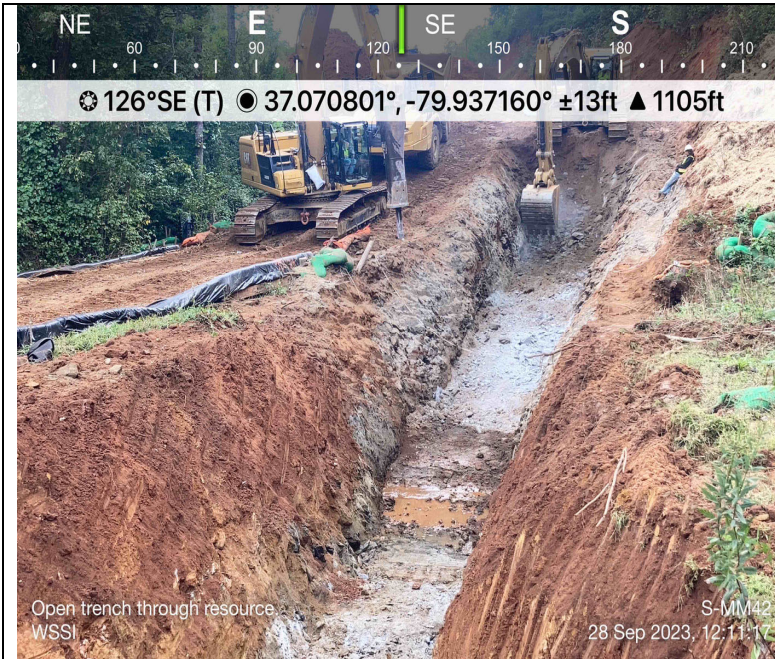
Photo Description: Open trench through resource.

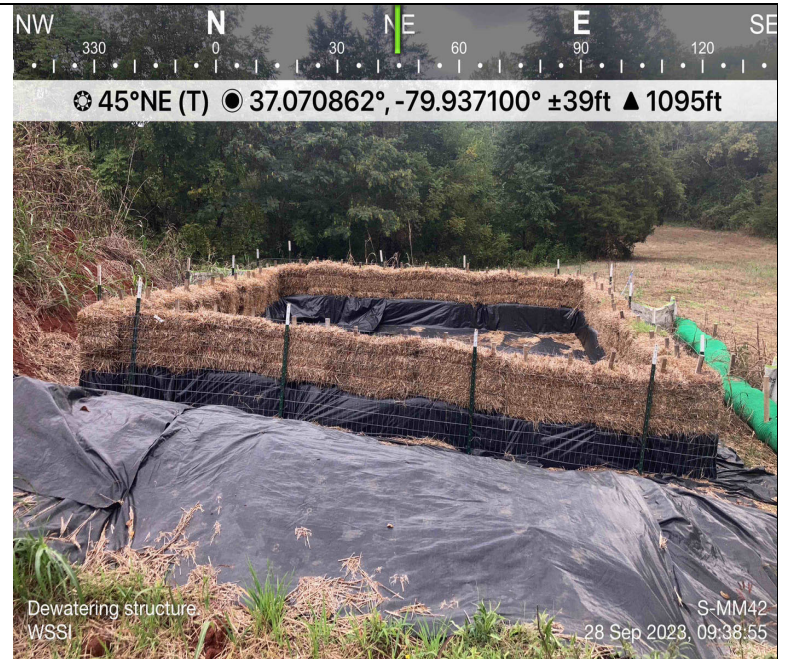
Photo Description: Dewatering structure

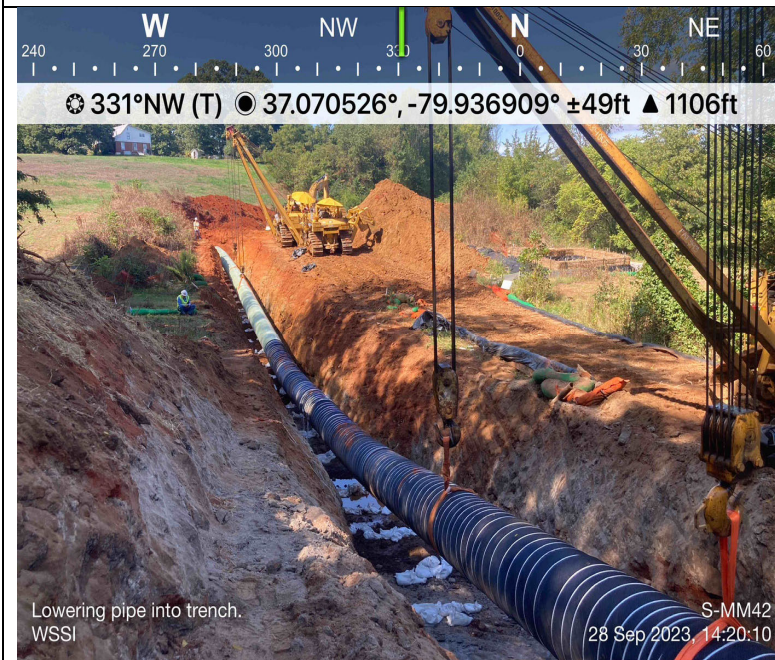
Photo Description: Pipe lowering in to resource.

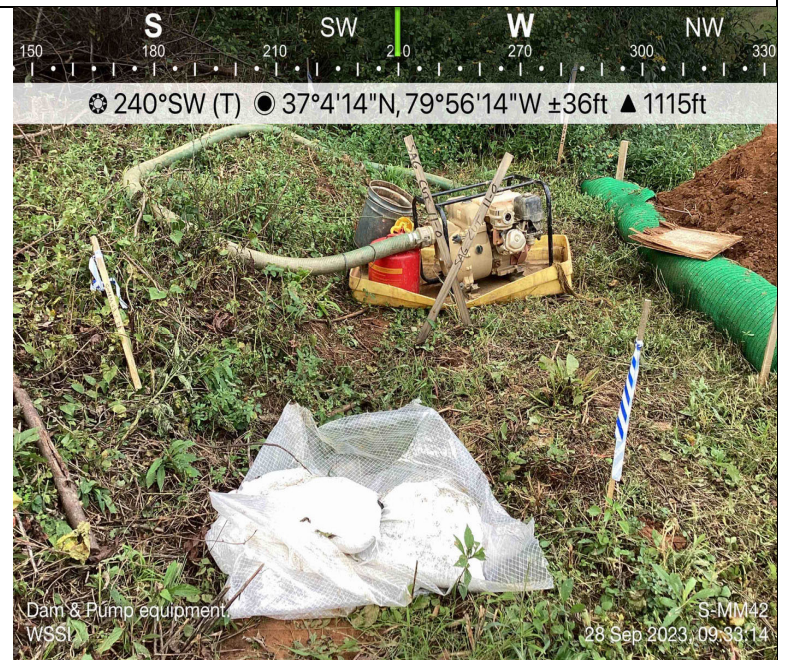
Photo Description: Dam and pump materials installed for crossing. Resource was dry during crossings, and pump arrounds were not needed to convey water around workspace.
