STREAM BIOLOGICAL CONDITIONS ENVIRONMENTAL AUDITOR REPORT

| Stream ID: S-MN21 | Crossing Start Date: 09/18/2023 | Crossing Completion Date: 09/25/2023 |
| Milepost: 221.2 | Pre-Con Assessment Date: 09/01/2023 | Post-Con Assessment Date: 09/25/2023 |
| Station: 11687+42 | Stream Classification: Perennial (Perennial, Intermittent, Ephemeral) | Bankfull Width (ft.): 7 |

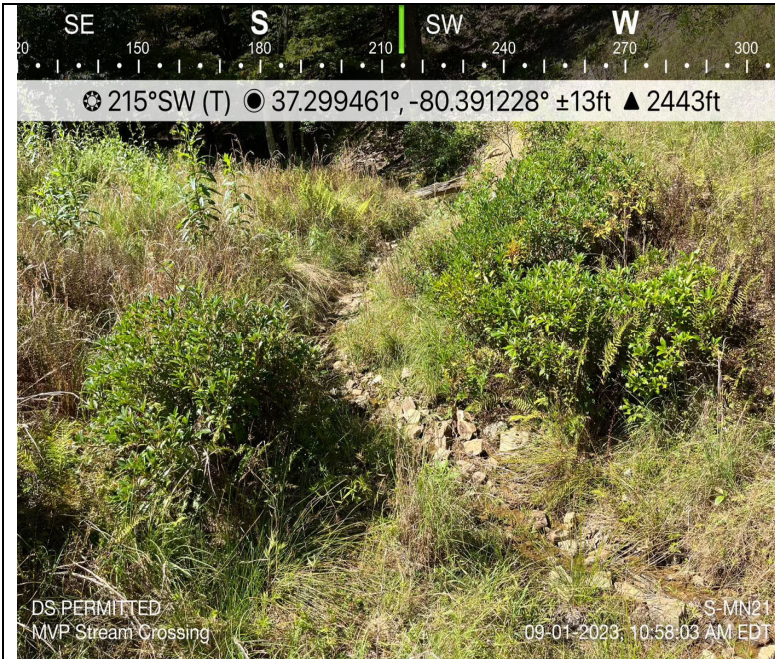
Photo Description: Downstream view of permitted impact area during pre-construction assessment.

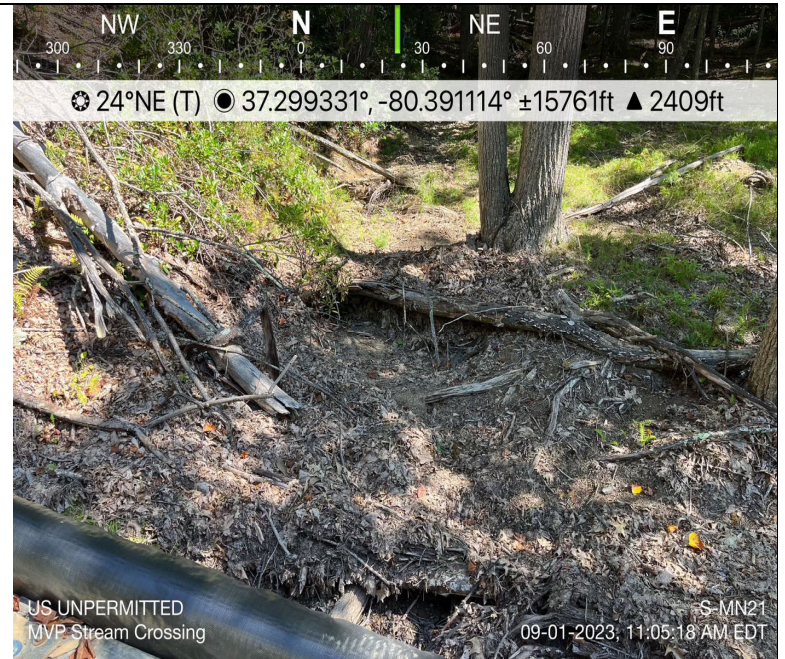
Photo Description: Conditions of the downstream area outside the ROW during pre-construction assessment.

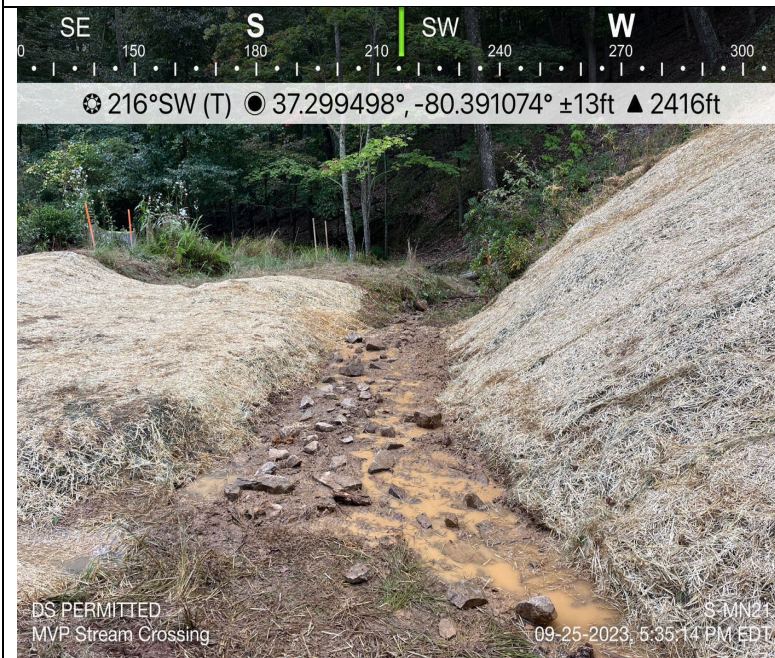
Photo Description: Downstream view of permitted impact area during post-construction assessment.

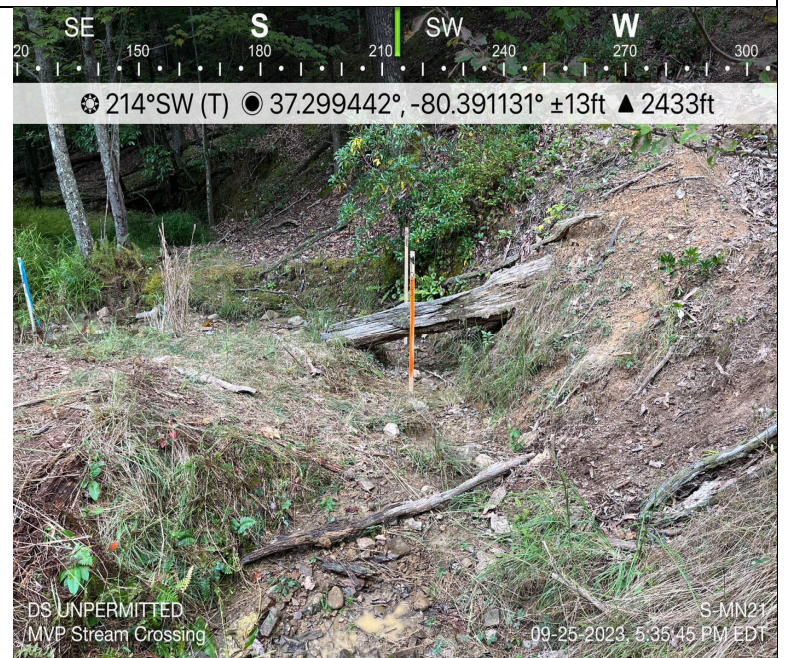
Photo Description: Conditions of the downstream area outside the ROW during post-construction assessment.

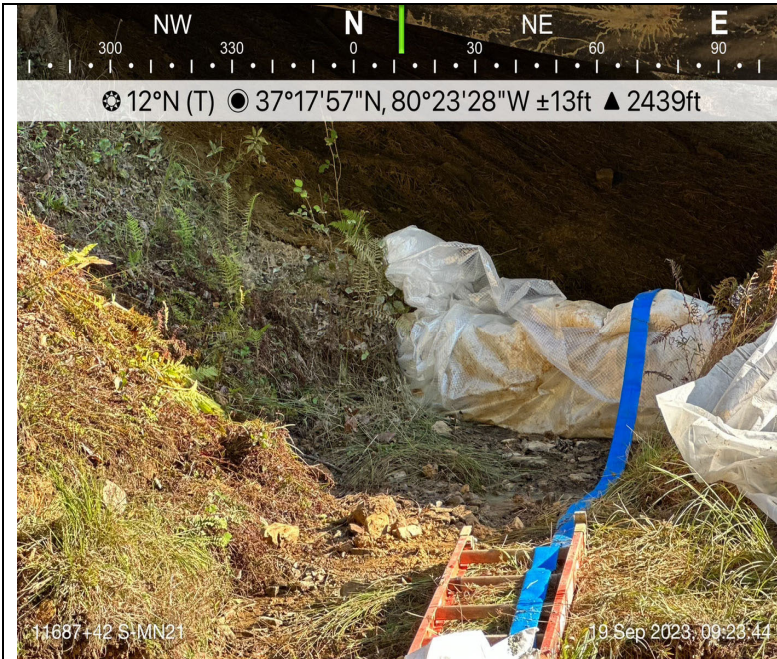
Photo Description: Dam & pump installed and operated throughout crossing.

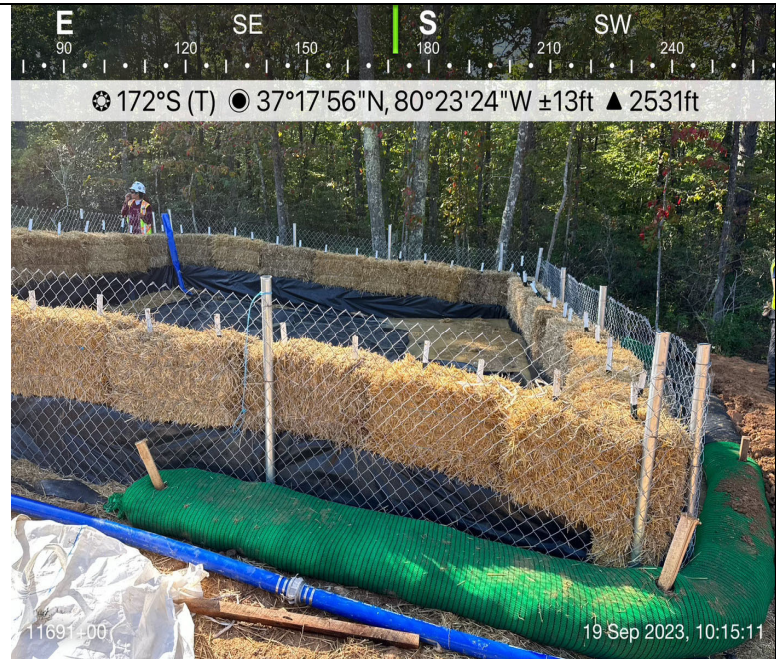
Photo Description: De-watering structure set up for use throughout crossing.

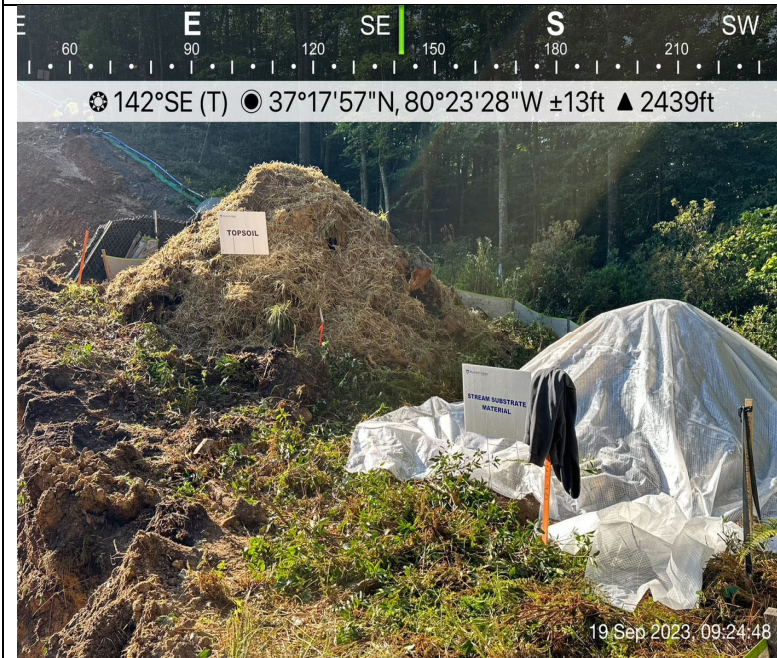
Photo Description: Soil and streambed stockpiles.

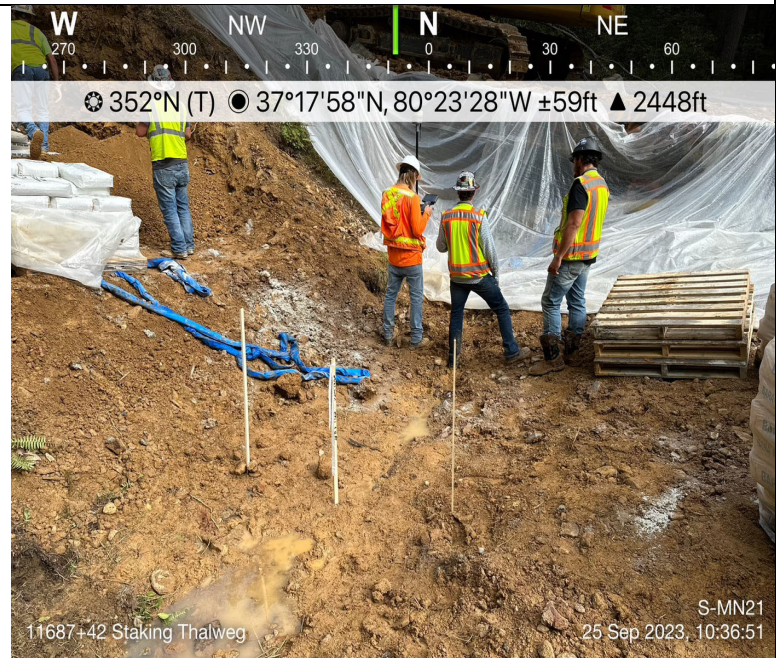
Photo Description: Survey stake out for restoration crews.
