Stream Biological Conditions EA Report

Project Name	H-600 Pipeline Spread D	AFE	124300132	Spread	H-600 Pipeline Spread D
Contractor	Precision	Report #	343		
Environmental Auditor	Gary Cruz	Date/Time	11/8/2023 10:10 AM		
Stream ID	S-N10-braid	Crossing Start Date	11/4/2023	Crossing Completion Date	11/11/2023
Milepost	122.72	Pre-Con Assessment Date	11/4/2023	Post-Con Assessment Date	11/11/2023
Station	6479+56	Bankfull Width (ft.)	3.0	Riffle:Pool Complexes Present?	No
State	WV	Stream Classification	Intermittent		
County	Nicholas	303(d) Impairment Listing	No

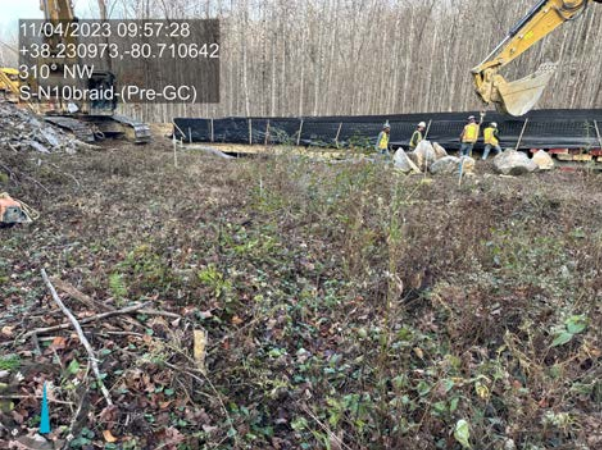
GPS Location	See photo above	GPS Location	See photo above
Description	Downstream view of permitted impact area during pre-construction assessment.	Description	Downstream view of unimpacted area during pre-construction assessment.

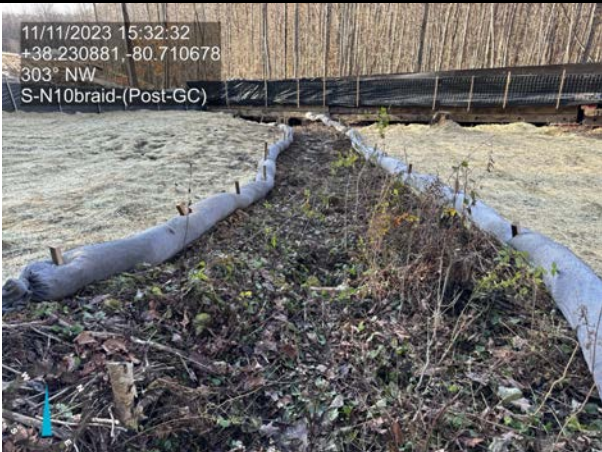
GPS Location	See photo above	GPS Location	See photo above
Description	Downstream view of permitted impact area during post-construction assessment.	Description	Downstream view of unimpacted area during post-construction assessment.

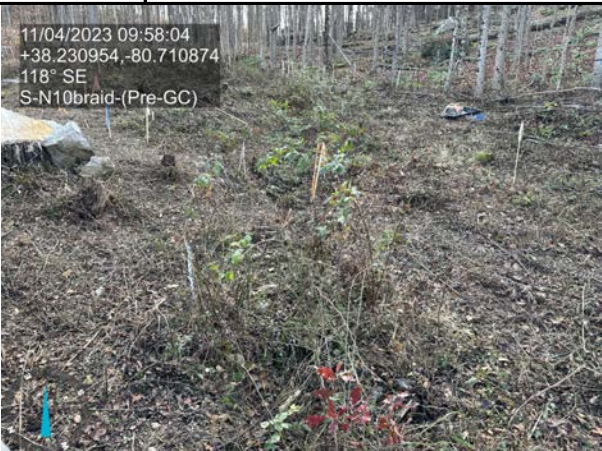
GPS Location	See photo above	GPS Location	See photo above
Description	Upstream view of permitted impact area during pre-construction assessment.	Description	Operator removing the top 12" of substrate from stream feature.
