# Stream Biological Conditions EA Report

<b>Project Name</b>	H-600 Pipeline Spread D	<b>AFE</b>	124300132	<b>Spread</b>	H-600 Pipeline Spread D
<b>Contractor</b>	Precision	<b>Report #</b>	344		
<b>Environmental Auditor</b>	Gary Cruz	<b>Date/Time</b>	11/8/2023 10:39 AM		
<b>Stream ID</b>	S-N10	<b>Crossing Start Date</b>	11/6/2023	<b>Crossing Completion Date</b>	11/11/2023
<b>Milepost</b>	122.71	<b>Pre-Con Assessment Date</b>	11/6/2023	<b>Post-Con Assessment Date</b>	11/11/2023
<b>Station</b>	6478+92	<b>Bankfull Width (ft.)</b>	4.0	<b>Riffle:Pool Complexes Present?</b>	No
<b>State</b>	WV	<b>Stream Classification</b>	Perennial		
<b>County</b>	Nicholas	<b>303(d) Impairment Listing</b>	No

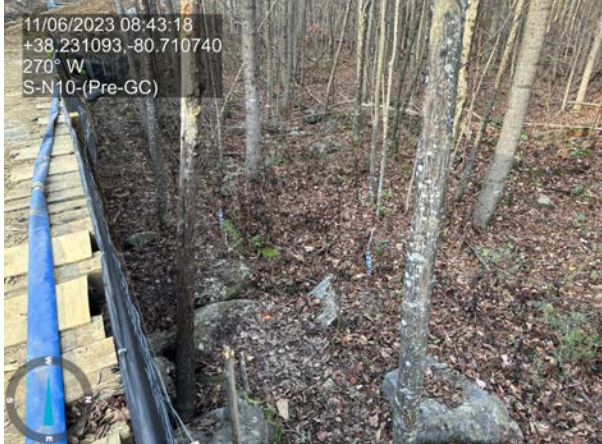
<b>GPS Location</b>	See photo above	<b>GPS Location</b>	See photo above
<b>Description</b>	Downstream view of permitted impact area during pre-construction assessment.	<b>Description</b>	Downstream view of unimpacted area during pre-construction assessment.

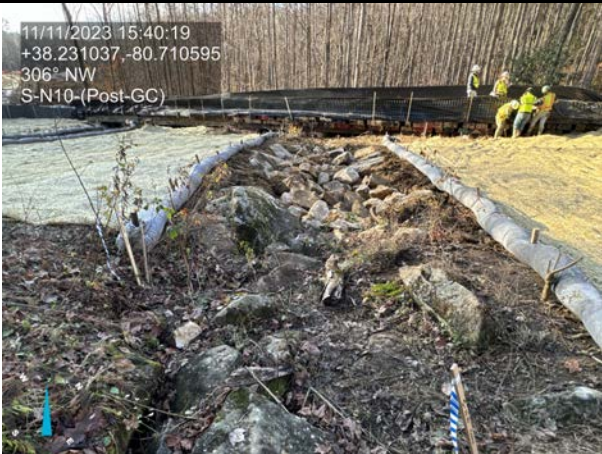
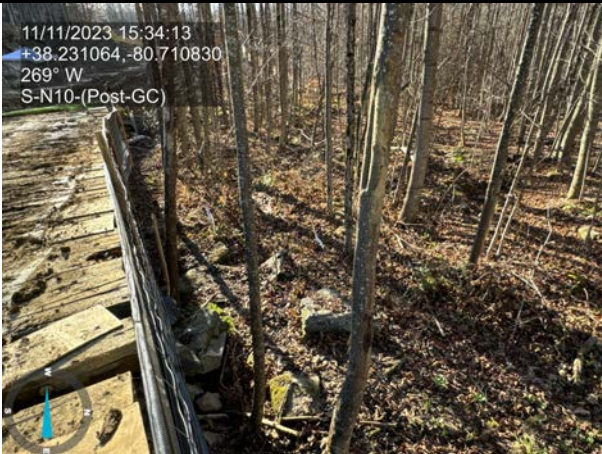
<b>GPS Location</b>	See photo above	<b>GPS Location</b>	See photo above
<b>Description</b>	Downstream view of permitted impact area during post-construction assessment.	<b>Description</b>	Downstream view of unimpacted area during post-construction assessment.

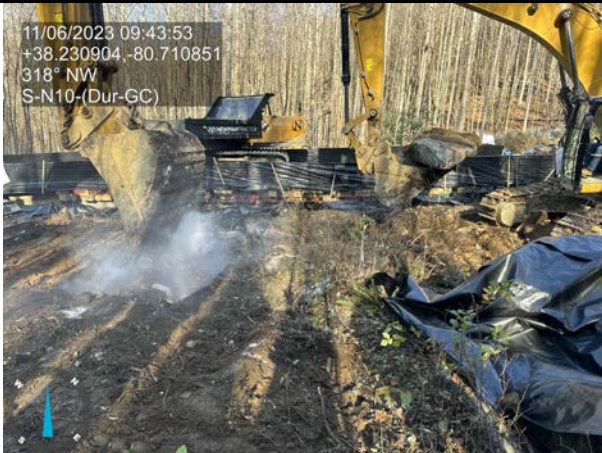
<b>GPS Location</b>	See photo above	<b>GPS Location</b>	See photo above
<b>Description</b>	Upstream view of permitted impact area during pre-construction assessment.	<b>Description</b>	Contractor removing the top 12" of substrate and boulders of stream feature.

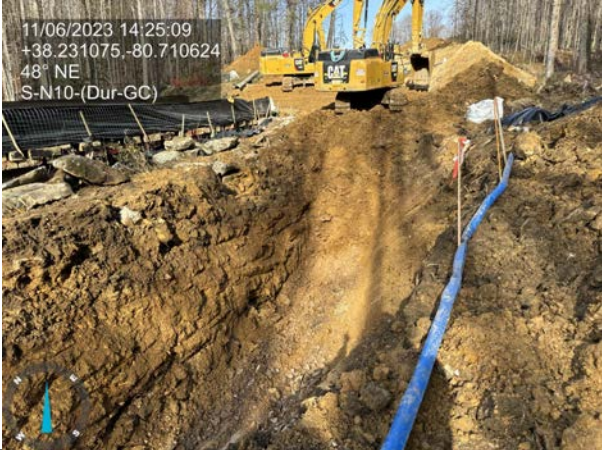
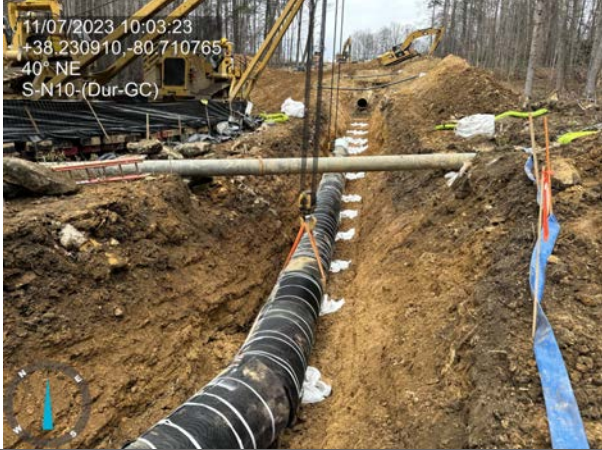
<b>GPS Location</b>	See photo above	<b>GPS Location</b>	See photo above
<b>Description</b>	The ditch line has been excavated through the stream feature.	<b>Description</b>	The stream feature section of pipe has been lowered-in.

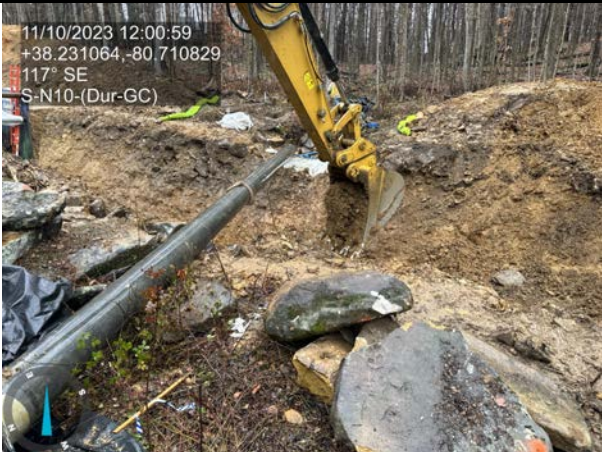
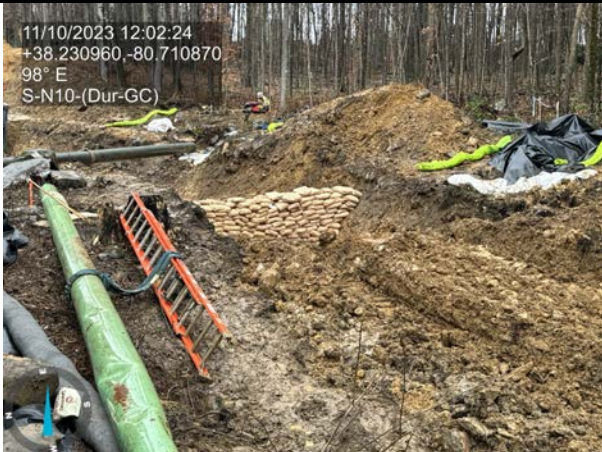
<b>GPS Location</b>	See photo above	<b>GPS Location</b>	See photo above
<b>Description</b>	Contractor backfilling stream section of ditch with subsoil.	<b>Description</b>	Impervious trench breaker has been installed the GAS of S-N10.

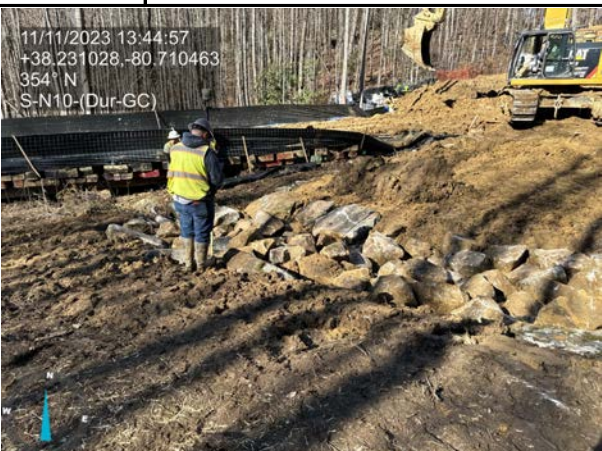
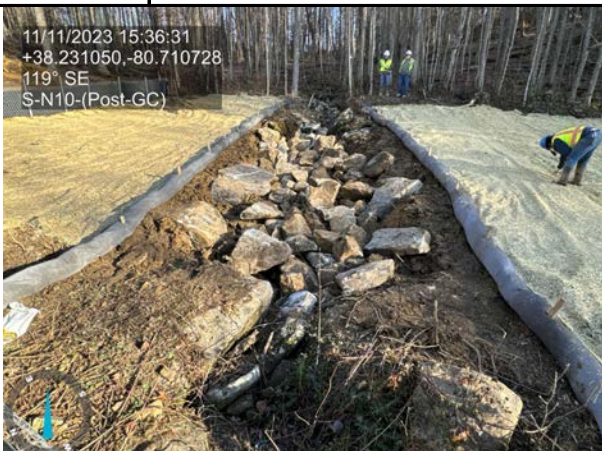
<b>GPS Location</b>	See photo above	<b>GPS Location</b>	See photo above
<b>Description</b>	Survey verifying that all elevations and contours meet pre-construction specifications.	<b>Description</b>	Upstream view of permitted impact area during post-construction assessment.
