Stream Biological Conditions EA Report

Project Name	H-600 Pipeline Spread D	AFE	124300132	Spread	H-600 Pipeline Spread D
Contractor	Precision	Report #	326		
Environmental Auditor	Kyle Gillow	Date/Time	10/28/2023 2:34 PM		
Stream ID	S-N13 Braid	Crossing Start Date	10/25/2023	Crossing Completion Date	10/27/2023
Milepost	123.11	Pre-Con Assessment Date	10/24/2023	Post-Con Assessment Date	10/28/2023
Station	6500+40	Bankfull Width (ft.)	6.0	Riffle:Pool Complexes Present?	No
State	WV	Stream Classification	Intermittent		
County	Nicholas	303(d) Impairment Listing	No

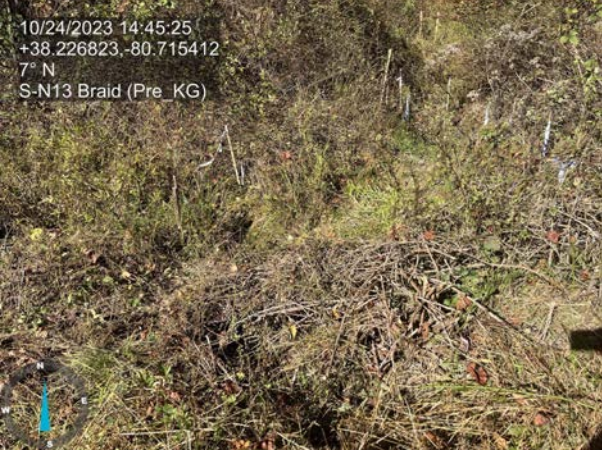
GPS Location	See caption in photo.	GPS Location	See caption in photo.
Description	Downstream view of permitted impact area during pre-construction assessment.	Description	Downstream view of unimpacted area during pre-construction assessment.

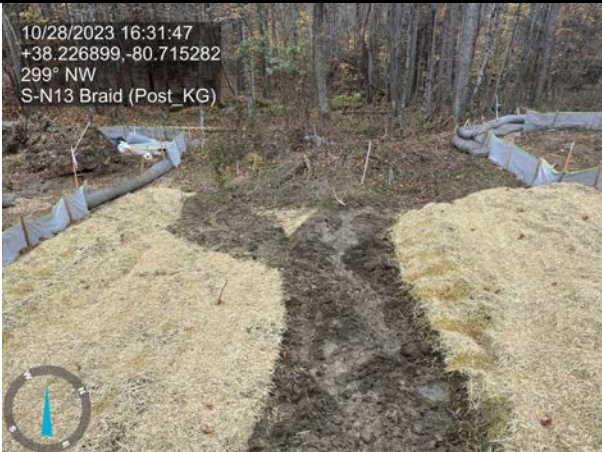
GPS Location	See caption in photo.	GPS Location	See caption in photo.
Description	Downstream view of permitted impact area during post-construction assessment.	Description	Downstream view of unimpacted area during post-construction assessment.

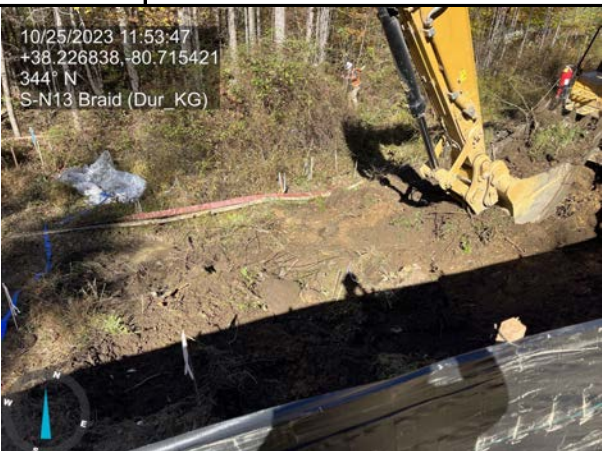
GPS Location	See caption in photo.	GPS Location	See caption in photo.
Description	Crew removing top 12" of stream substrate.	Description	Crew segregating the stream substrate into super sacks to be stored upstream.
