Stream Biological Conditions EA Report

Project Name	H-600 Pipeline Spread D	AFE	124300132	Spread	H-600 Pipeline Spread D
Contractor	Precision	Report #	321		
Environmental Auditor	Kyle Gillow	Date/Time	10/25/2023 12:07 PM		
Stream ID	S-N13	Crossing Start Date	10/25/2023	Crossing Completion Date	10/27/2023
Milepost	123.11	Pre-Con Assessment Date	10/24/2023	Post-Con Assessment Date	10/29/2023
Station	6500+36	Bankfull Width (ft.)	2.0	Riffle:Pool Complexes Present?	No
State	WV	Stream Classification	Intermittent		
County	Nicholas	303(d) Impairment Listing	No

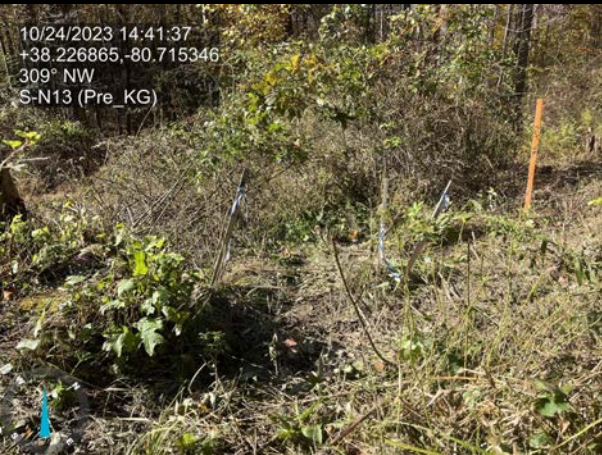
GPS Location See Caption in photo.		GPS Location See caption in photo.			
Description Downstream view of permitted impact area during pre-construction assessment.		Description Downstream view of unimpacted area during pre-construction assessment.

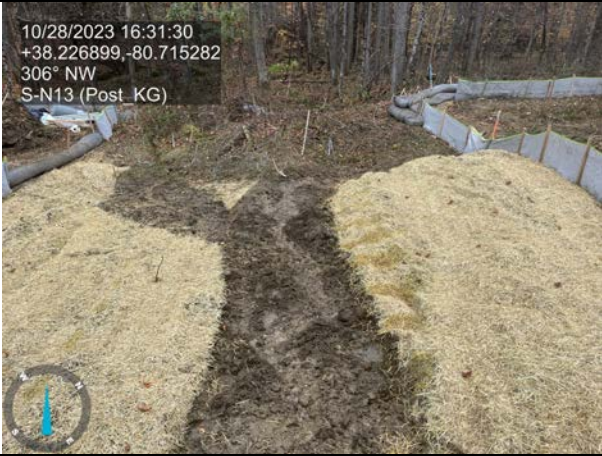
GPS Location See caption in photo.		GPS Location See caption in photo.			
Description Downstream view of permitted impact area during post-construction assessment.		Description Downstream view of unimpacted area during post-construction assessment.

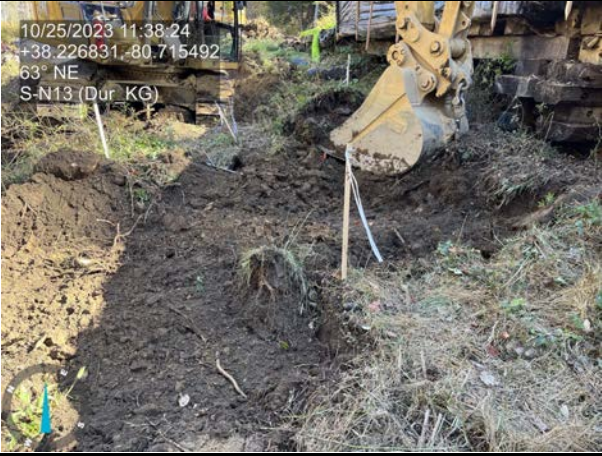
GPS Location See caption in photo.		GPS Location See caption in photo.			
Description Crew stripping top 12" of stream substrate.		Description Crew segregating the top 12" of stream substrate to be stored upstream.
