# STREAM BIOLOGICAL CONDITIONS ENVIRONMENTAL AUDITOR REPORT

<b>Stream ID:</b> S-NN11	<b>Crossing Start Date:</b> 09/19/2023	<b>Crossing Completion Date:</b> 10/03/2023
<b>Milepost:</b> 214.8	<b>Pre-Con Assessment Date:</b> 09/18/2023	<b>Post-Con Assessment Date:</b> 10/04/2023
<b>Station:</b> 11352+97	<b>Stream Classification:</b> Intermittent (Perennial, Intermittent, Ephemeral)	<b>Bankfull Width (ft.):</b> 5
<b>County:</b> Giles	<b>303(d) Impairment Listing:</b> Not Impaired	<b>Riffle:Pool Complexes Present?</b> No

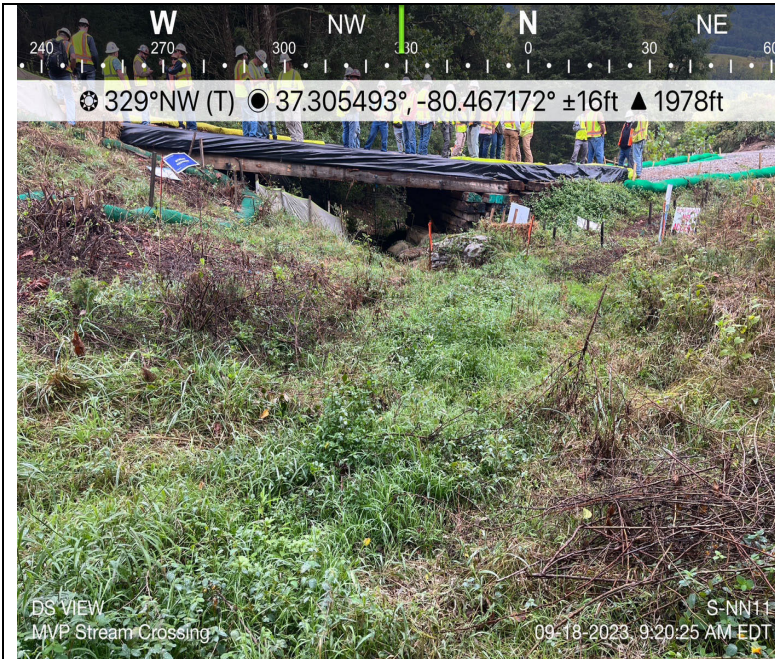
**Photo Description:** Downstream view of permitted impact area during pre-construction assessment.

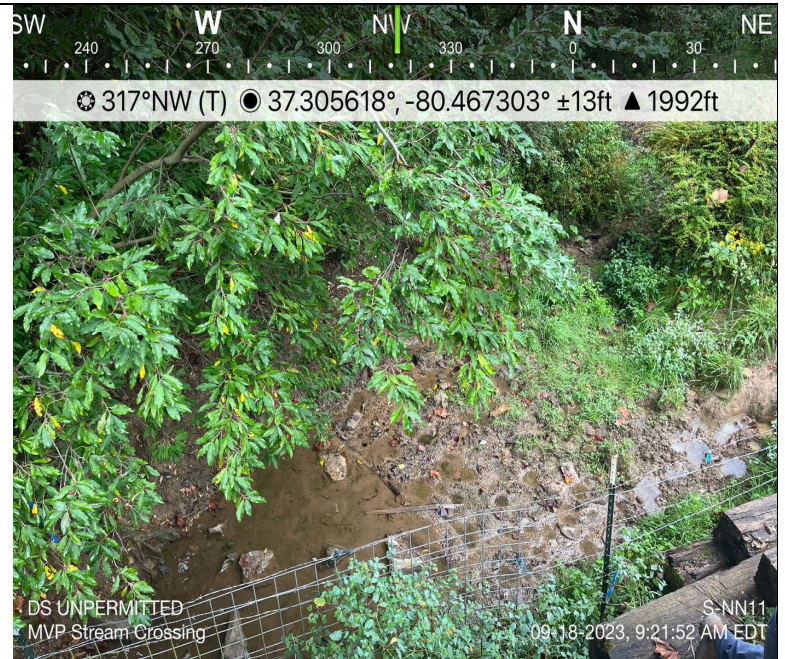
**Photo Description:** Conditions of the downstream area outside the ROW during pre-construction assessment.

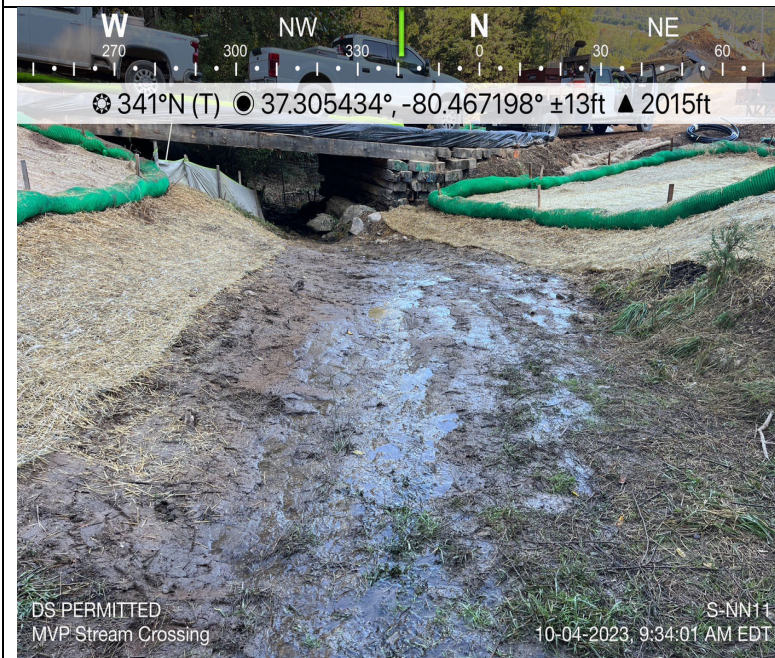
**Photo Description:** Downstream view of permitted impact area during post-construction assessment.

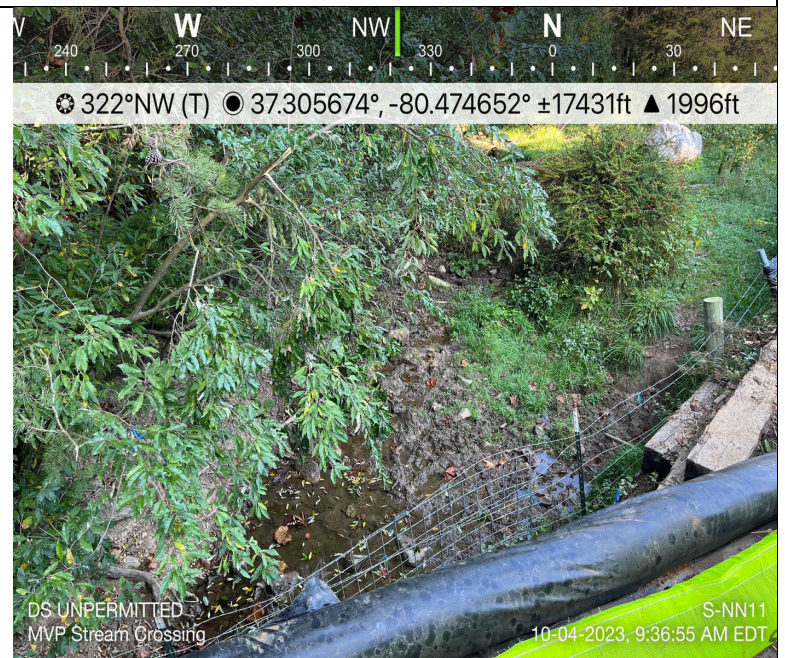
**Photo Description:** Conditions of the downstream area outside the ROW during post-construction assessment.

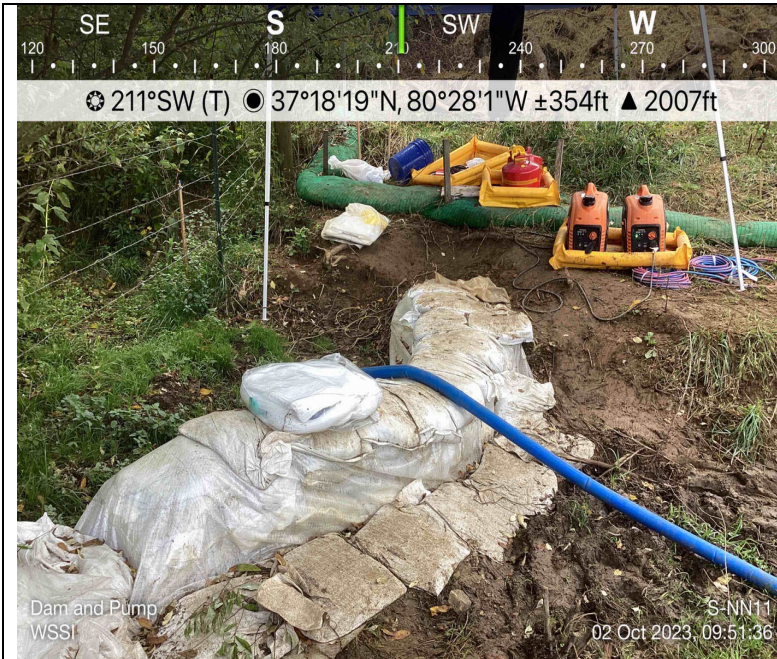
**Photo Description:** Dam and pumps installed and functioning.

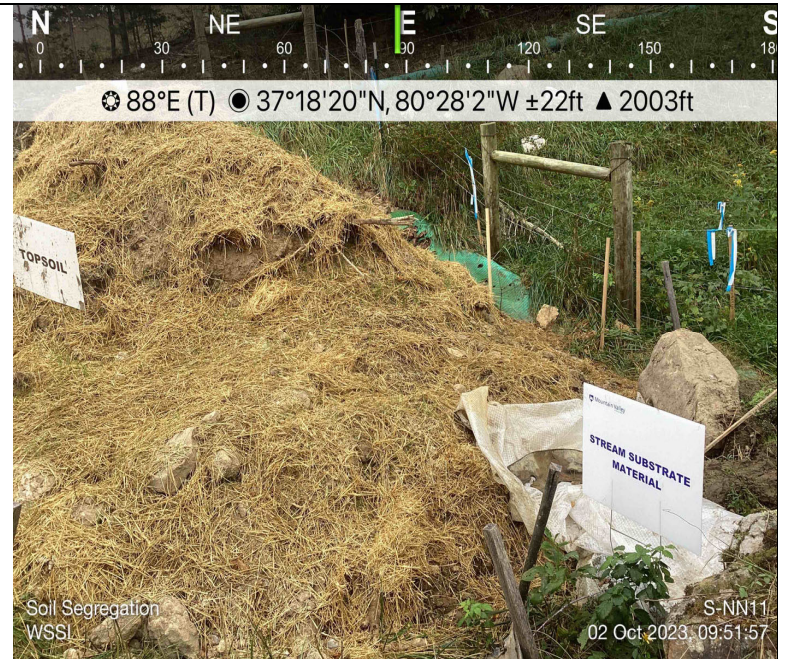
**Photo Description:** Soil segregated properly with signage.

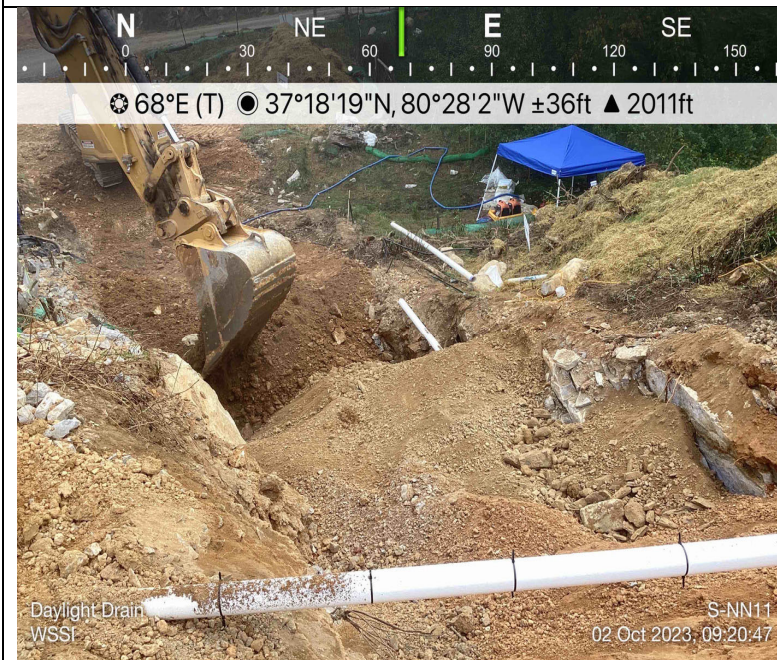
**Photo Description:** Daylight drain installed.

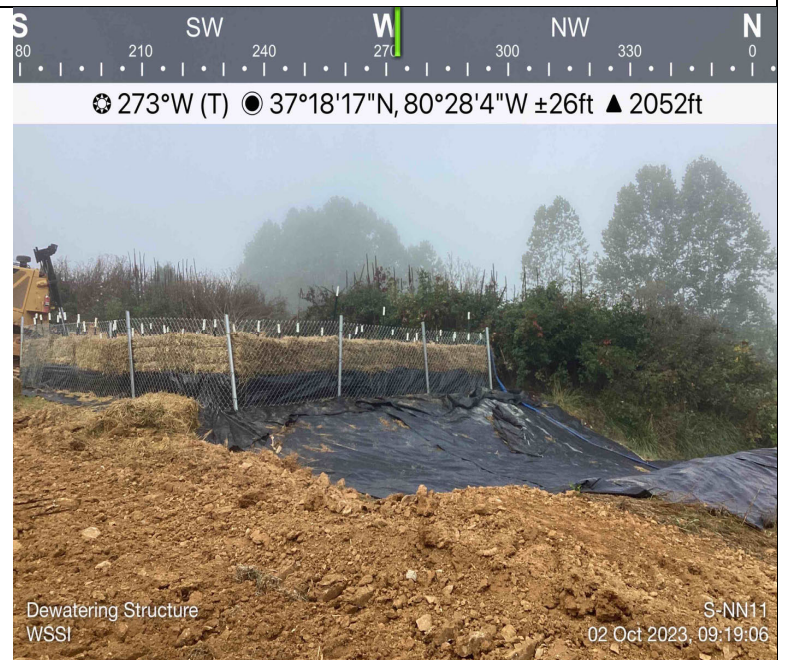
**Photo Description:** Dewatering structure located on-site.
