STREAM BIOLOGICAL CONDITIONS ENVIRONMENTAL AUDITOR REPORT

Stream ID: S-001	Crossing Start Date: 10/30/2023	Crossing Completion Date: 11/02/2023
Milepost: 302.4	Pre-Con Assessment Date: 10/28/2023	Post-Con Assessment Date: 11/03/2023
Station: 15977+35	Stream Classification: Intermittent (Perennial, Intermittent, Ephemeral)	Bankfull Width (ft.): 5
County: Pittsylvania	303(d) Impairment Listing: Not Impaired	Riffle:Pool Complexes Present? No

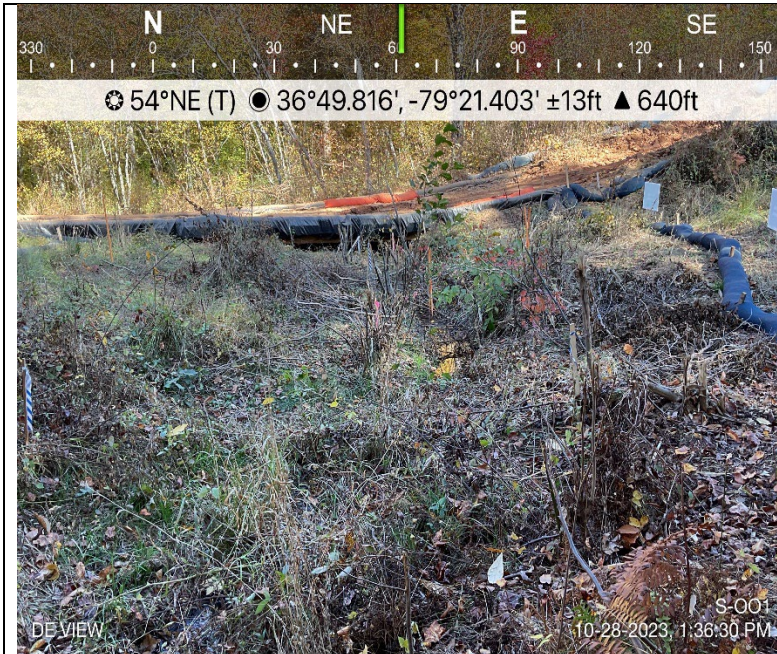
Photo Description: Downstream view of permitted impact area during pre-construction assessment.

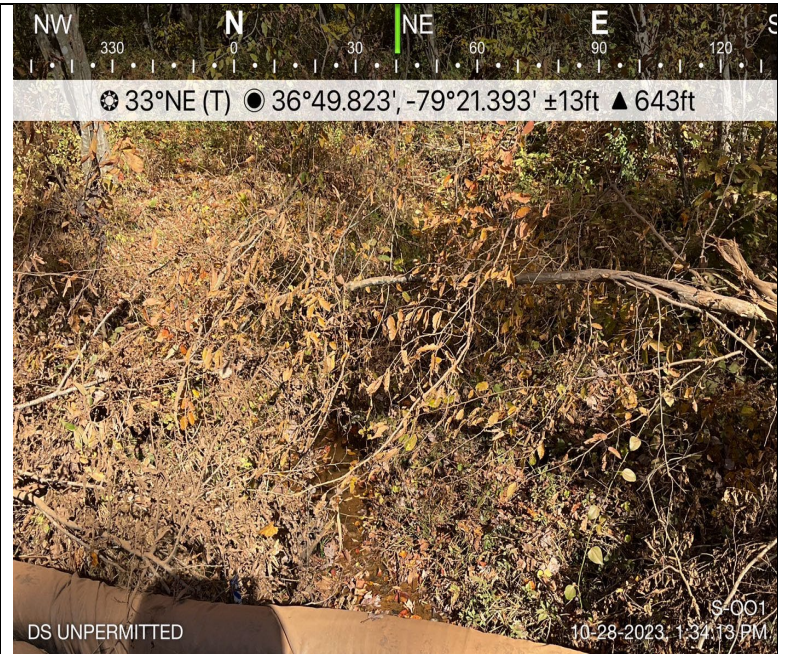
Photo Description: Conditions of the downstream area outside the ROW during pre-construction assessment.

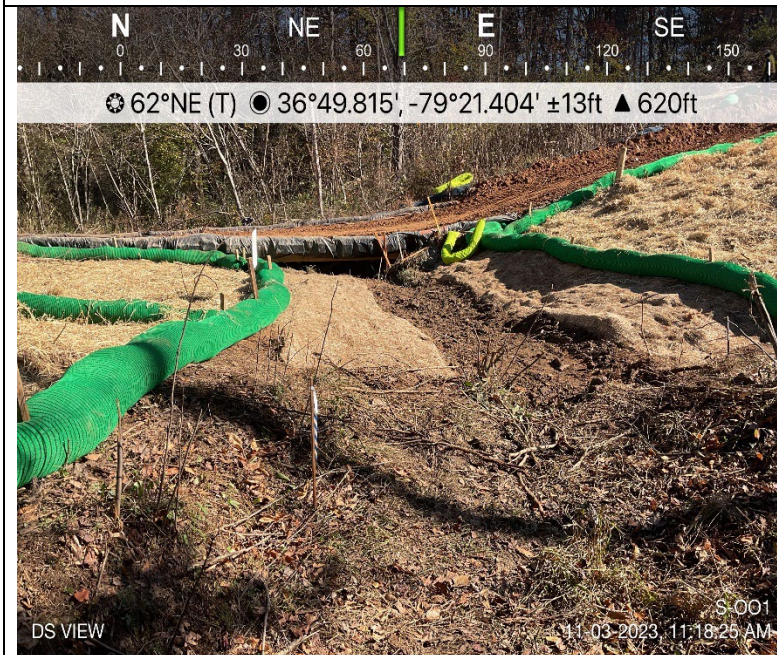
Photo Description: Downstream view of permitted impact area during post-construction assessment.

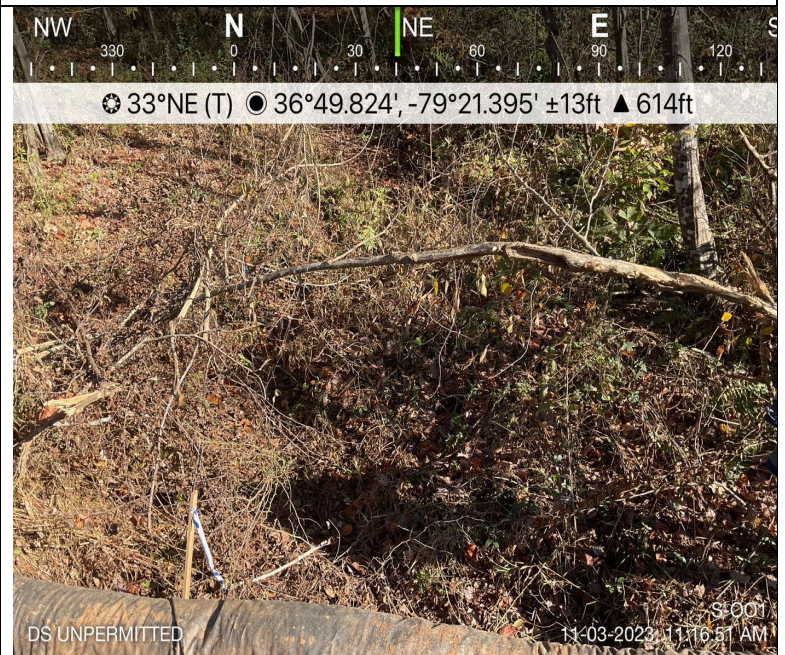
Photo Description: Conditions of the downstream area outside the ROW during post-construction assessment.

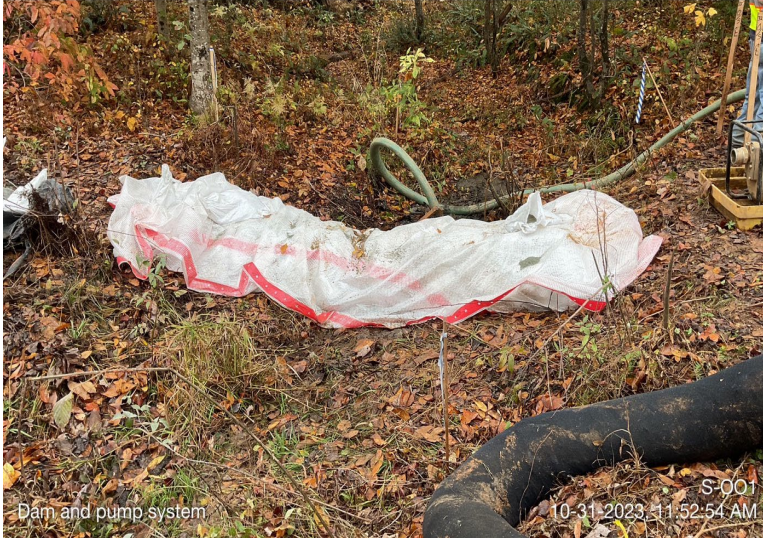
Dam and pump system

Photo Description: The dam and pump installed at the crossing.

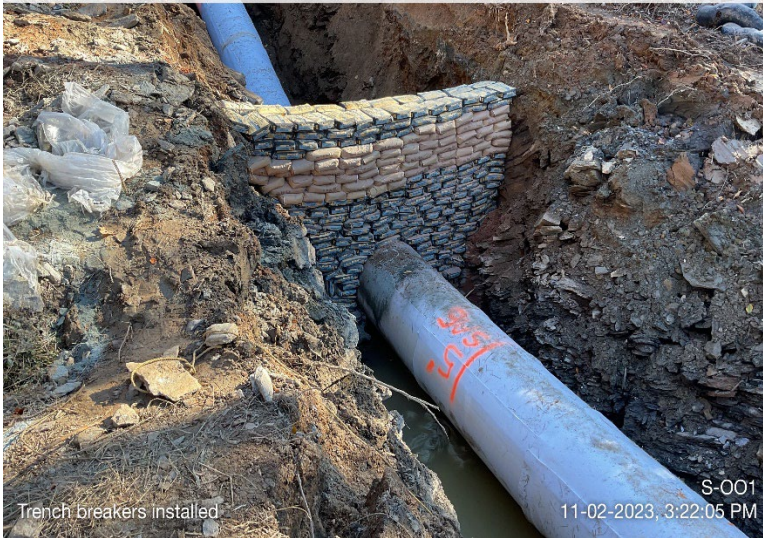
Trench breakers installed

Photo Description: A trench breaker installed over the pipe.

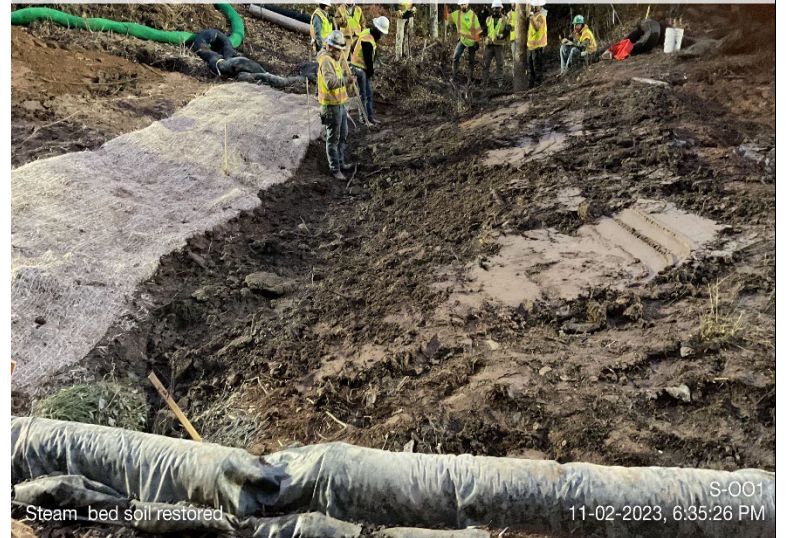
Stream bed soil restored

Photo Description: Restoration of the stream bed.
