STREAM BIOLOGICAL CONDITIONS ENVIRONMENTAL AUDITOR REPORT

Stream ID: S-0013	Crossing Start Date: 10/17/2023	Crossing Completion Date: 10/26/2023
Milepost: 216.7	Pre-Con Assessment Date: 10/16/2023	Post-Con Assessment Date: 10/27/2023
Station: 11451+28	Stream Classification: Perennial (Perennial, Intermittent, Ephemeral)	Bankfull Width (ft.): 20
County: Giles	303(d) Impairment Listing: Not Impaired	Riffle:Pool Complexes Present? No

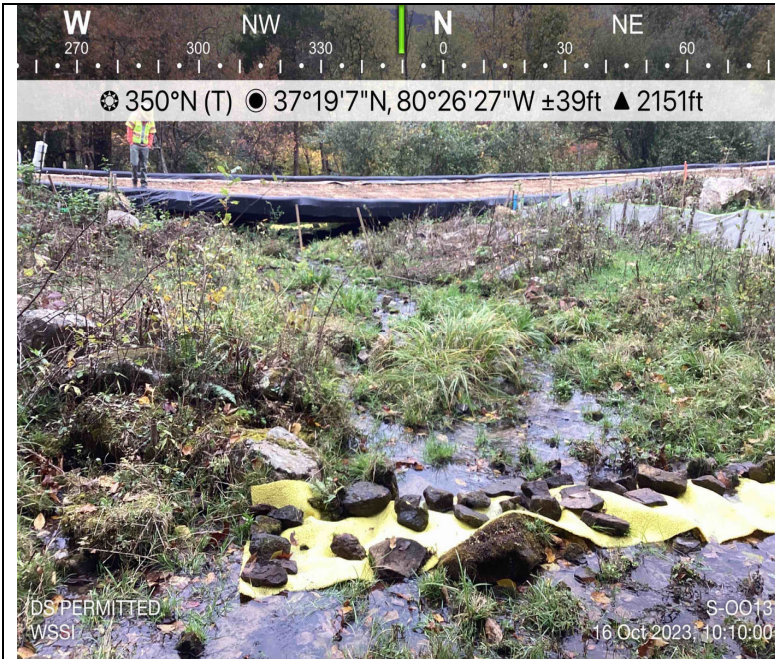
Photo Description: Downstream view of permitted impact area during pre-construction assessment.

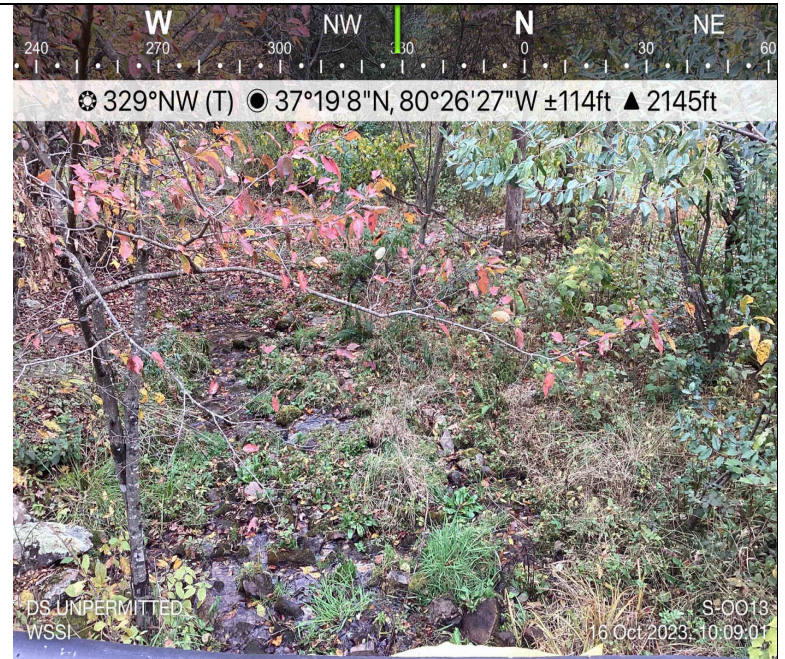
Photo Description: Conditions of the downstream area outside the ROW during pre-construction assessment.

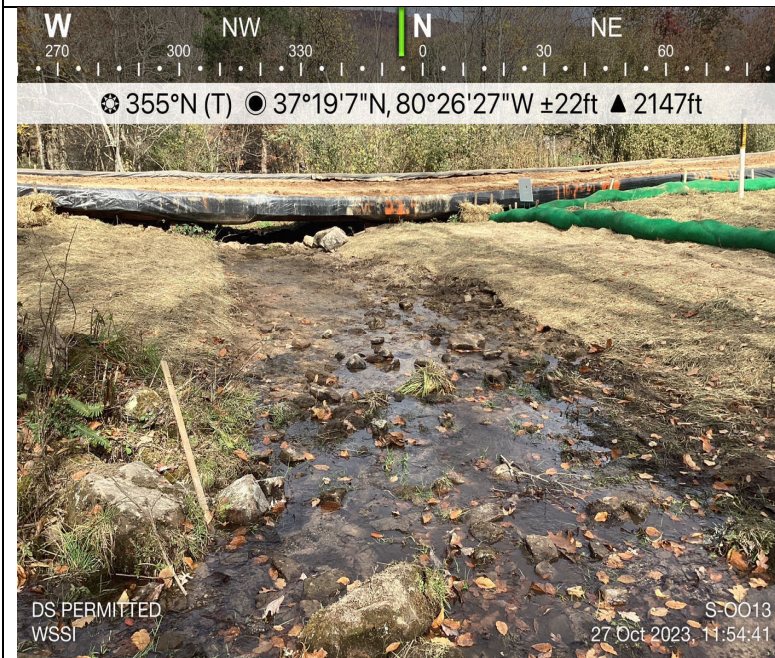
Photo Description: Downstream view of permitted impact area during post-construction assessment.

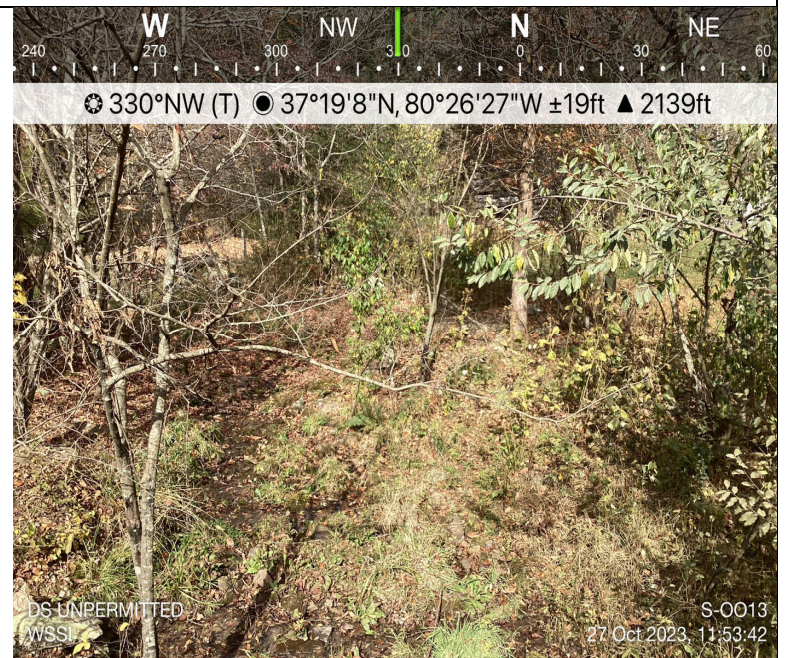
Photo Description: Conditions of the downstream area outside the ROW during post-construction assessment.

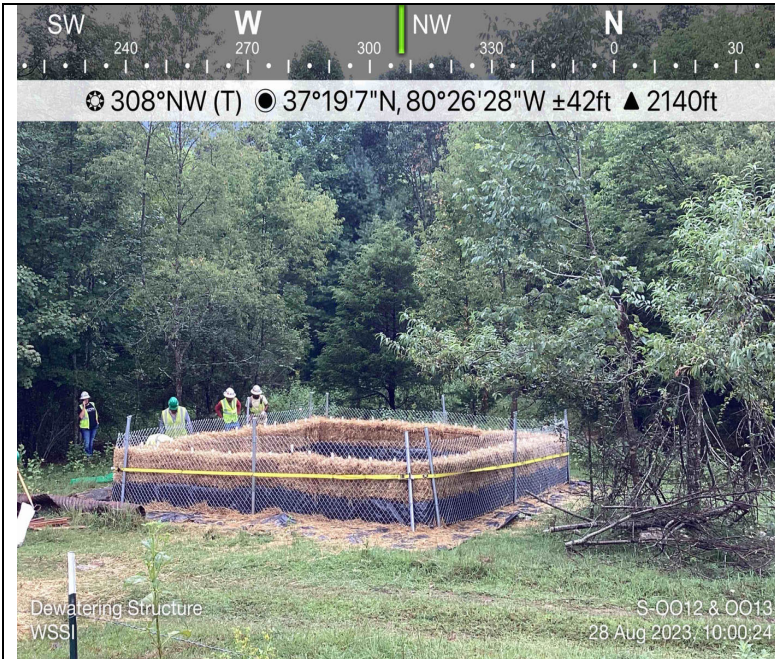
Photo Description: Dewatering structure located off ROW with landowner permission and shared with OO12.

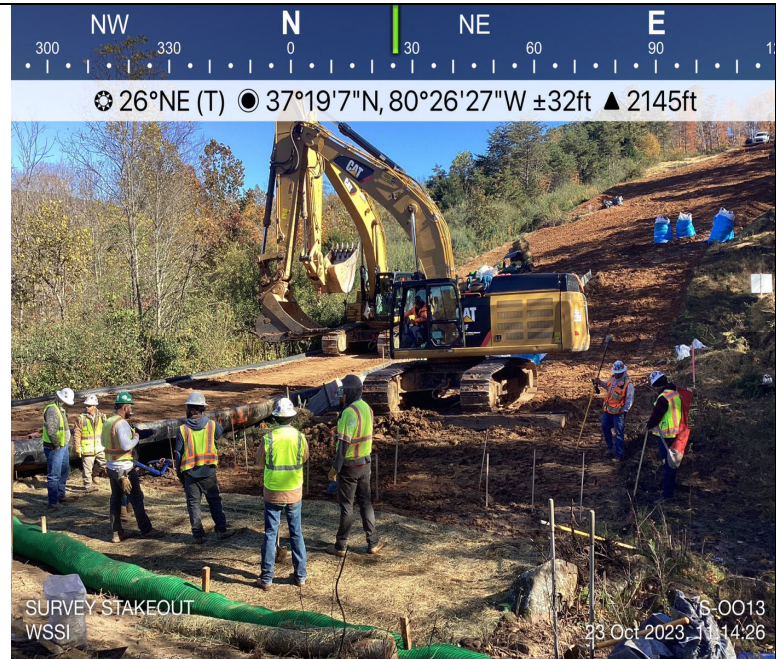
Photo Description: Survey staking out final contours.

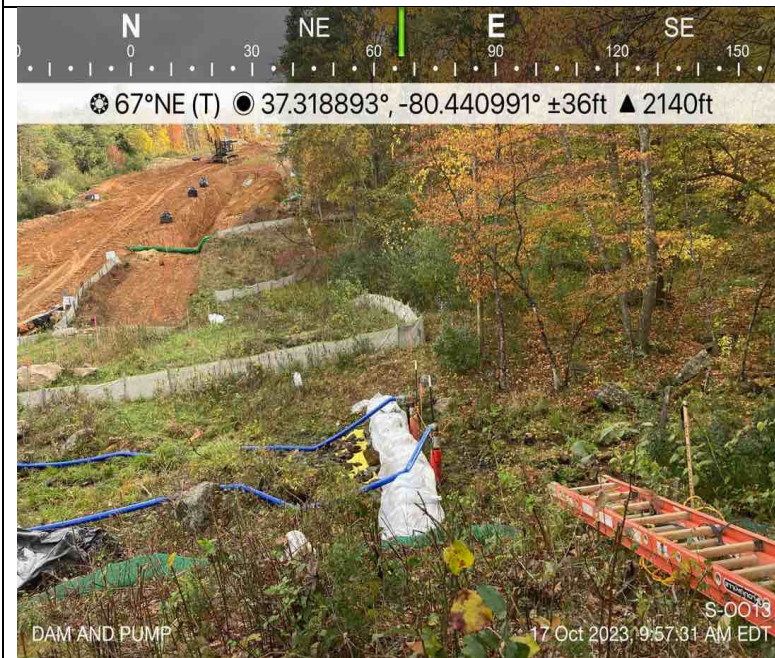
Photo Description: Dam and pump around installed.

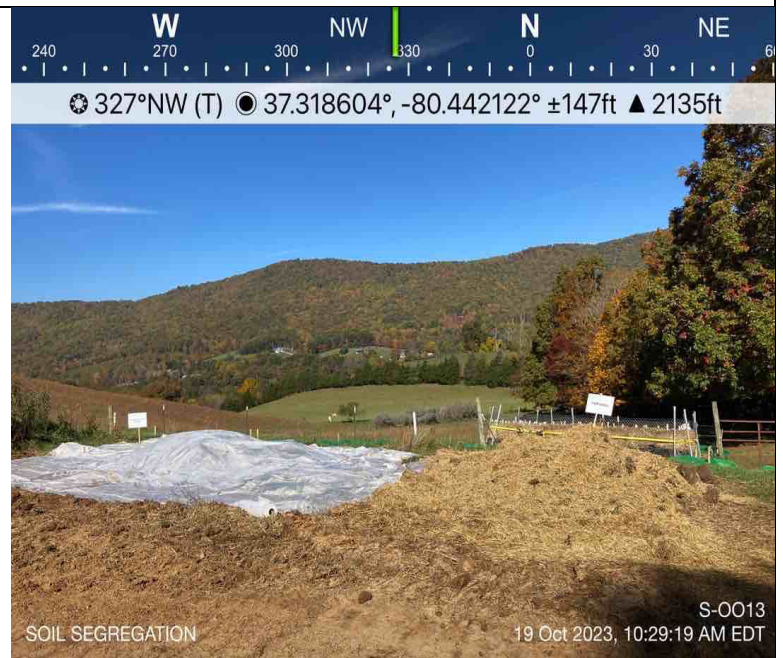
Photo Description: Soil and substrate segregated appropriately.
