STREAM BIOLOGICAL CONDITIONS ENVIRONMENTAL AUDITOR REPORT

Stream ID: S-0014	Crossing Start Date: 10/23/2023	Crossing Completion Date: 10/28/2023
Milepost: 216.6	Pre-Con Assessment Date: 10/16/2023	Post-Con Assessment Date: 10/30/2023
Station: 11448+93	Stream Classification: Perennial (Perennial, Intermittent, Ephemeral)	Bankfull Width (ft.): 4
County: Giles	303(d) Impairment Listing: Not Impaired	Riffle:Pool Complexes Present? No

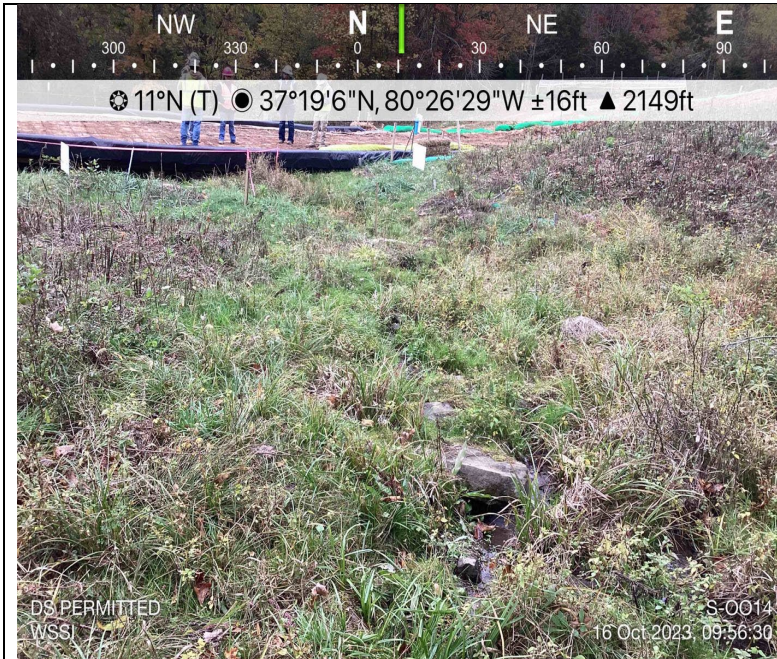
Photo Description: Downstream view of permitted impact area during pre-construction assessment.

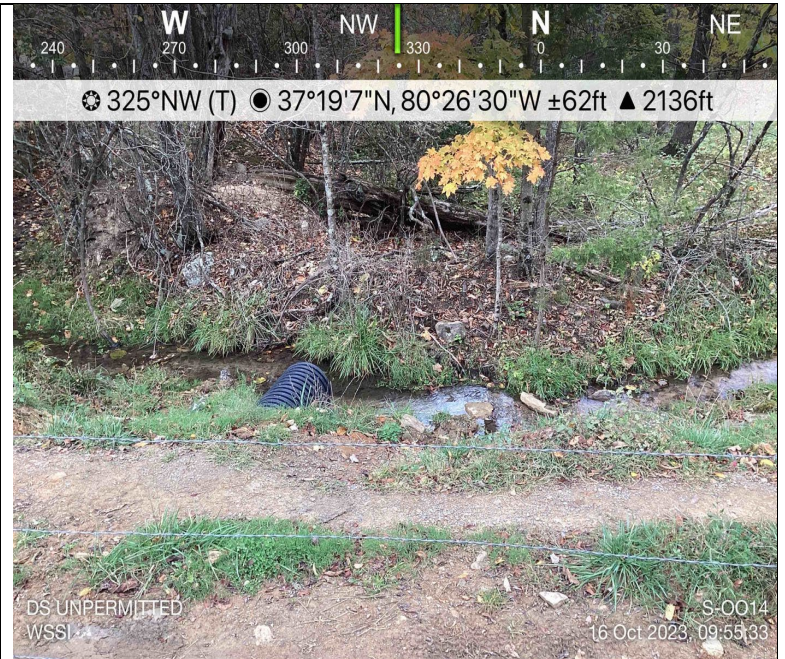
Photo Description: Conditions of the downstream area outside the ROW during pre-construction assessment.

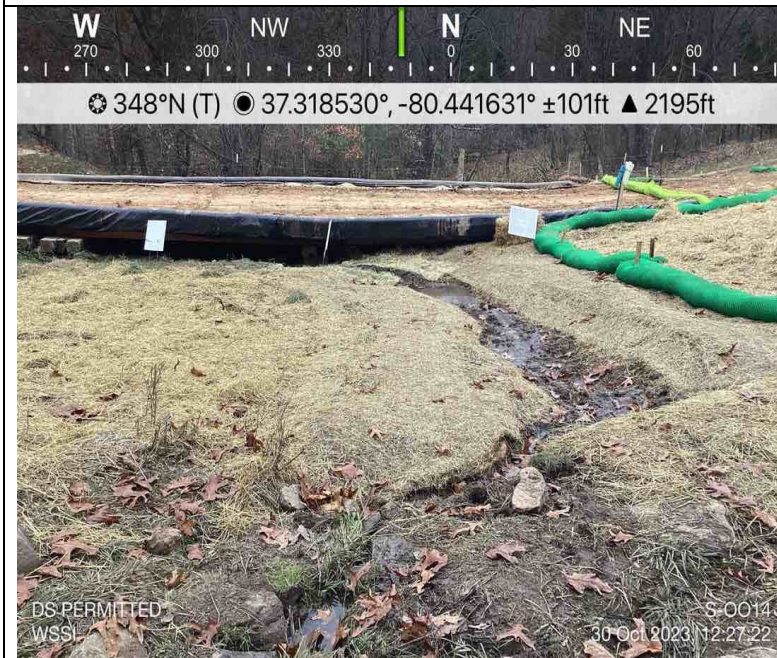
Photo Description: Downstream view of permitted impact area during post-construction assessment.

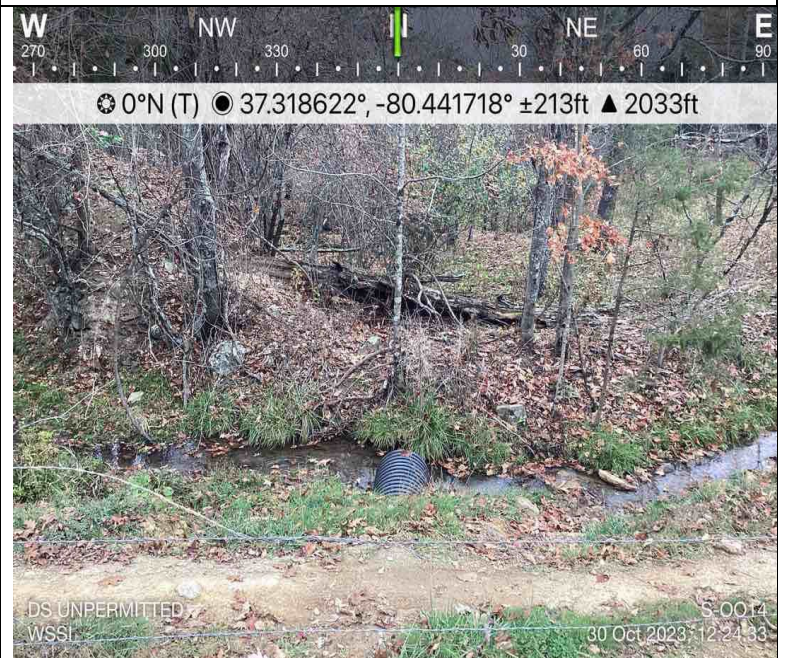
Photo Description: Conditions of the downstream area outside the ROW during post-construction assessment.

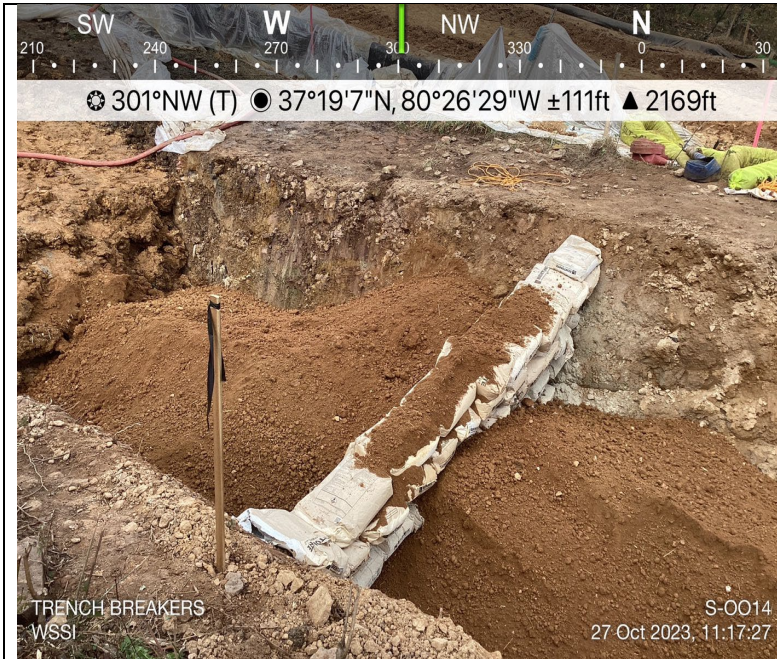
Photo Description: Trench breakers installed.

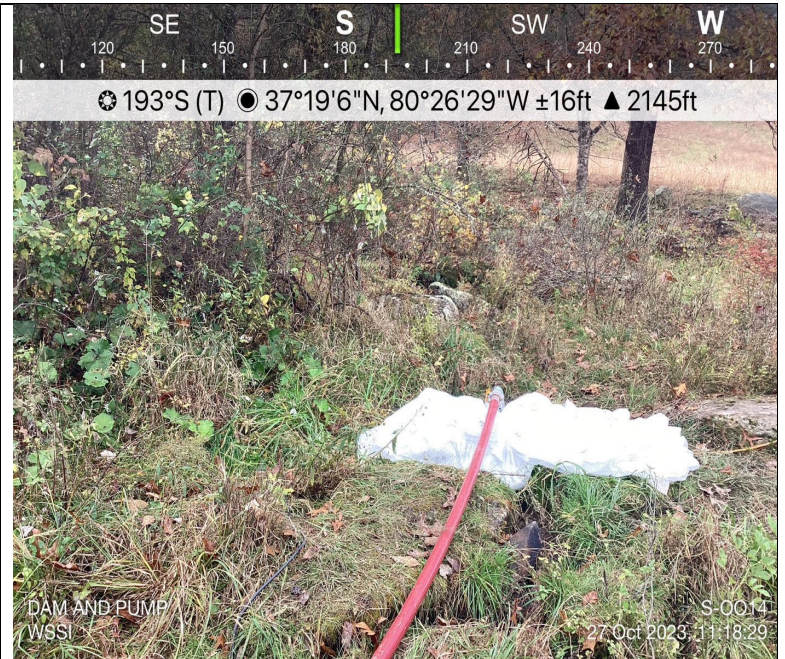
Photo Description: Dam and pump installed and functioning.

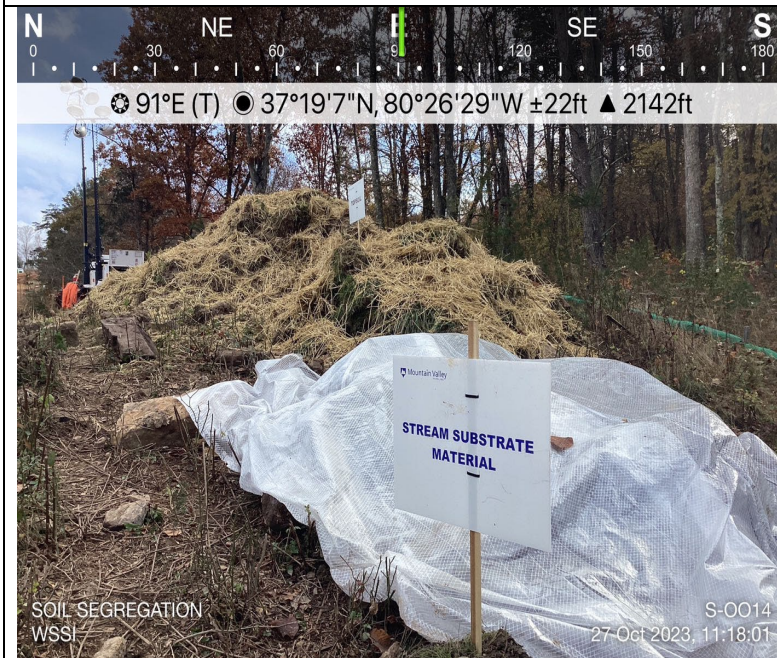
Photo Description: Stream substrate and subsoils segregated.

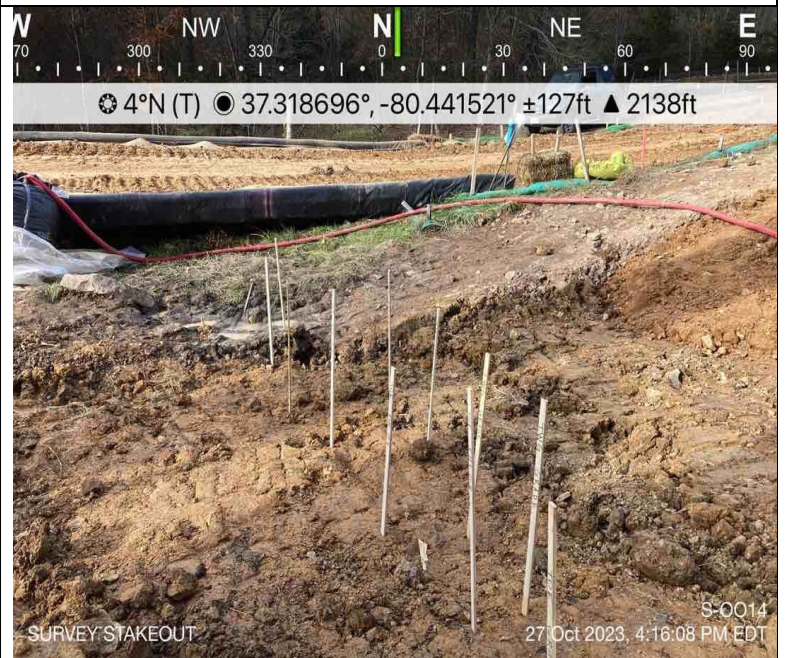
Photo Description: Survey staking out final contours.
