# STREAM BIOLOGICAL CONDITIONS ENVIRONMENTAL AUDITOR REPORT

Version 2.3

<b>Stream ID:</b> S-002	<b>Crossing Start Date:</b> 10/23/2023	<b>Crossing Completion Date:</b> 10/28/2023
<b>Milepost:</b> 302.6	<b>Pre-Con Assessment Date:</b> 10/18/2023	<b>Post-Con Assessment Date:</b> 10/28/2023
<b>Station:</b> 15987+31	<b>Stream Classification:</b> Intermittent (Perennial, Intermittent, Ephemeral)	<b>Bankfull Width (ft.):</b> 5
<b>County:</b> Pittsylvania	<b>303(d) Impairment Listing:</b> Not Impaired	<b>Riffle:Pool Complexes Present?</b> No

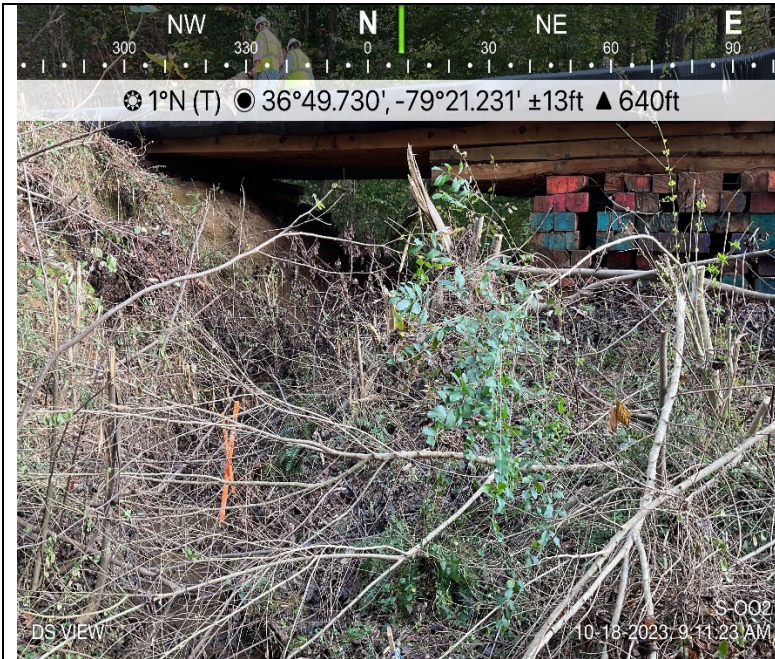
**Photo Description:** Downstream view of permitted impact area during pre-construction assessment.

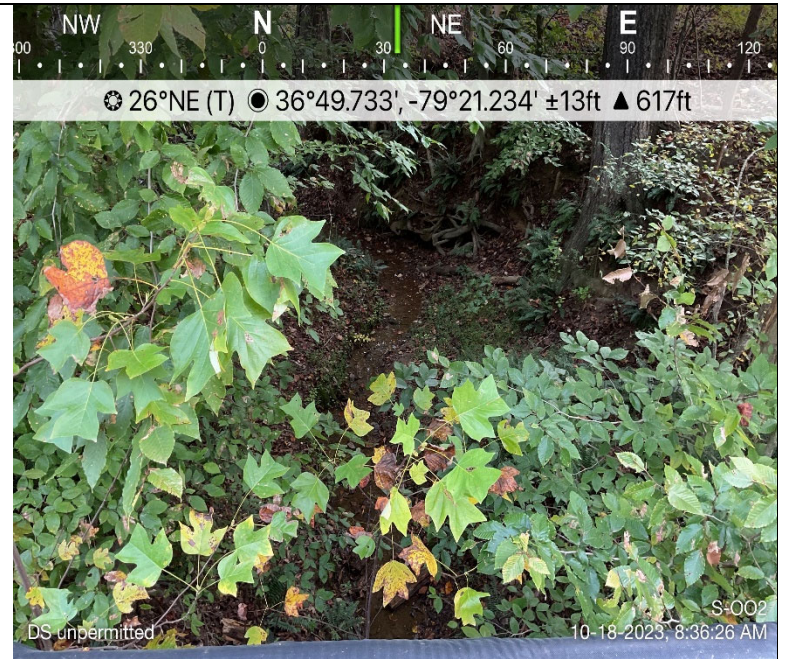
**Photo Description:** Conditions of the downstream area outside the ROW during pre-construction assessment.

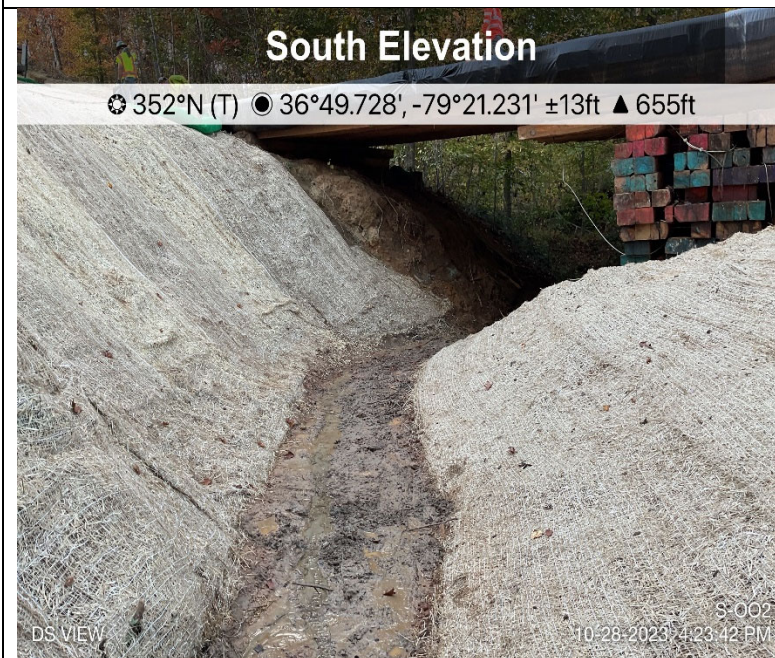
**Photo Description:** Downstream view of permitted impact area during post-construction assessment.

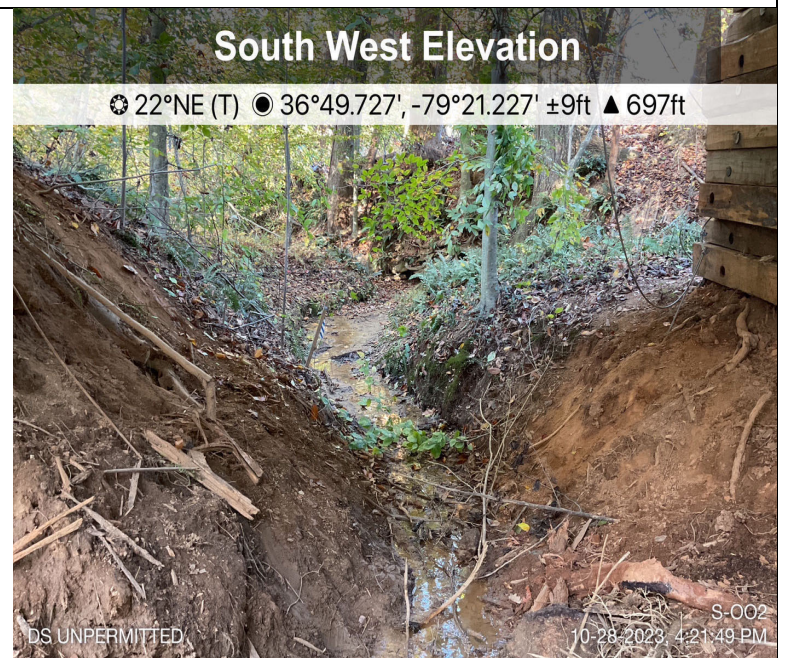
**Photo Description:** Conditions of the downstream area outside the ROW during post-construction assessment.

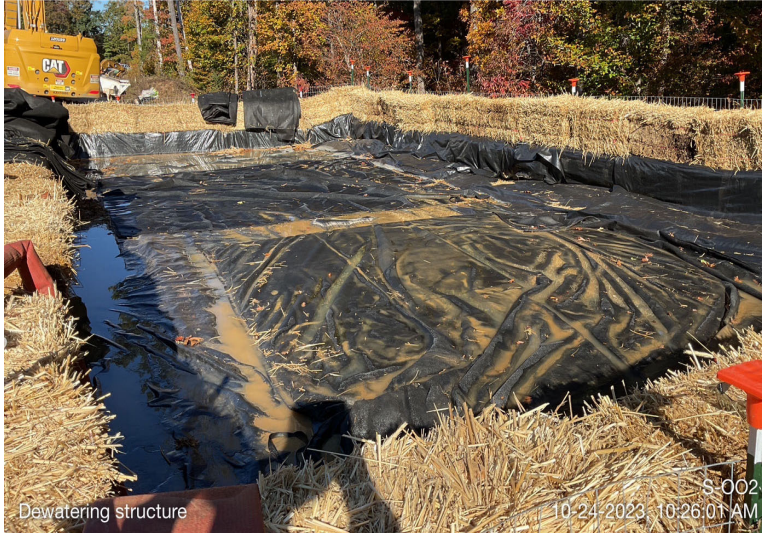
S-002  
10-24-2023, 10:26:01 AM

Dewatering structure

**Photo Description:** An overview of the dewatering structure.

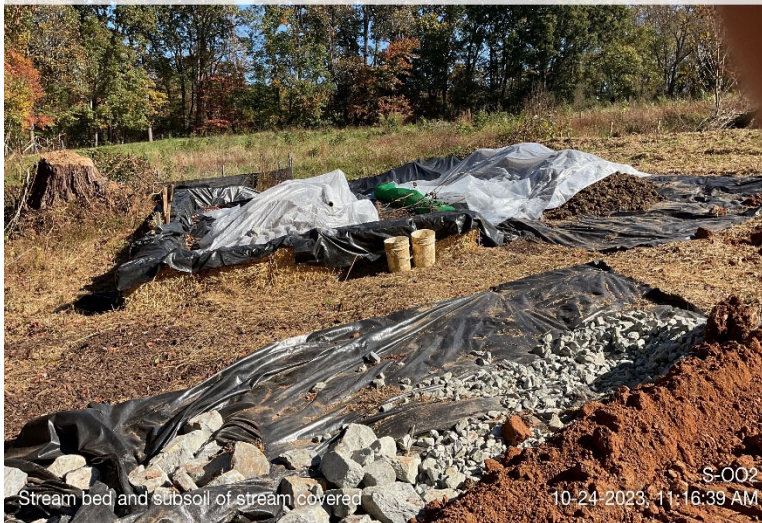
S-002  
10-24-2023, 11:16:39 AM

Stream bed and subsoil of stream covered

**Photo Description:** Stream bed and substrate separated and covered after excavation.
