STREAM BIOLOGICAL CONDITIONS ENVIRONMENTAL AUDITOR REPORT

Stream ID: S-Q13	Crossing Start Date: 09/18/2023	Crossing Completion Date: 09/25/2023
Milepost: 199	Pre-Con Assessment Date: 09/14/2023	Post-Con Assessment Date: 09/26/2023
Station: 10519+69	Stream Classification: Perennial (Perennial, Intermittent, Ephemeral)	Bankfull Width (ft.): 15
County: Giles	303(d) Impairment Listing: Not Impaired	Riffle:Pool Complexes Present? Yes

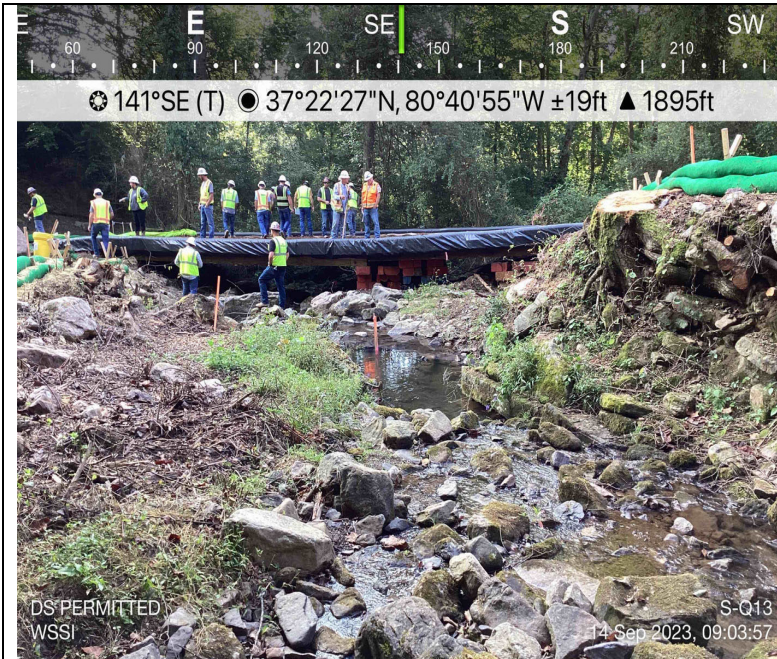
Photo Description: Downstream view of permitted impact area during pre-construction assessment.

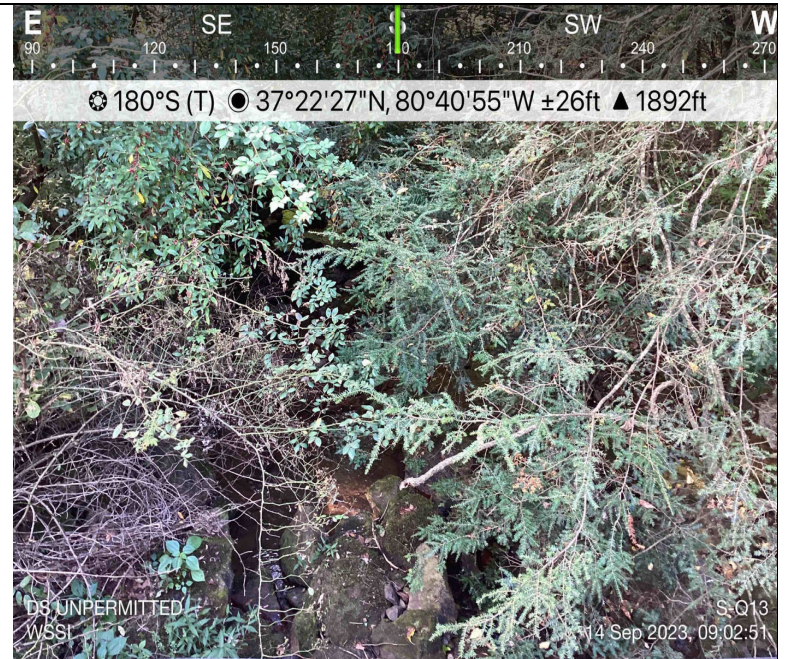
Photo Description: Conditions of the downstream area outside the ROW during pre-construction assessment.

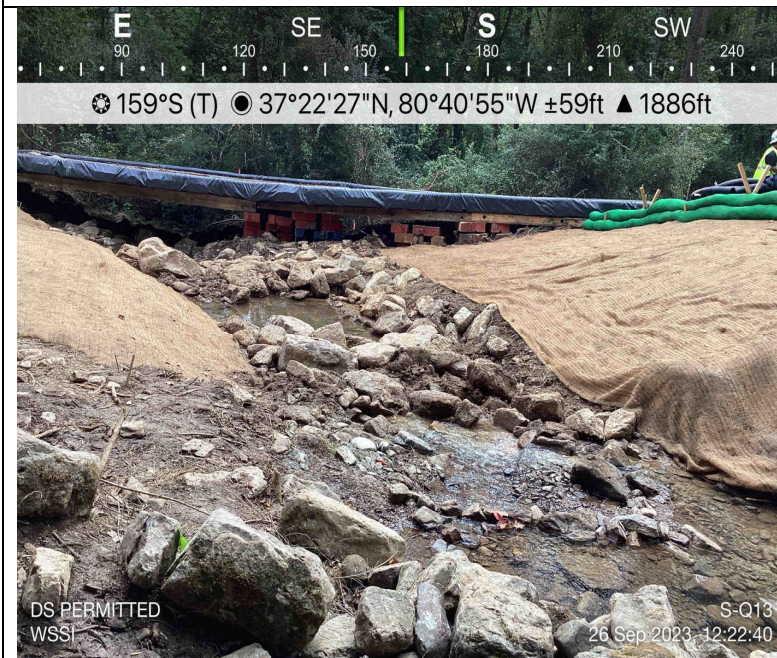
Photo Description: Downstream view of permitted impact area during post-construction assessment.

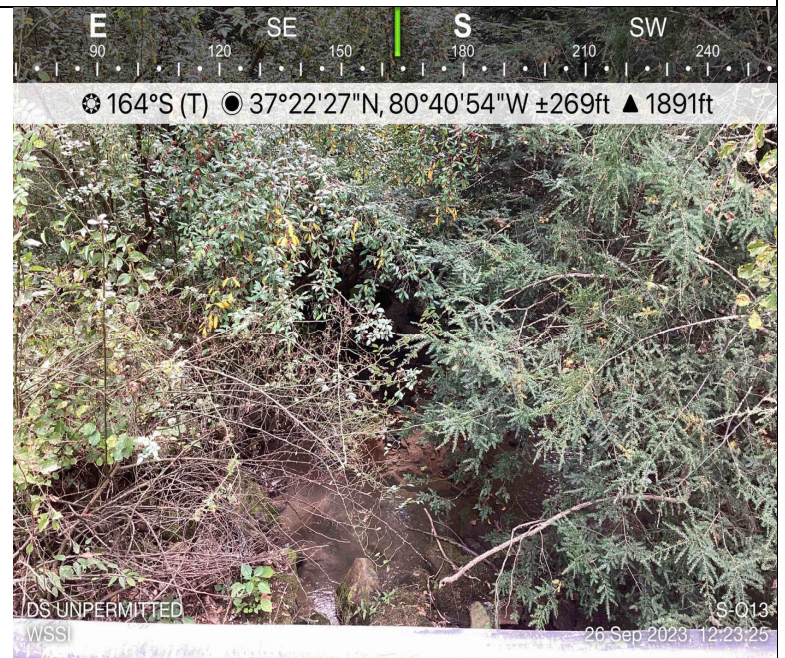
Photo Description: Conditions of the downstream area outside the ROW during post-construction assessment.

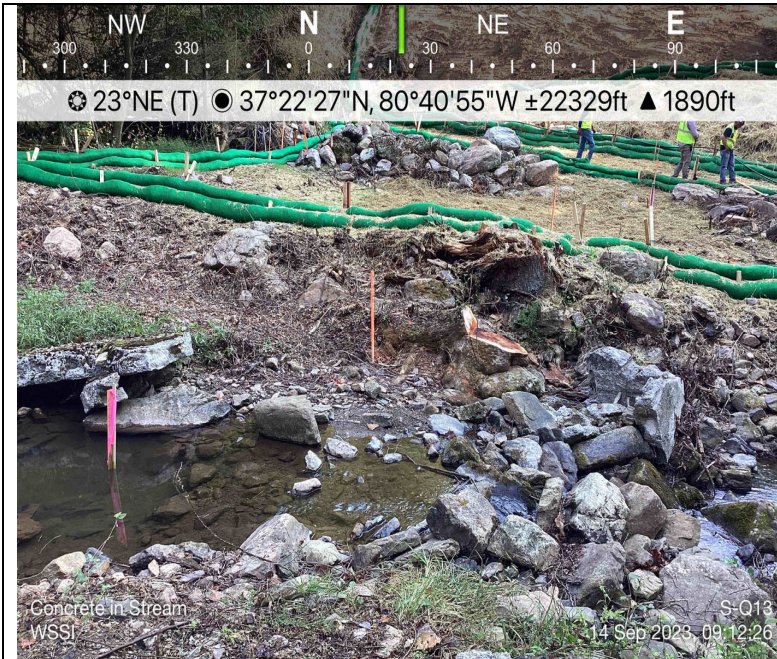
Photo Description: Pre-existing concrete to be removed and disposed of properly.

09/14/2023: Preconstruction meeting held and pre assessment completed for stream crossing. MVP EI will be Mindy Lou Metcalf. Pre-existing concrete structures will be removed with tree stumps and disposed of. Crossing to start on 9/18/2023. Turbidity curtain installed downstream. -A. Breeding

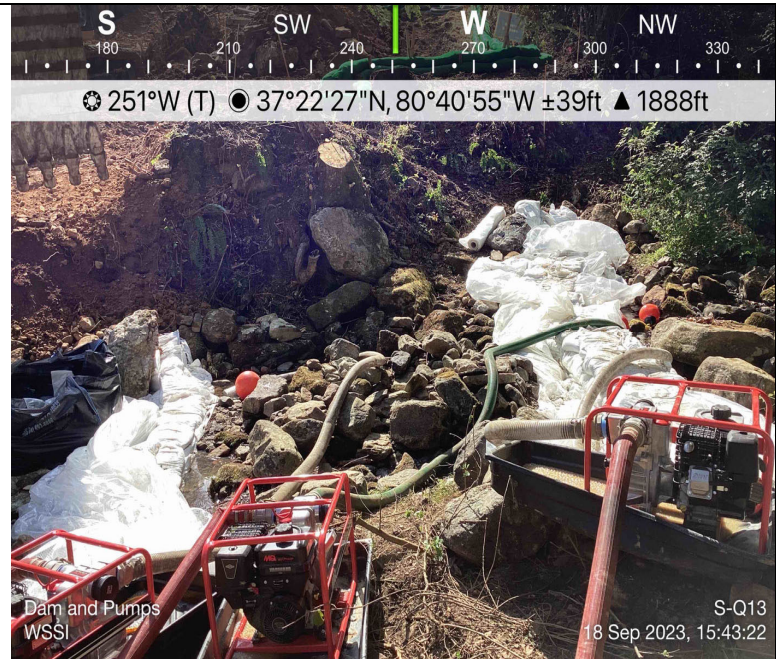
Photo Description: Double dam and pump around due to poor sealing.

09/18/2023: Fish relocation (Edge) complete. Dam and pump (additional dam installed for better sealing), energy dissipator is installed. Boulder removal from buffer zones complete. Topsoil removal and segregation complete. -A. Breeding

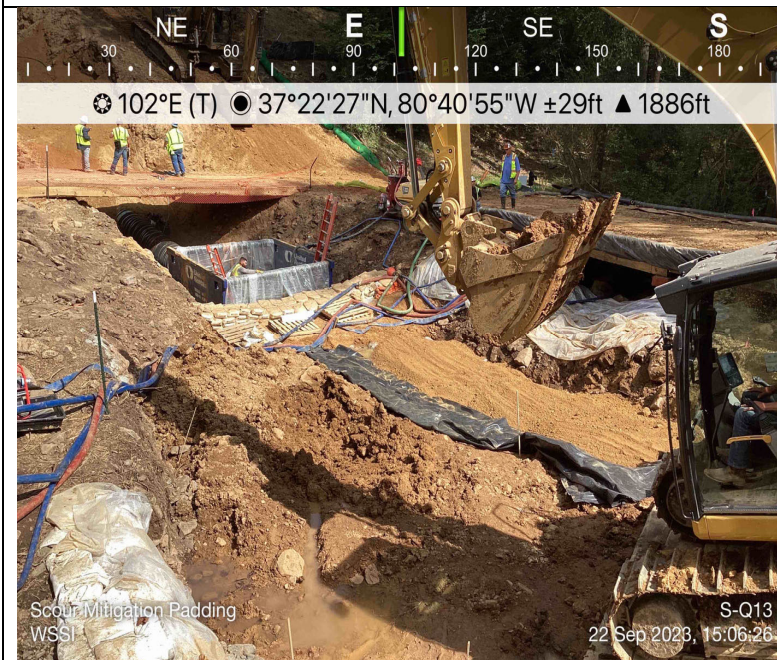
Photo Description: Scour mitigation padding between stone layers to fill void space.

09/22/2023: Meeting to discuss specification for scour mitigation efforts. Rock brought into line pipe. Welding completed for section of pipe under landowner driveway. Padding of end section of pipe. Scour mitigation completed installation, survey shot in points, filter fabric, first and second stone layers, padding, appears to be installed to specification. Stream subsoil and subsoil restored, visqueen laid out to prevent washout of stream material in impending inclement weather. -A. Breeding

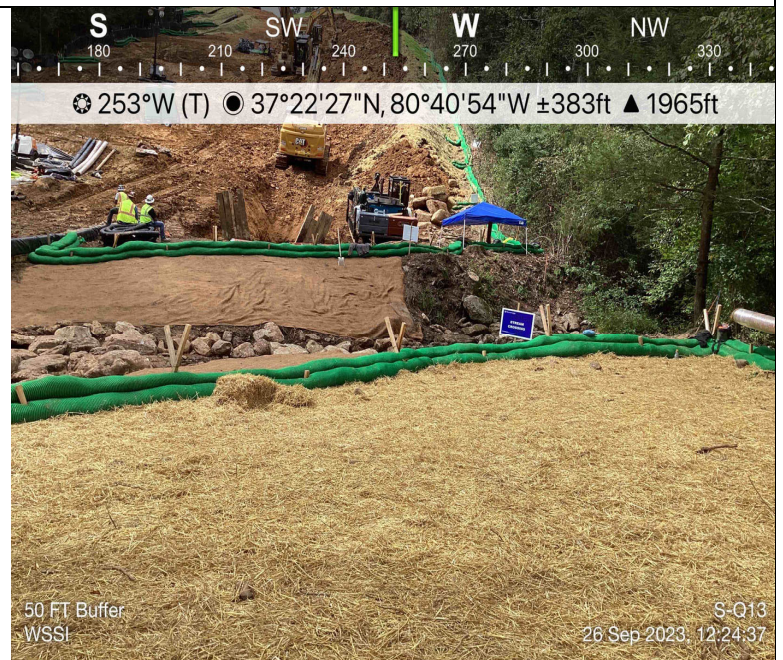
Photo Description: 50' buffer restored on right side with left side left open for tie in.

09/26/2023: Work in left 50 ft buffer continues, tie in to be completed by end of day. -A. Breeding
