# STREAM BIOLOGICAL CONDITIONS ENVIRONMENTAL AUDITOR REPORT

<b>Stream ID:</b> S-Q15	<b>Crossing Start Date:</b> 09/28/2023	<b>Crossing Completion Date:</b> 10/03/2023
<b>Milepost:</b> 285.9	<b>Pre-Con Assessment Date:</b> 09/26/2023	<b>Post-Con Assessment Date:</b> 10/04/2023
<b>Station:</b> 15104+28	<b>Stream Classification:</b> Ephemeral (Perennial, Intermittent, Ephemeral)	<b>Bankfull Width (ft.):</b> 5
<b>County:</b> Pittsylvania	<b>303(d) Impairment Listing:</b> Not Impaired	<b>Riffle:Pool Complexes Present?</b> No

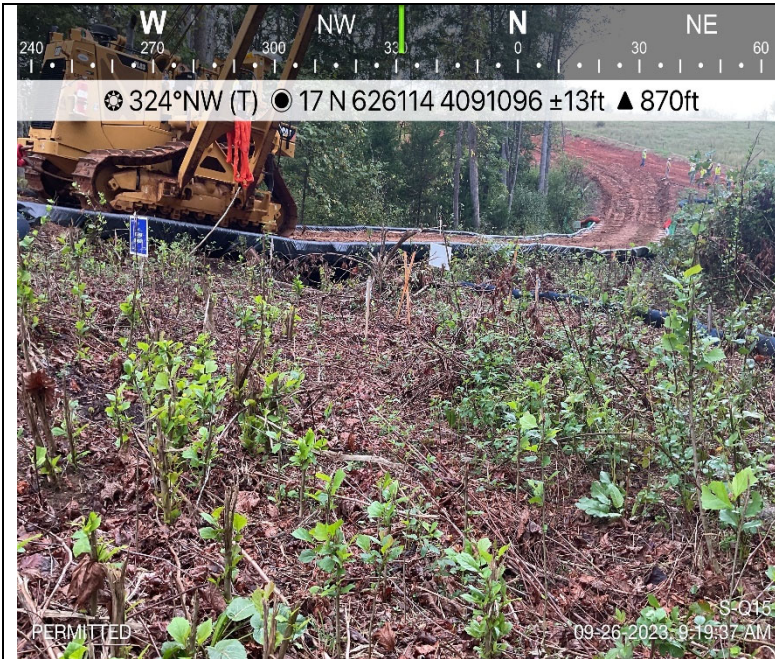
**Photo Description:** Downstream view of permitted impact area during pre-construction assessment.

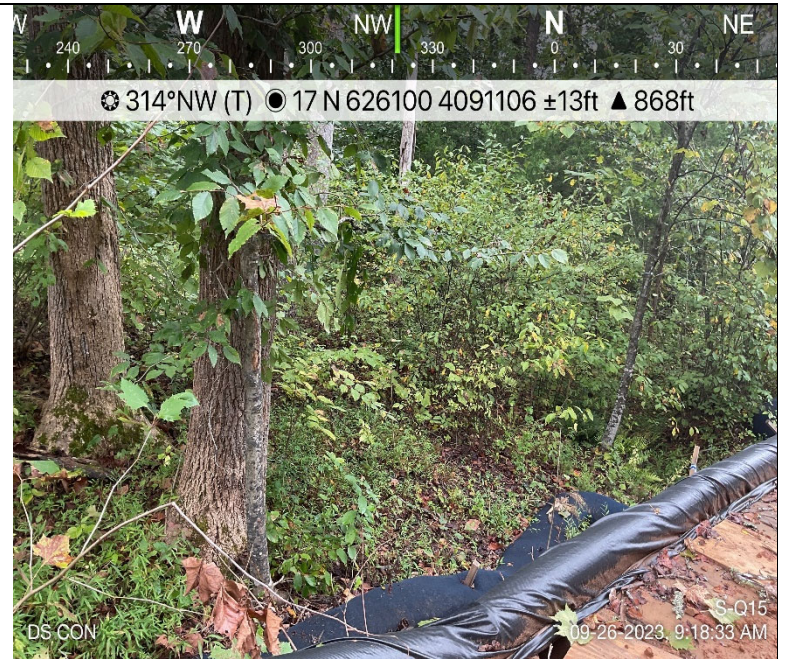
**Photo Description:** Conditions of the downstream area outside the ROW during pre-construction assessment.

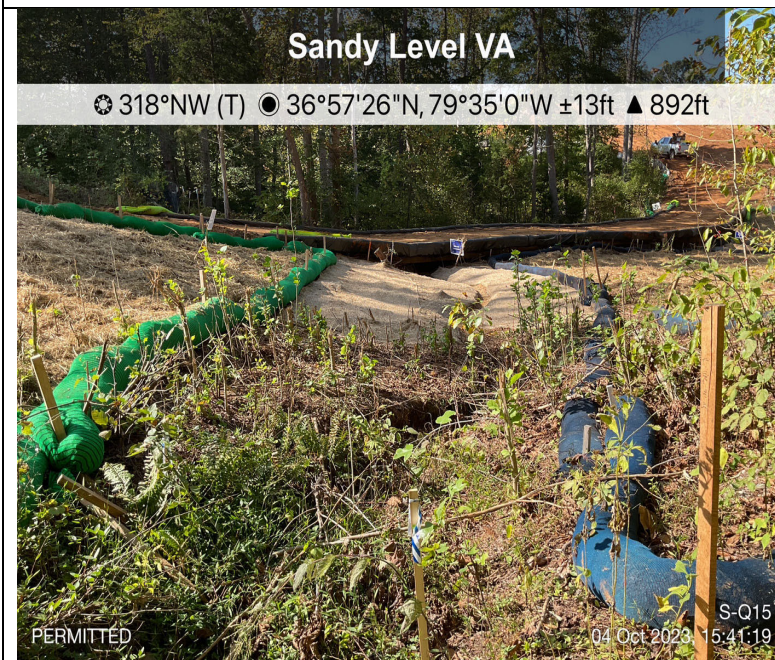
**Photo Description:** Downstream view of permitted impact area during post-construction assessment.

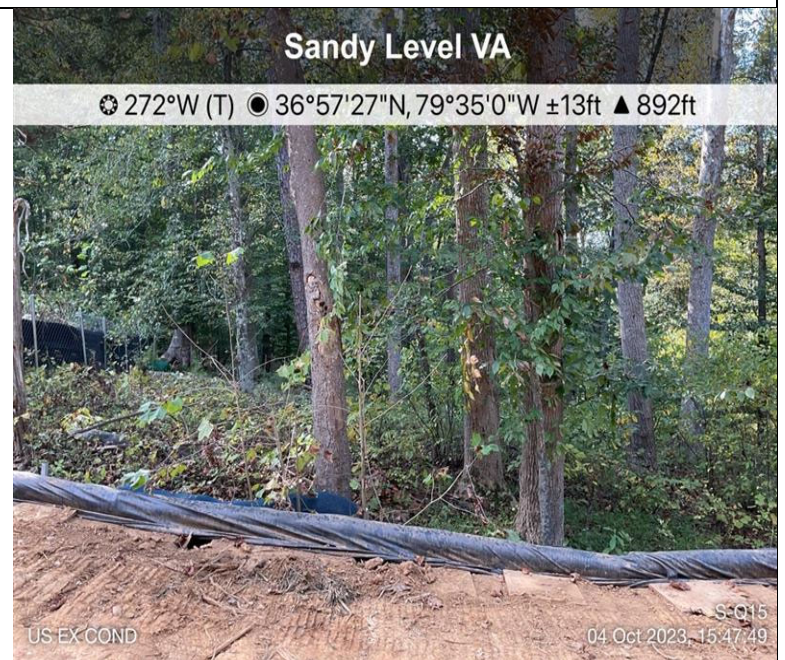
**Photo Description:** Conditions of the downstream area outside the ROW during post-construction assessment. Typo in photo watermark — “DS\* EX COND”

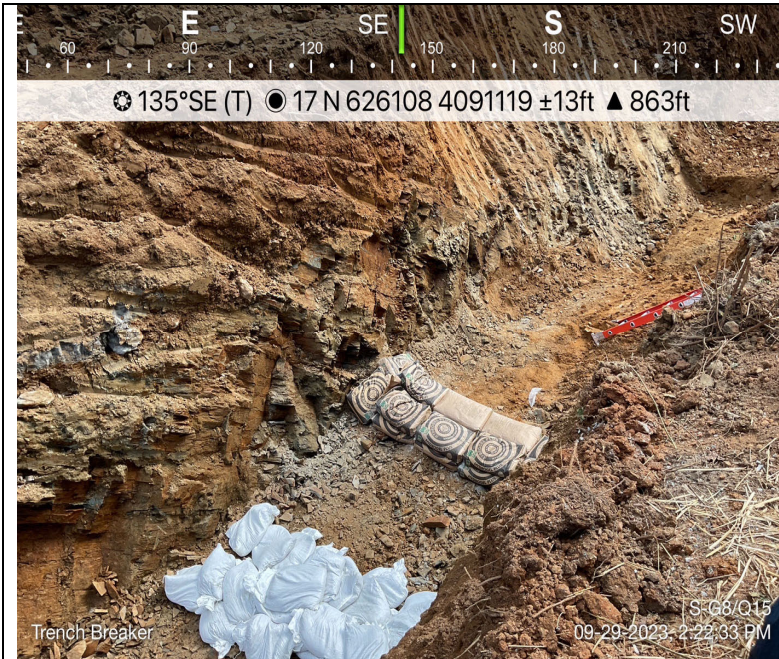
**Photo Description:** Installation preparation for trenchbreakers.

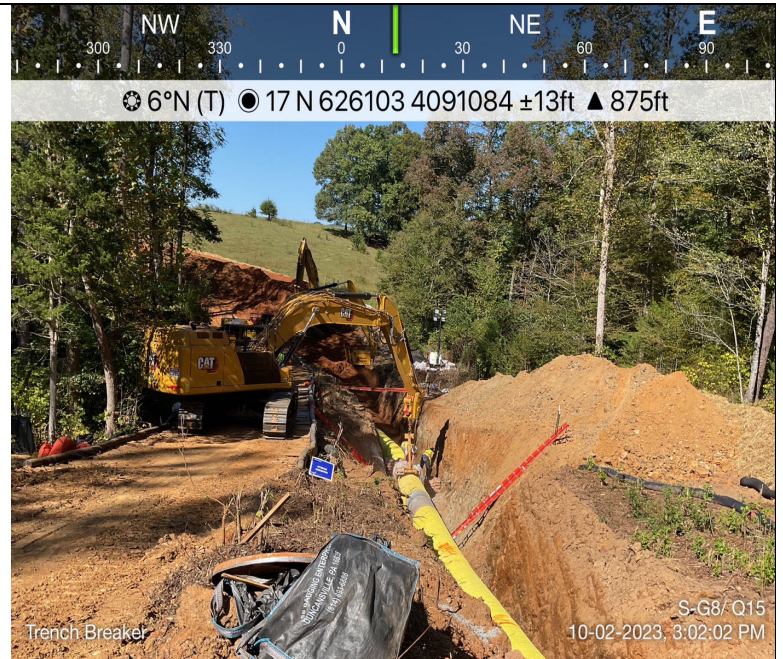
**Photo Description:** Pipe lowered into trench.

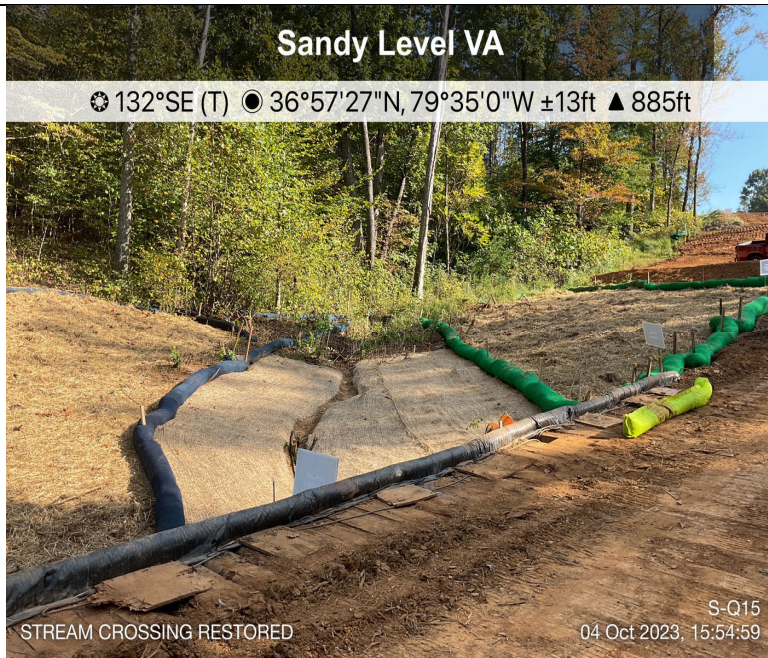
**Photo Description:** Stream crossing completed and restoration complete.

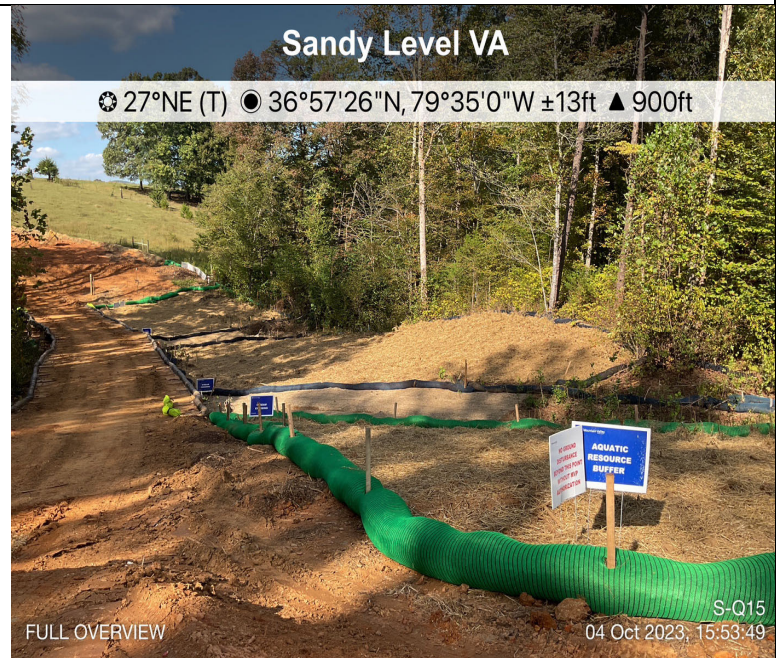
**Photo Description:** Travel lane remains installed/active. Resource area restoration/revegetation overview.
