# STREAM BIOLOGICAL CONDITIONS ENVIRONMENTAL AUDITOR REPORT

<b>Stream ID:</b> S-RR09	<b>Crossing Start Date:</b> 10/23/2023	<b>Crossing Completion Date:</b> 10/31/2023
<b>Milepost:</b> 252.7	<b>Pre-Con Assessment Date:</b> 10/21/2023	<b>Post-Con Assessment Date:</b> 11/01/2023
<b>Station:</b> 13352+23	<b>Stream Classification:</b> Ephemeral (Perennial, Intermittent, Ephemeral)	<b>Bankfull Width (ft.):</b> 9
<b>County:</b> Franklin	<b>303(d) Impairment Listing:</b> Not Impaired	<b>Riffle:Pool Complexes Present?</b> No

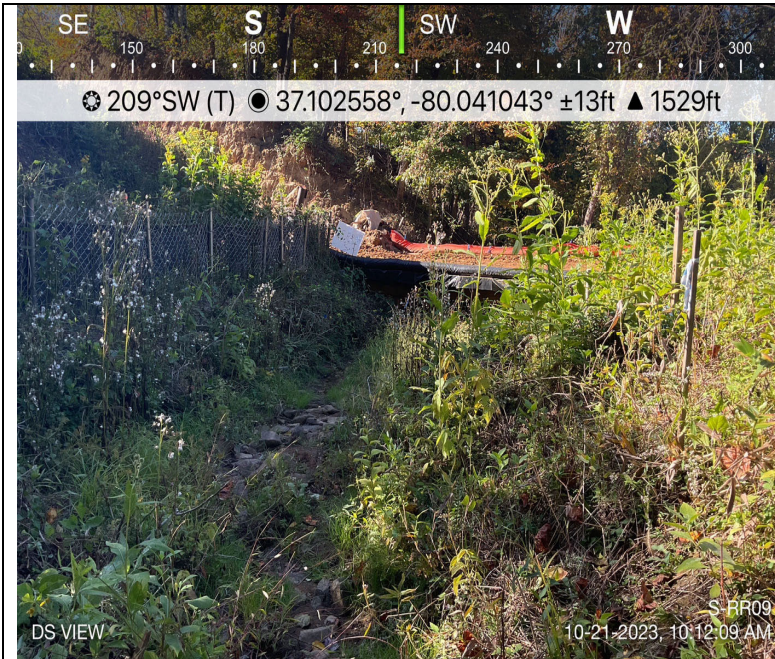
**Photo Description:** Downstream view of permitted impact area during pre-construction assessment.

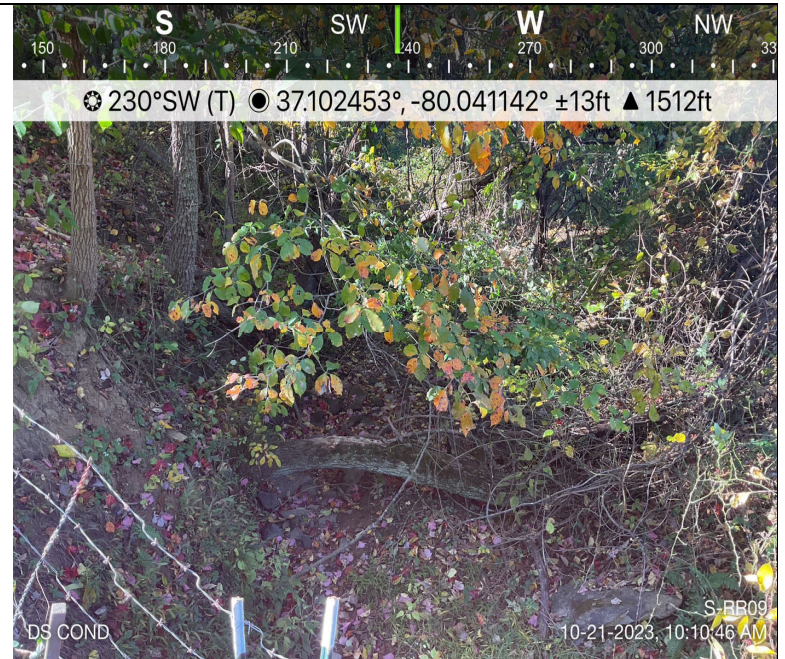
**Photo Description:** Conditions of the downstream area outside the ROW during pre-construction assessment.

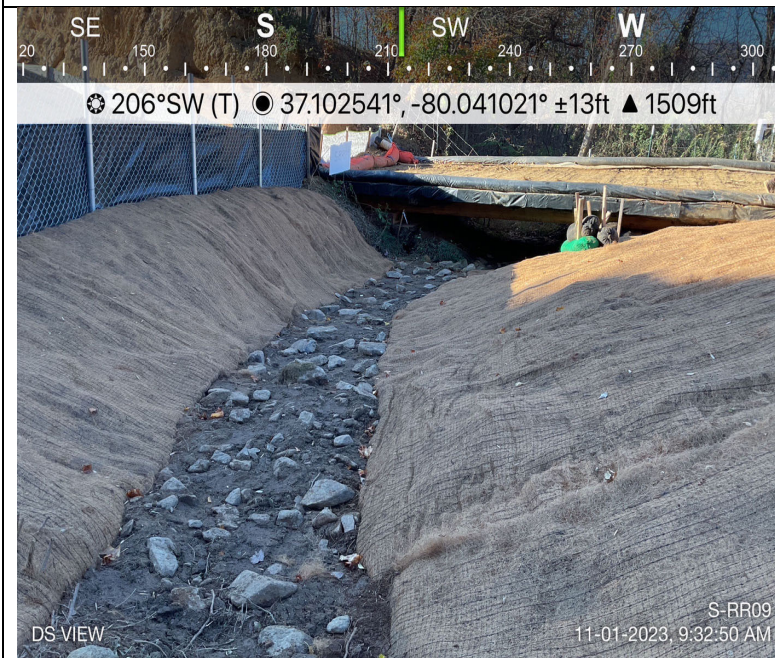
**Photo Description:** Downstream view of permitted impact area during post-construction assessment.

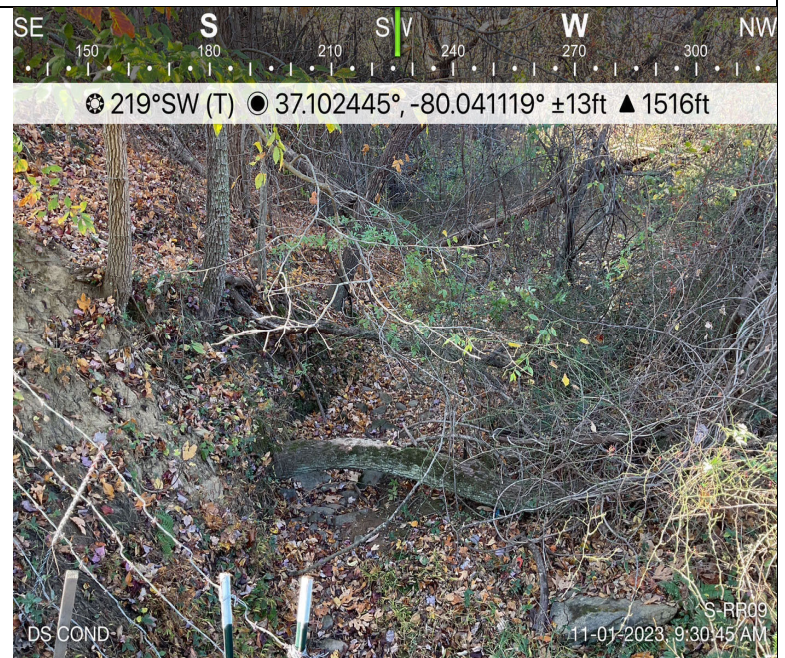
**Photo Description:** Conditions of the downstream area outside the ROW during post-construction assessment.
