# STREAM BIOLOGICAL CONDITIONS ENVIRONMENTAL AUDITOR REPORT

<b>Stream ID:</b> S-RR11	<b>Crossing Start Date:</b> 10/10/2023	<b>Crossing Completion Date:</b> 10/19/2023
<b>Milepost:</b> 252.8	<b>Pre-Con Assessment Date:</b> 10/04/2023	<b>Post-Con Assessment Date:</b> 10/21/2023
<b>Station:</b> 13358+64	<b>Stream Classification:</b> Ephemeral (Perennial, Intermittent, Ephemeral)	<b>Bankfull Width (ft.):</b> 7
<b>County:</b> Franklin	<b>303(d) Impairment Listing:</b> Not Impaired	<b>Riffle:Pool Complexes Present?</b> No

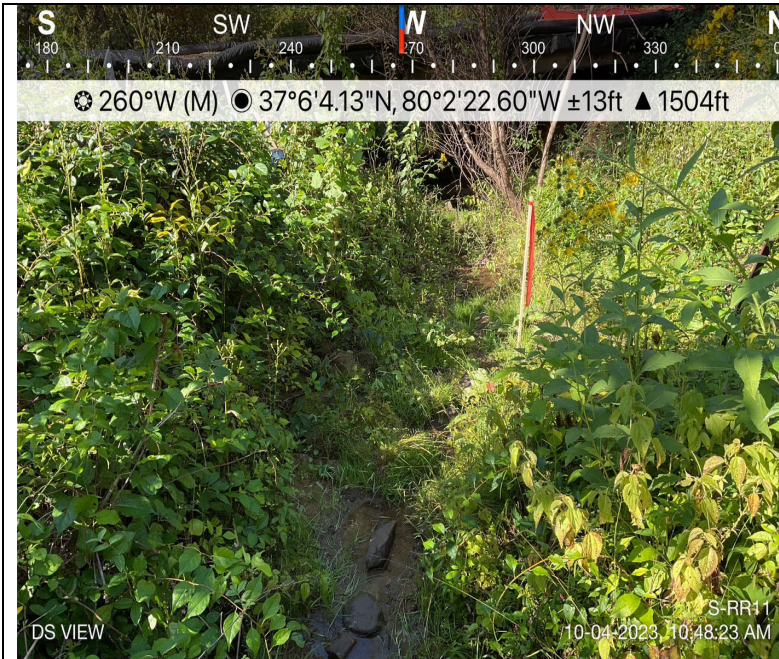
**Photo Description:** Downstream view of permitted impact area during pre-construction assessment.

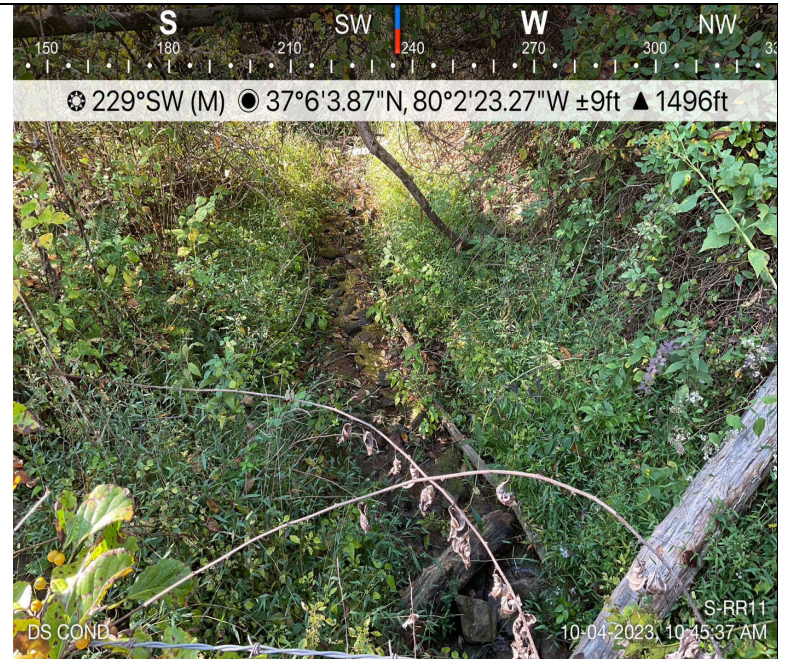
**Photo Description:** Conditions of the downstream area outside the ROW during pre-construction assessment.

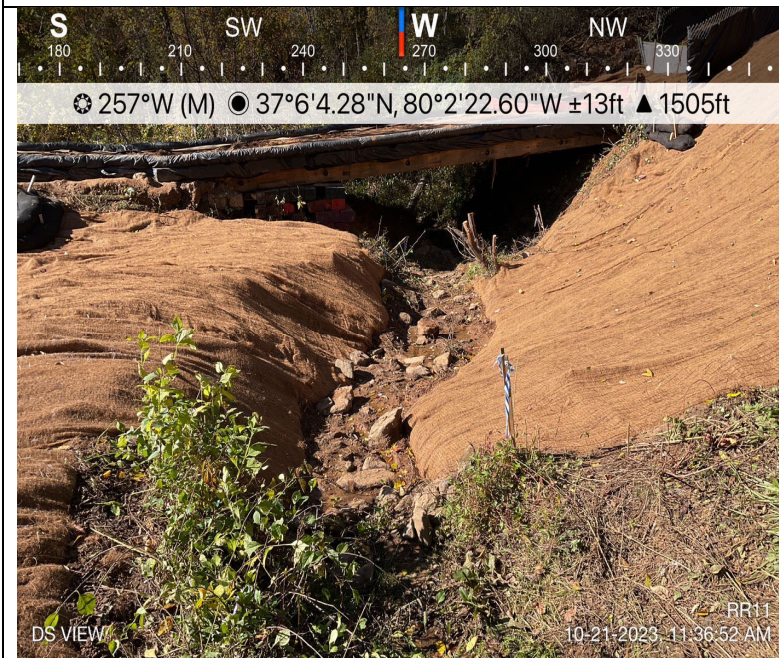
**Photo Description:** Downstream view of permitted impact area during post-construction assessment.

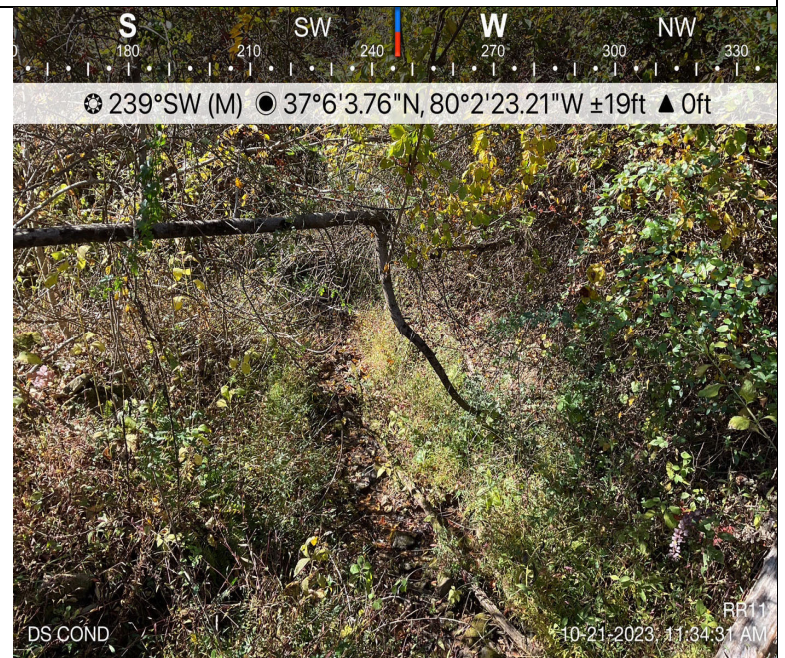
**Photo Description:** Conditions of the downstream area outside the ROW during post-construction assessment.

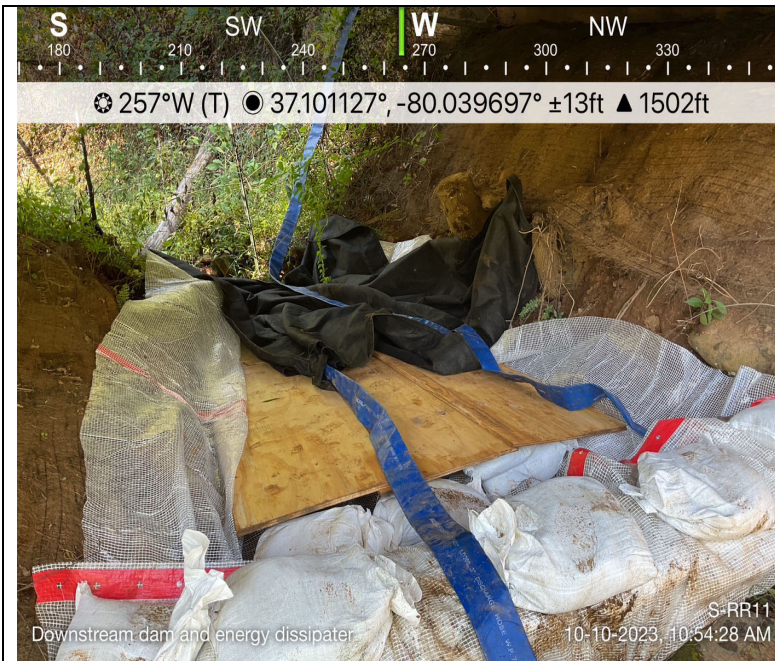
**Photo Description:** Energy dissipater.

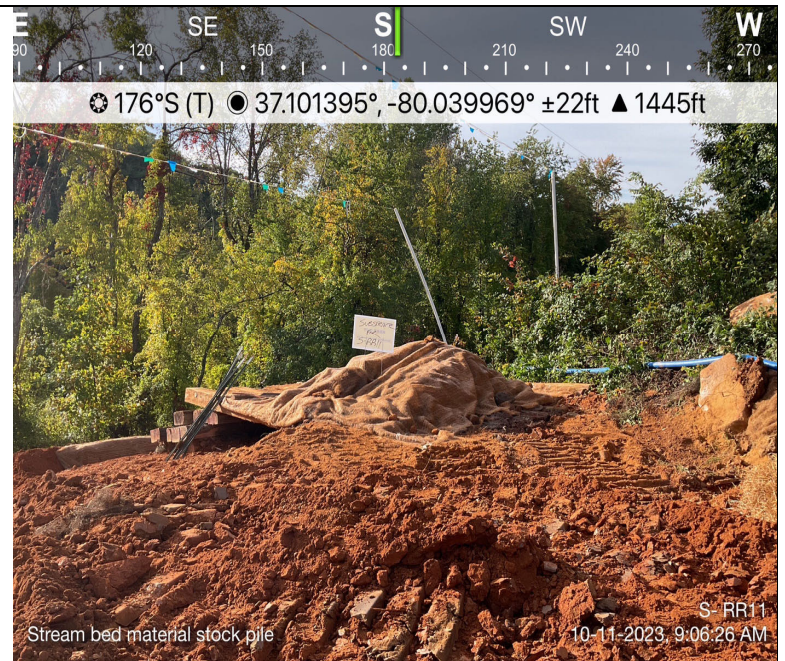
**Photo Description:** Stream bed material segregation.

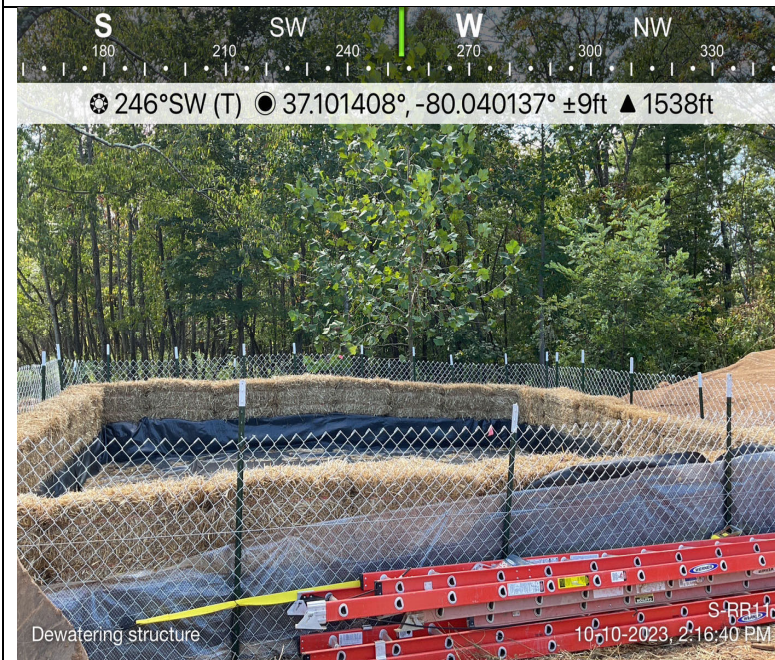
**Photo Description:** Dewatering structure.

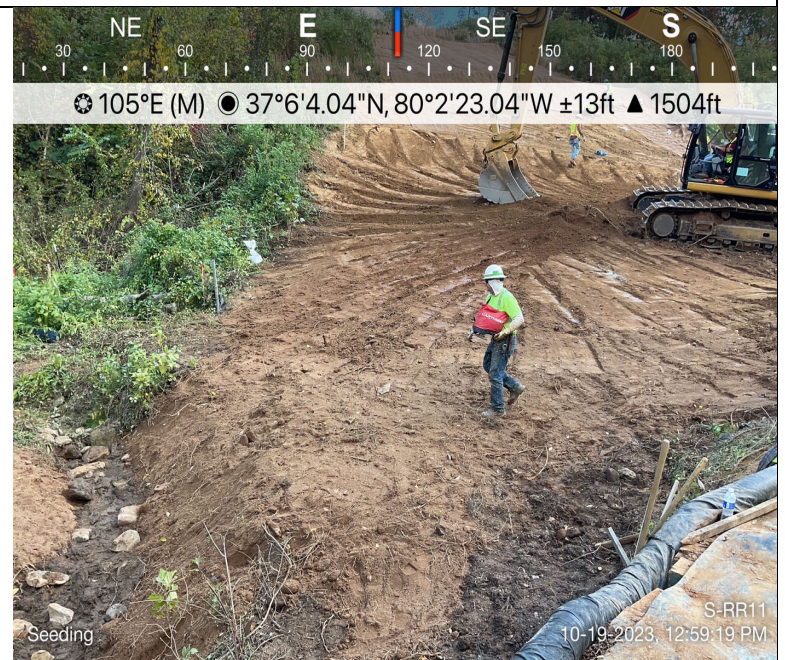
**Photo Description:** Restoration crews applying seed mixes to disturbed resource area.
