Stream Biological Conditions EA Report

Project Name	H-600 Pipeline Spread F	AFE	124300135	Spread	H-600 Pipeline Spread F
Contractor	Price Gregory	Report #	318		
Environmental Auditor	Tim Ferguson	Date/Time	10/26/2023 12:05 PM		
Stream ID	S-UV6	Crossing Start Date	10/31/2023	Crossing Completion Date	11/9/2023
Milepost	155.75	Pre-Con Assessment Date	10/26/2023	Post-Con Assessment Date	11/9/2023
Station	8223+50	Bankfull Width (ft.)	10.0	Riffle:Pool Complexes Present?	No
State	WV	Stream Classification	Perennial		
County	Greenbrier	303(d) Impairment Listing	No

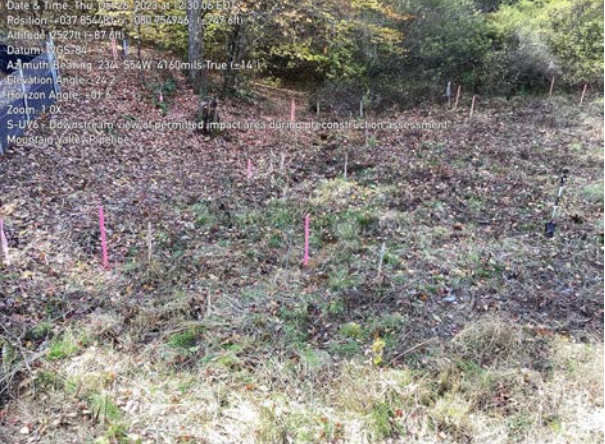
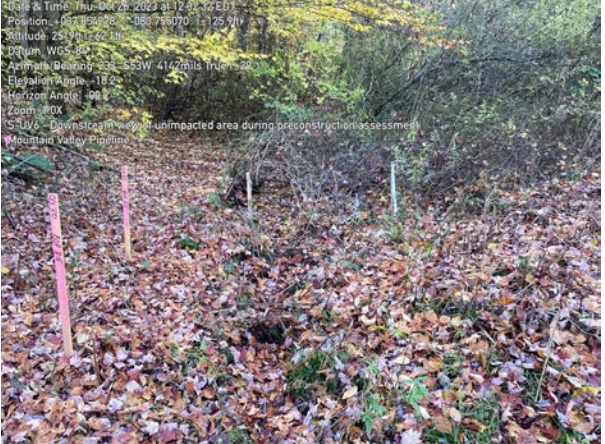
GPS Location See Photo	GPS Location See Photo
Description Downstream view of permitted impact area during pre-construction assessment.	Description Downstream view of unimpacted area during pre-construction assessment.

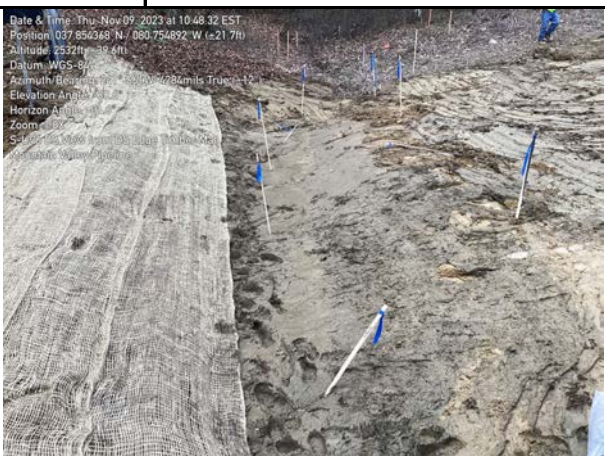
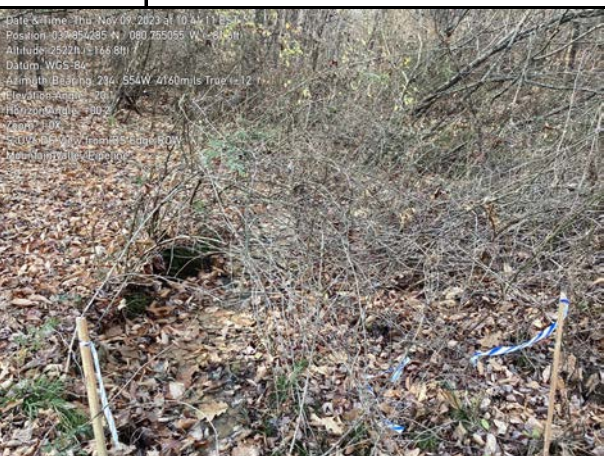
GPS Location See Photo	GPS Location See Photo
Description Downstream view of permitted impact area during post-construction assessment.	Description Downstream view of unimpacted area during post-construction assessment.

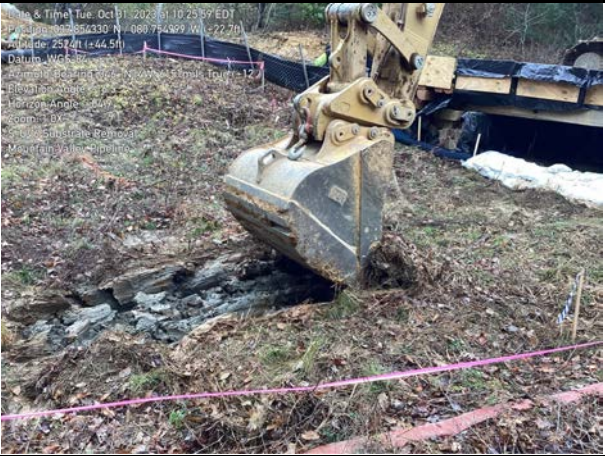
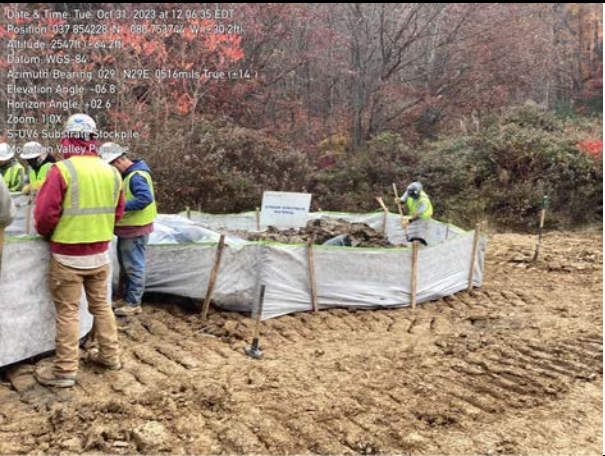
GPS Location See Photo	GPS Location See Photo
Description Photo 1: Removal of top 12-inches of stream substrate.	Description Photo 2: Stream substrate segregated in upland.

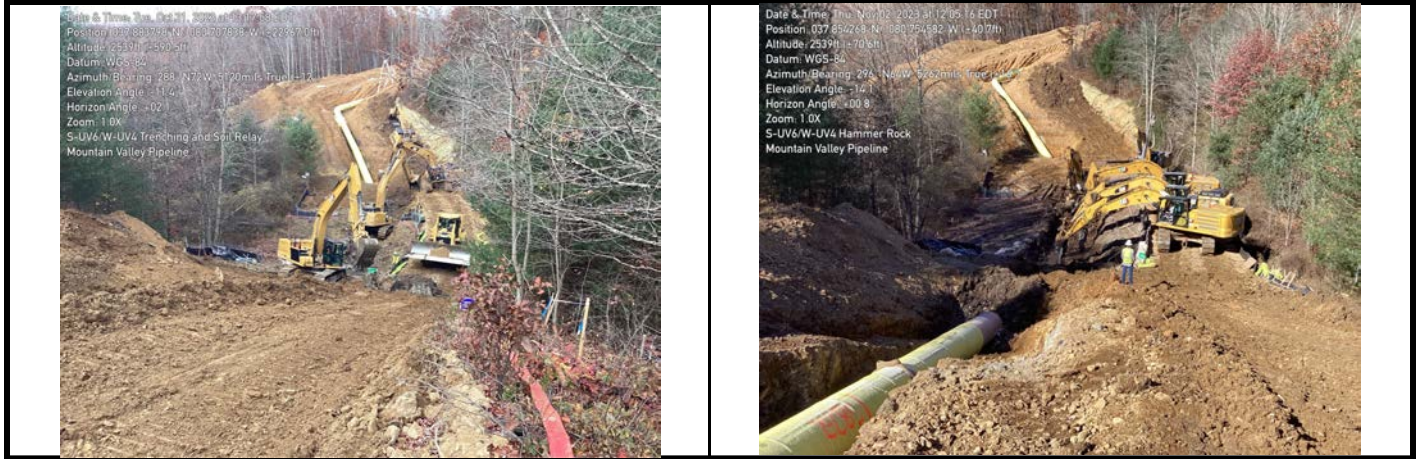
GPS Location	See Photo	GPS Location	See Photo
Description	Photo 3: Trenching through aquatic resource.	Description	Photo 4: Hammering rock in aquatic resource area.

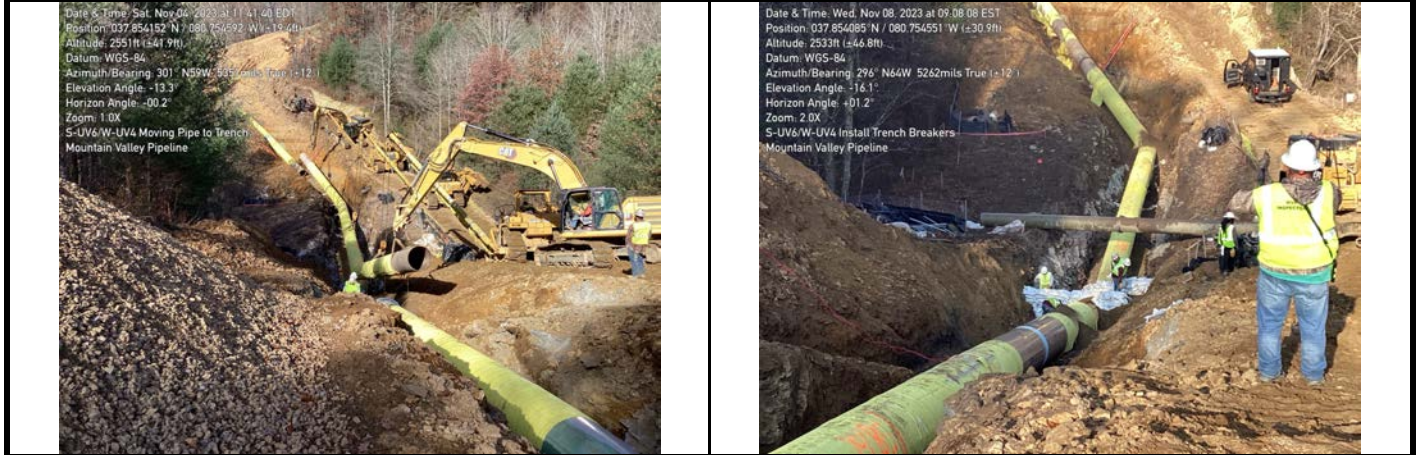
GPS Location	See Photo	GPS Location	See Photo
Description	Photo 5: Lowering pipe into trench.	Description	Photo 6: Building trench breakers adjacent to aquatic resource area.

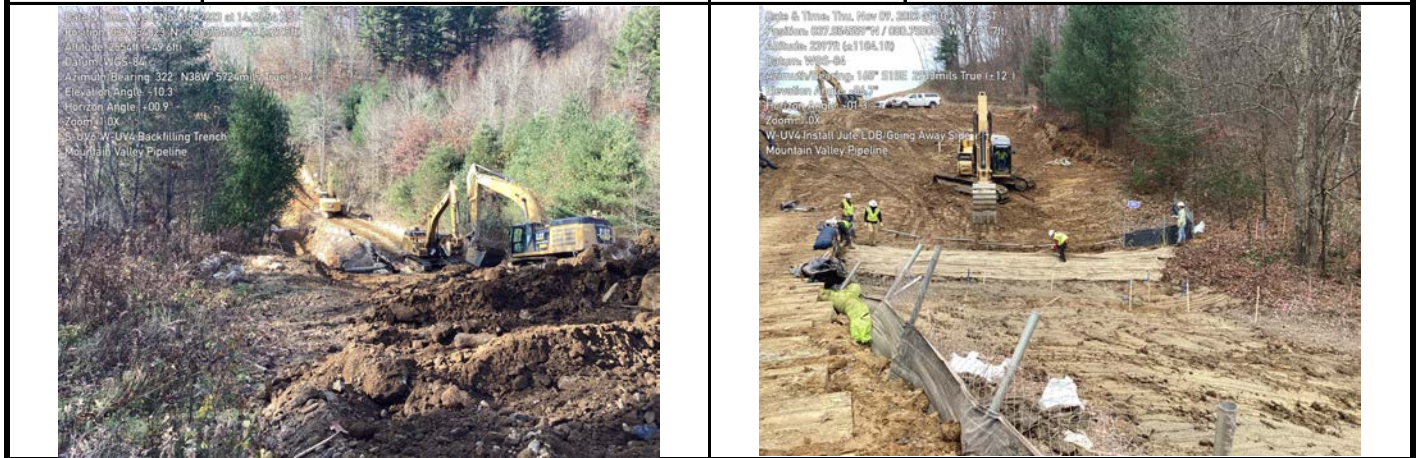
GPS Location	See Photo	GPS Location	See Photo
Description	Photo 7: Backfilling of resource area.	Description	Photo 8: Jute installed on LDB of stream.
