WETLAND BIOLOGICAL CONDITIONS ENVIRONMENTAL AUDITOR REPORT

Wetland ID: W-A12-PEM	Crossing Start Date: 10/17/2023	Crossing Completion Date: 10/20/2023
Milepost: 272.4	Pre-Con Assessment Date: 10/09/2023	Post-Con Assessment Date: 10/20/2023
Station: 14392 + 03	Cowardin Classification: PEM (PEM, PFO, PSS, POW)	Wetland Impact Area (sq ft.): 2835.76
County: Franklin

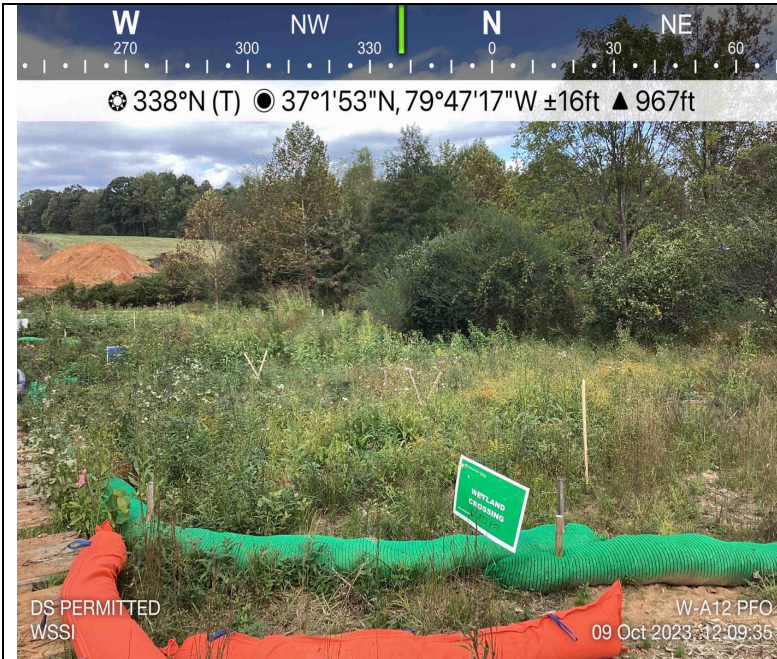
Photo Description: View of permitted resource impact area during pre-construction assessment. Typo in photo watermark. W-A12-PEM, not PFO.

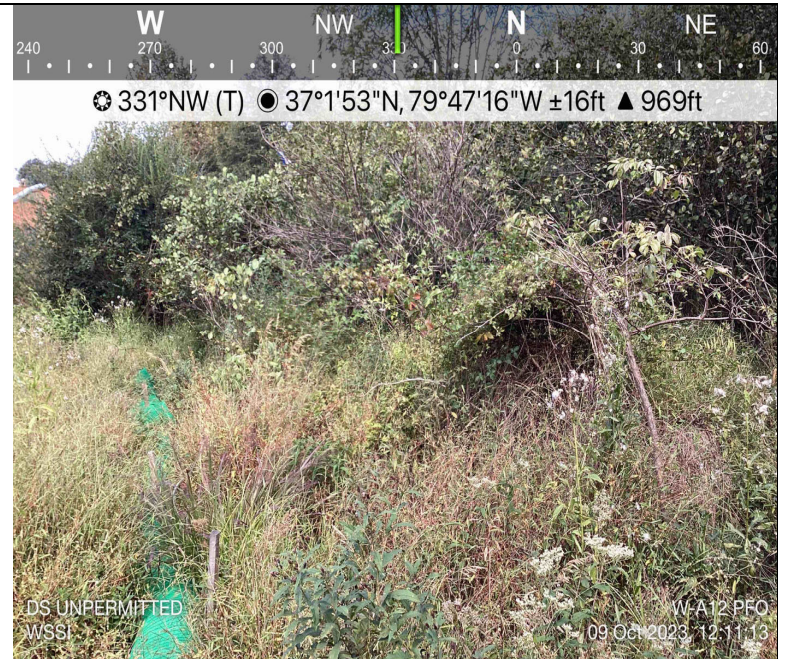
Photo Description: At edge of LOD, view of unpermitted resource area conditions during pre-construction assessment. Typo in photo watermark. W-A12-PEM, not PFO.

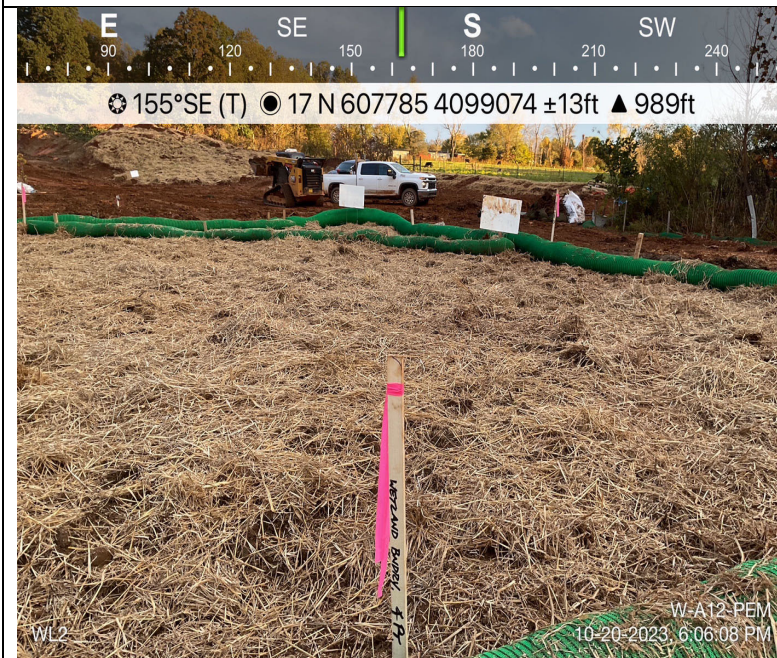
Photo Description: View of permitted resource impact area during post-construction assessment.

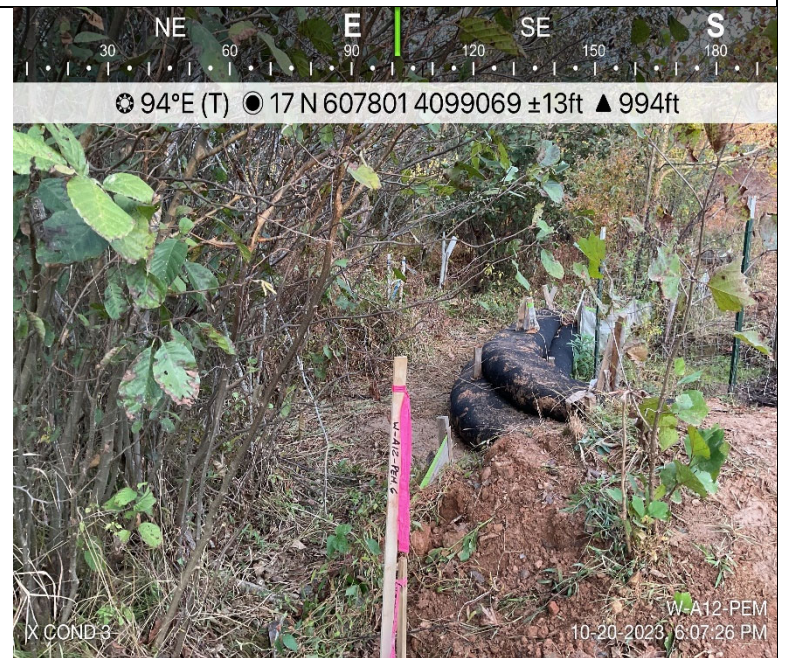
Photo Description: At edge of LOD, view of unpermitted resource area conditions during post-construction assessment.

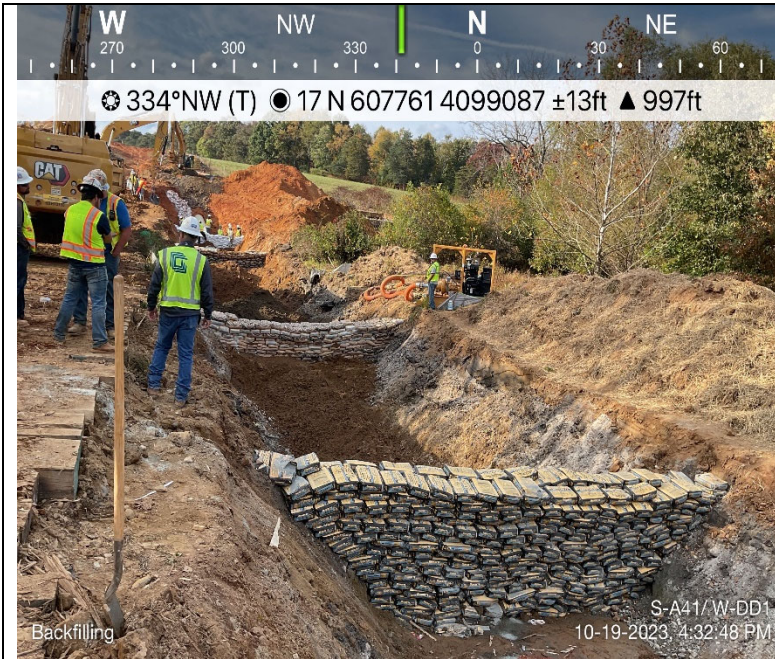
Item #10: The E&S plan only required a Trench Breaker on the GAS. The trench breaker was placed 25-feet from the resource. -T. Snideman

Photo Description: Trenchbreaker installations and pipe padding backfill.

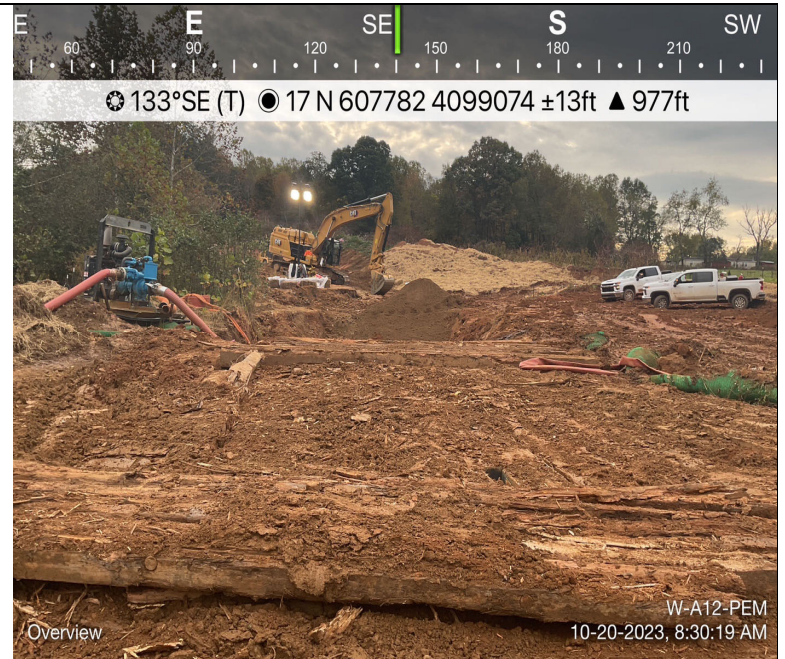
Photo Description: Timber mats used during the resource crossing.

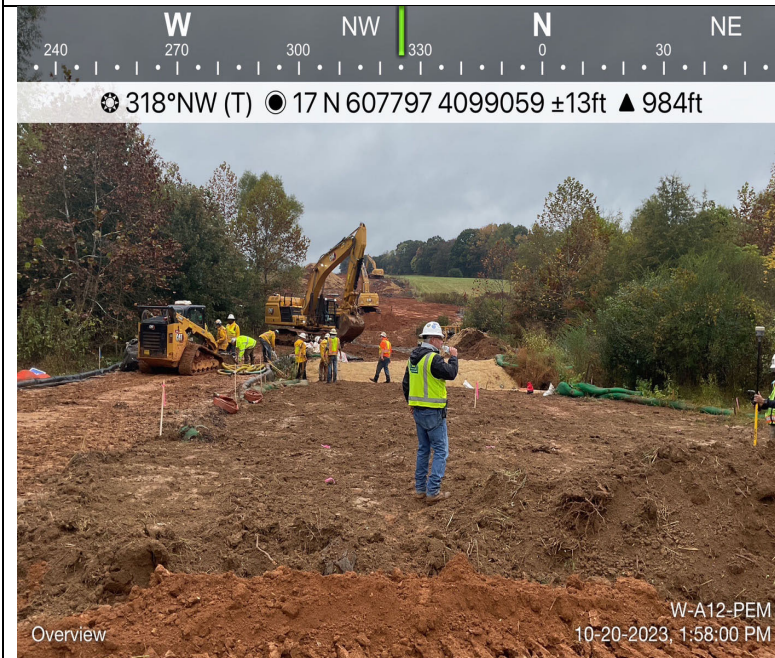
Photo Description: Restoration of the wetland's subsoil and topsoil.

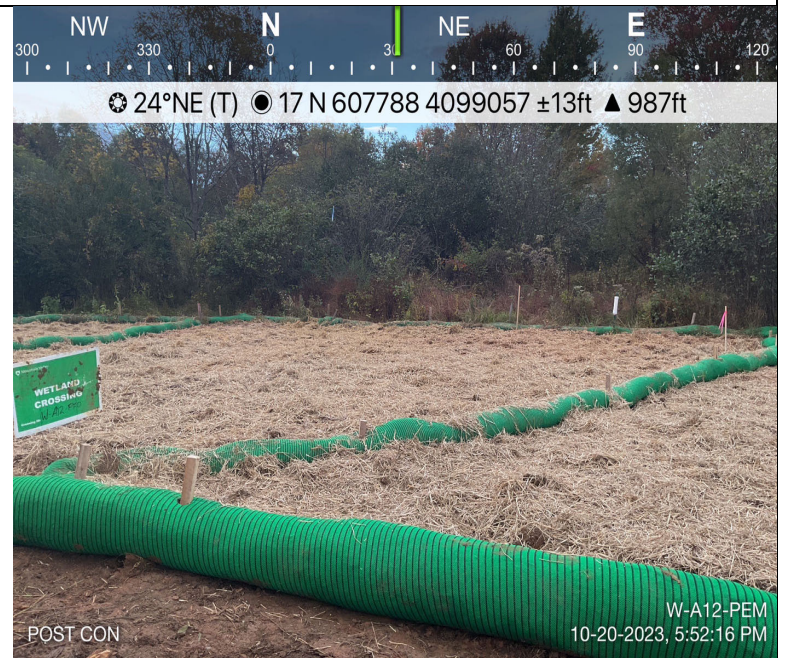
Photo Description: Restoration of the resource is complete.
