WETLAND BIOLOGICAL CONDITIONS ENVIRONMENTAL AUDITOR REPORT

Wetland ID: W-A8	Crossing Start Date: 10/26/2023	Crossing Completion Date: 10/28/2023
Milepost: 278.3	Pre-Con Assessment Date: 10/26/2023	Post-Con Assessment Date: 10/28/2023
Station: 14722+11	Cowardin Classification: PEM (PEM, PFO, PSS, POW)	Wetland Impact Area (sq ft.): 670.82
County: Franklin

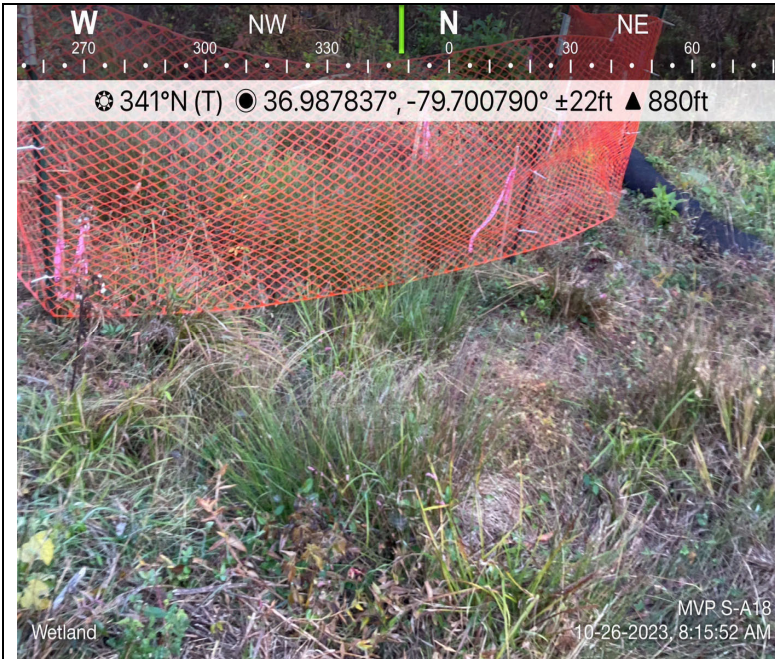
Photo Description: View of permitted resource impact area during pre-construction assessment.

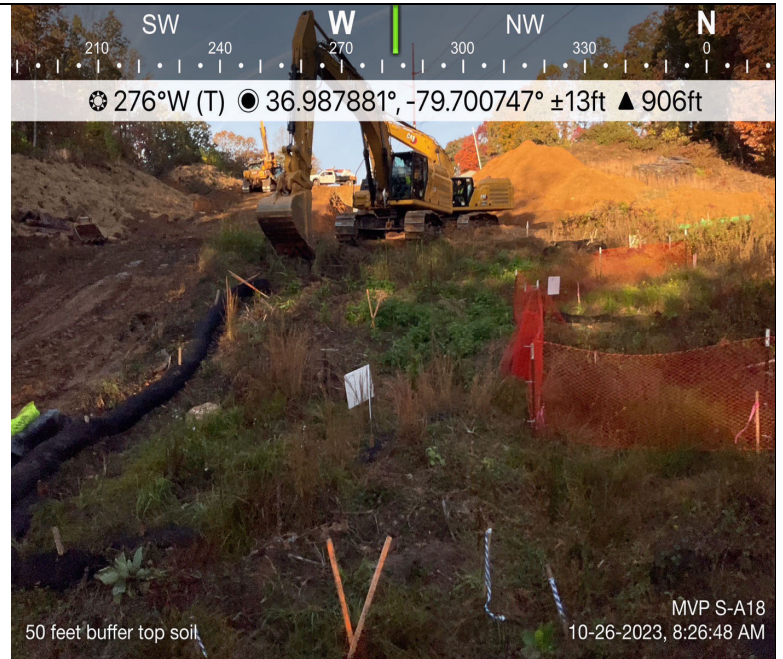
Photo Description: At edge of LOD, view of unpermitted resource area conditions during pre-construction assessment.

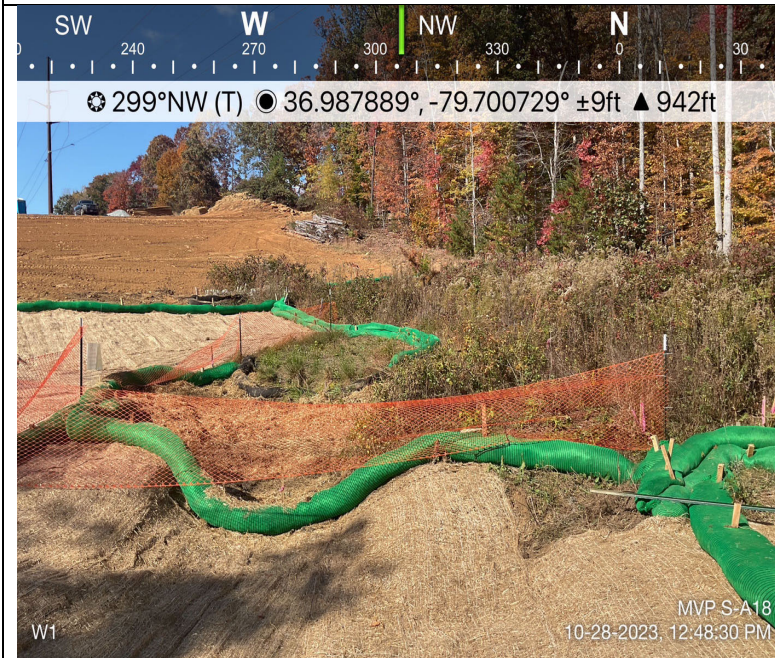
Photo Description: View of permitted resource impact area during post-construction assessment.

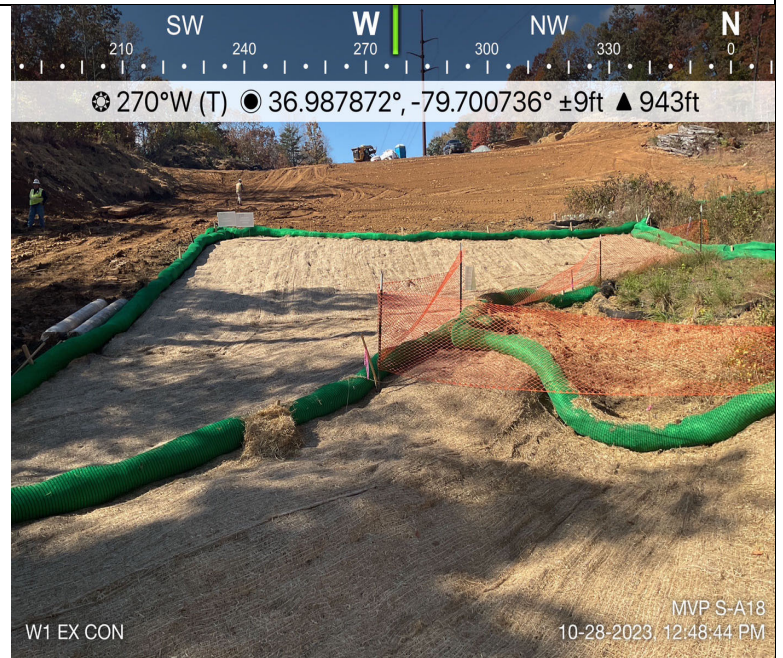
Photo Description: At edge of LOD, view of unpermitted resource area conditions during post-construction assessment.

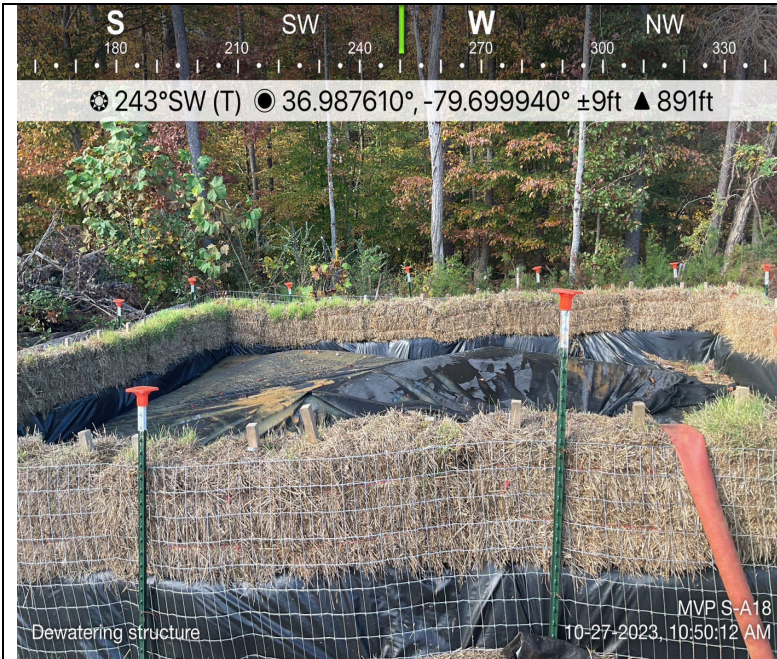
Photo Description: Dewatering structure available on site for combined crossing.

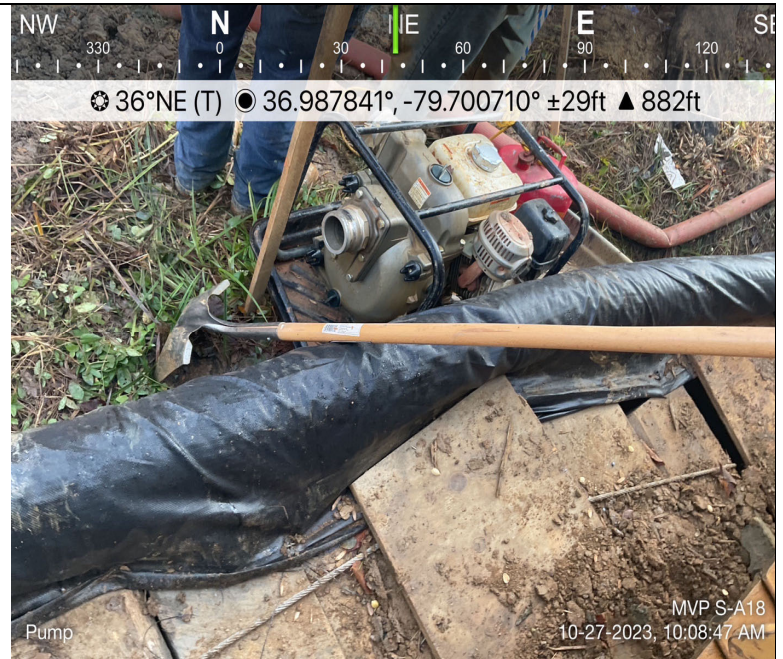
Photo Description: Dam and pumps installed on-site for stream and wetland crossing.

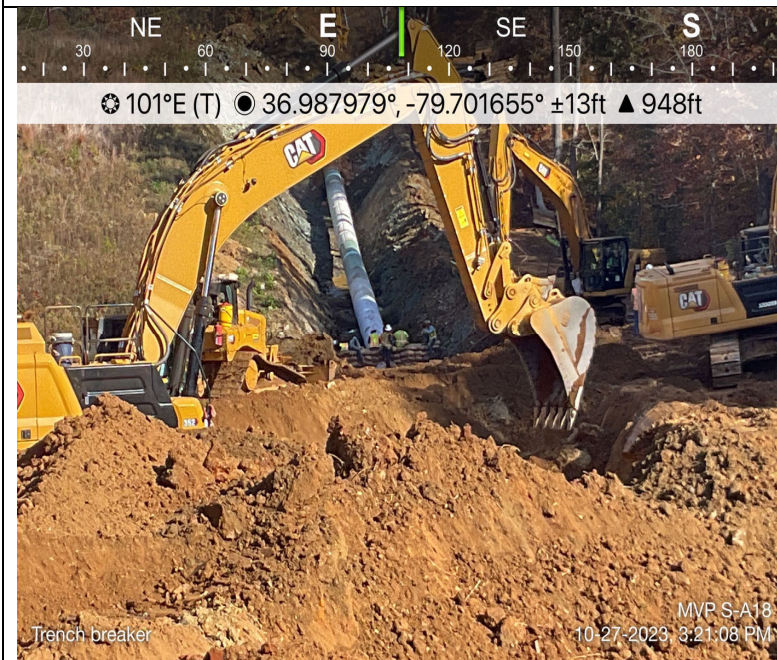
Photo Description: Trench breaker installation.

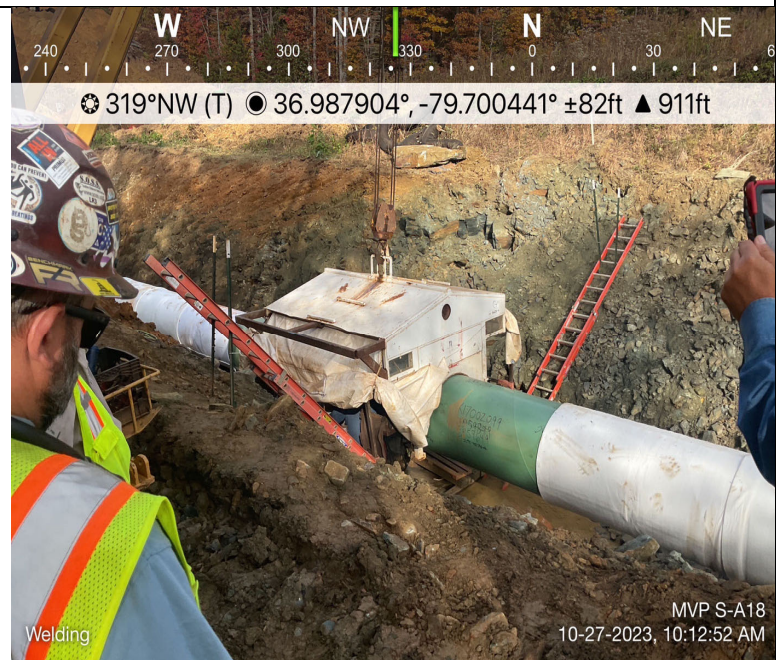
Photo Description: Welding pipe within trench.
