WETLAND BIOLOGICAL CONDITIONS ENVIRONMENTAL AUDITOR REPORT

Wetland ID: W-C11	Crossing Start Date: 09/13/2023	Crossing Completion Date: 10/02/2023
Milepost: 229.4	Pre-Con Assessment Date: 09/11/2023	Post-Con Assessment Date: 10/02/2023
Station: 12122+02	Cowardin Classification: PSS (PEM, PFO, PSS, POW)	Wetland Impact Area (sq ft.): 2008.12
County: Montgomery

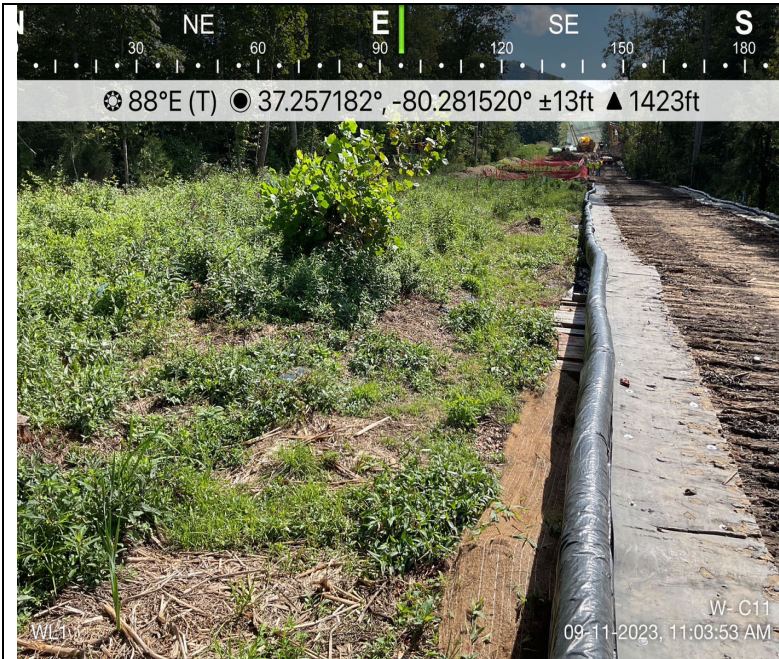
Photo Description: View of permitted resource impact area during pre-construction assessment.

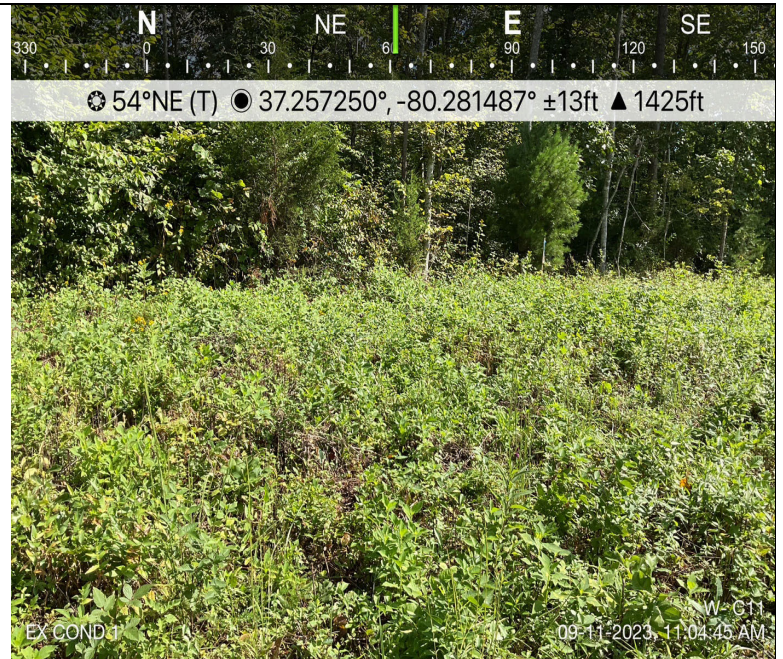
Photo Description: At edge of LOD, view of unpermitted resource area conditions during pre-construction assessment.

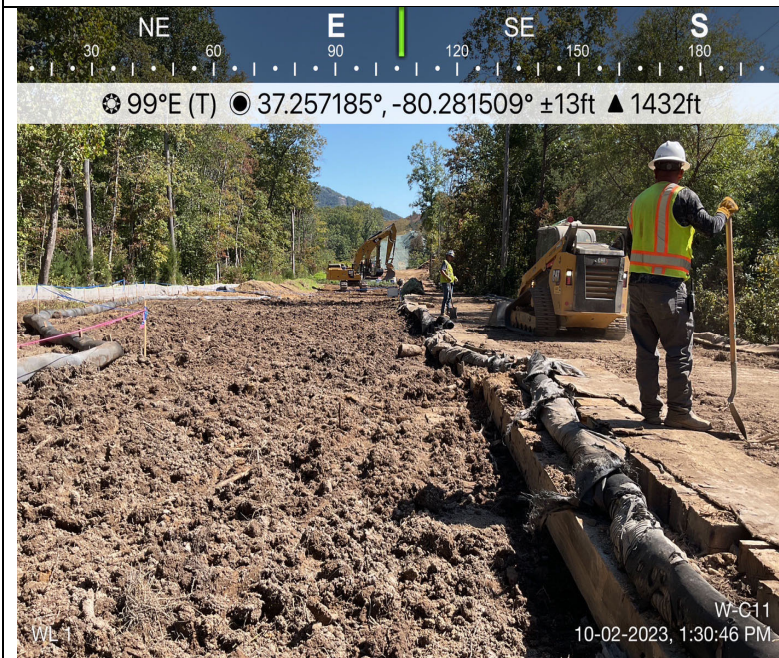
Photo Description: View of permitted resource impact area during post-construction assessment.

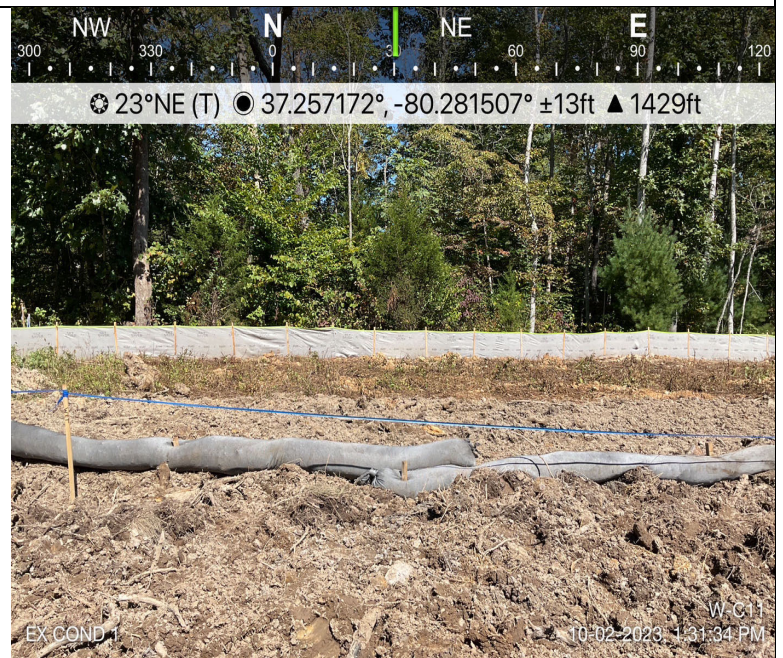
Photo Description: At edge of LOD, view of unpermitted resource area conditions during post-construction assessment.

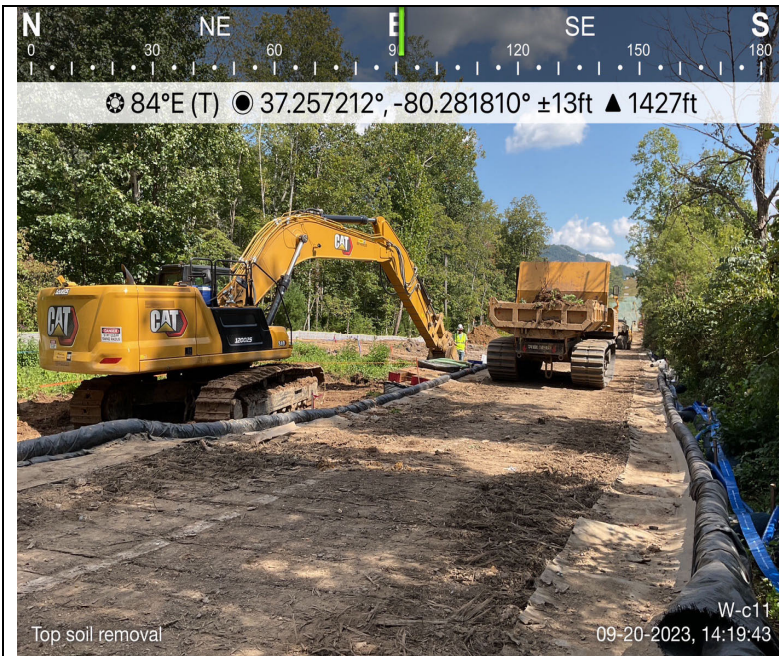
9/20/2023: Stripped edge of wetlands to avoid topsoil from falling into trench. Stockpiled separately from subsoil. -B. Fantauzzi

Photo Description: Top soil removal in wetland.

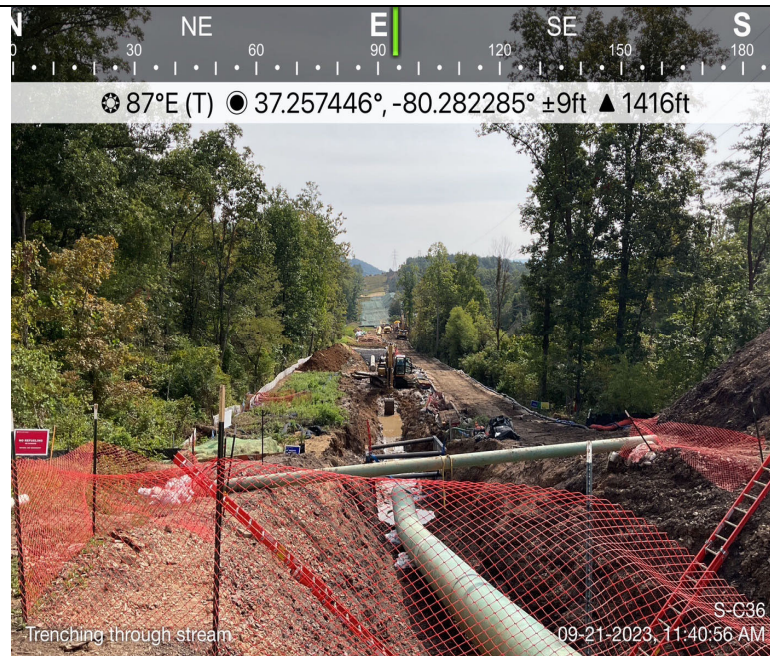
9/21/2023: Trenching through wetlands and stream. Flume added for secondary protection along with pumping operation. Dewatering structure expanded. -S. Frost

Photo Description: Trenching through resources.

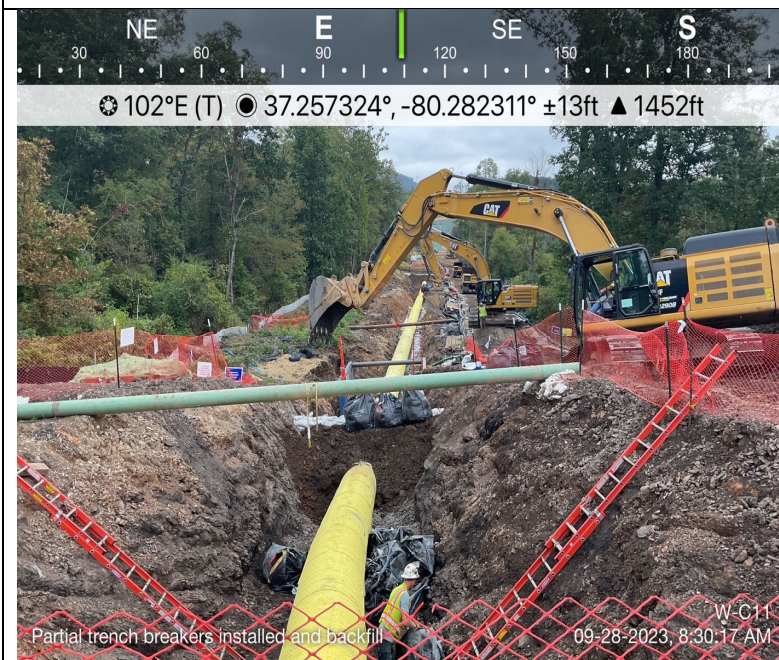
9/28/2023: Partial trench breakers and backfill of subsoil started. - S. Frost

Photo Description: Trench breakers installed within 25 ft of resources.

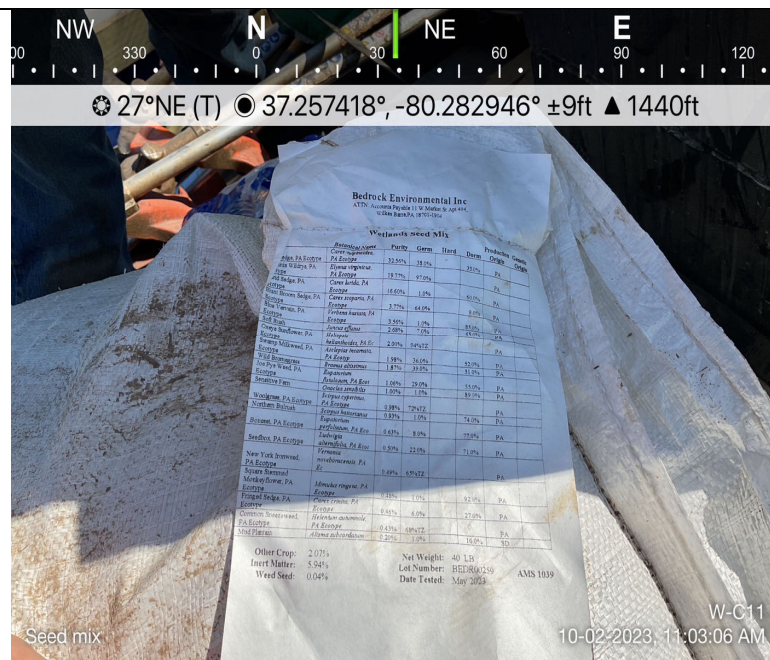
Photo Description: Wetland seed mix tag.
