WETLAND BIOLOGICAL CONDITIONS ENVIRONMENTAL AUDITOR REPORT

Wetland ID: W-C12-PEM	Crossing Start Date: 09/13/2023	Crossing Completion Date: 10/02/2023
Milepost: 229.4	Pre-Con Assessment Date: 09/11/2023	Post-Con Assessment Date: 10/02/2023
Station: 12120+52	Cowardin Classification: PEM (PEM, PFO, PSS, POW)	Wetland Impact Area (sq ft.): 8999.5
County: Montgomery

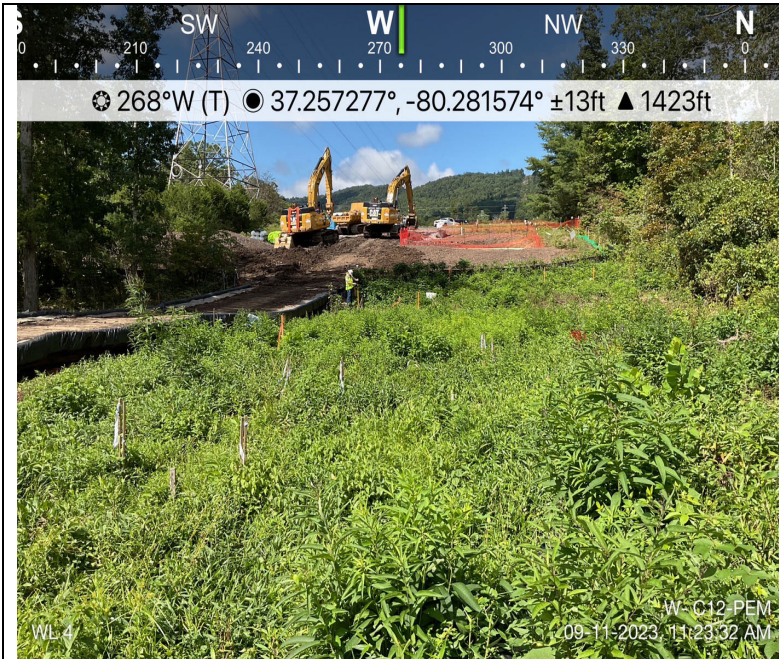
Photo Description: View of permitted resource impact area during pre-construction assessment.

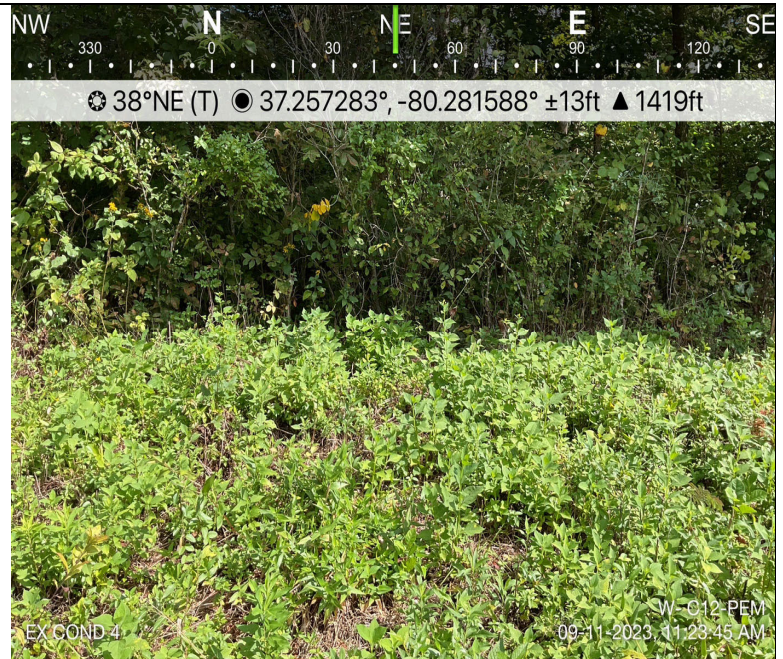
Photo Description: At edge of LOD, view of unpermitted resource area conditions during pre-construction assessment.

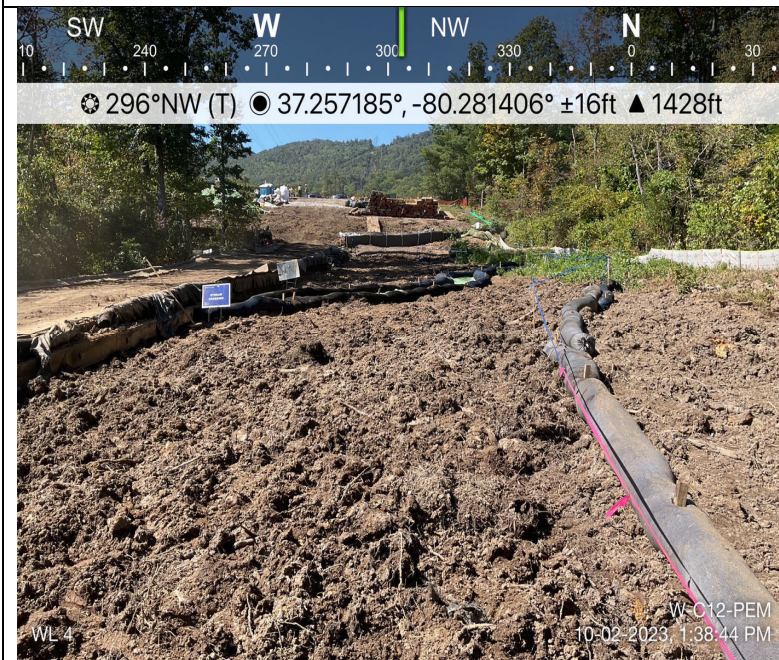
Photo Description: View of permitted resource impact area during post-construction assessment.

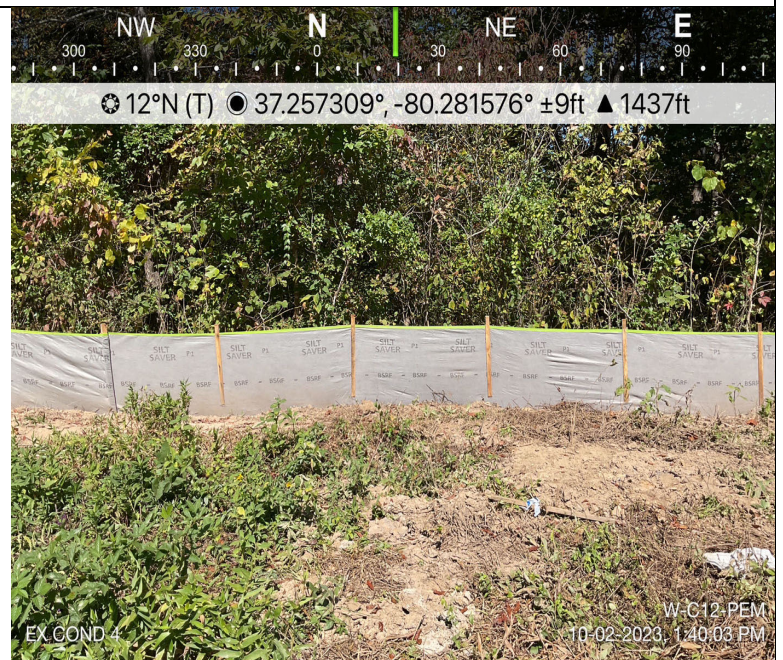
Photo Description: At edge of LOD, view of unpermitted resource area conditions during post-construction assessment.

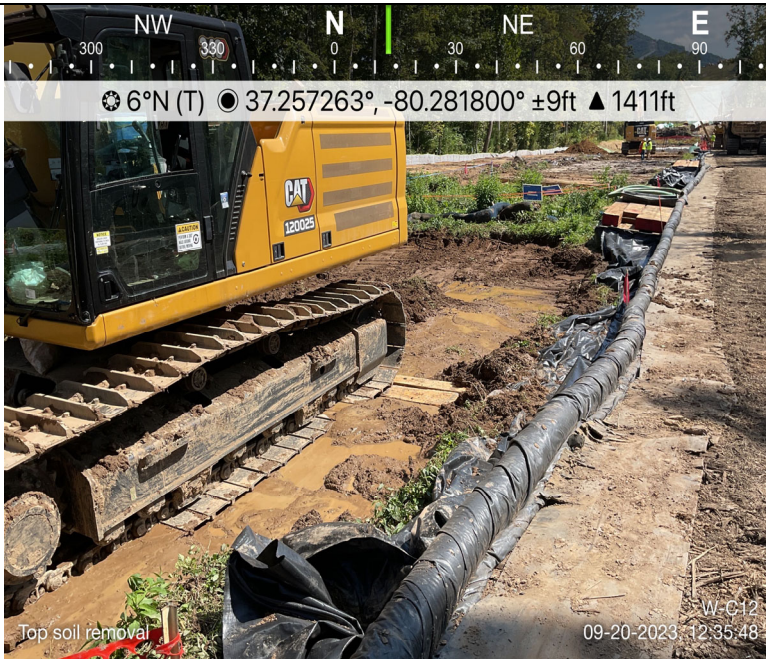
Photo Description: Wetland top soil removal.

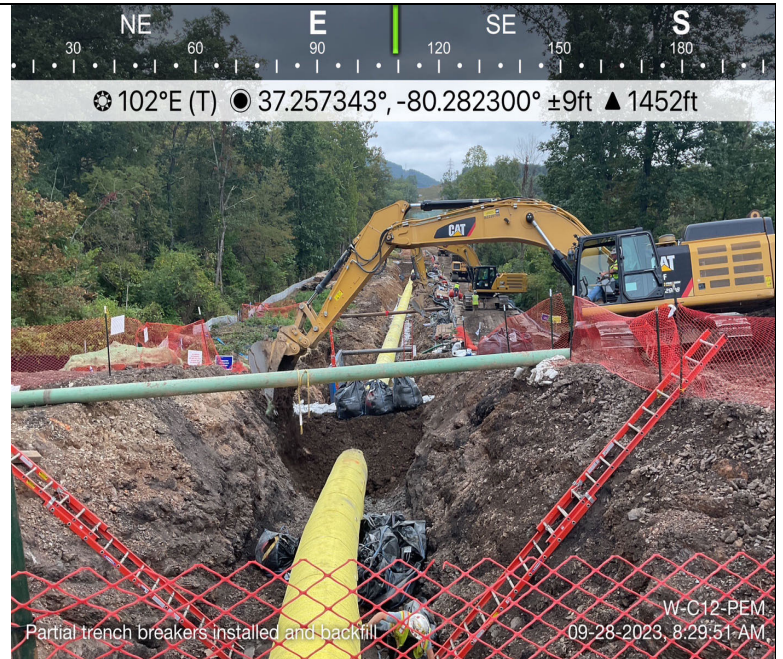
Photo Description: Trench breakers within 25 of the resources.

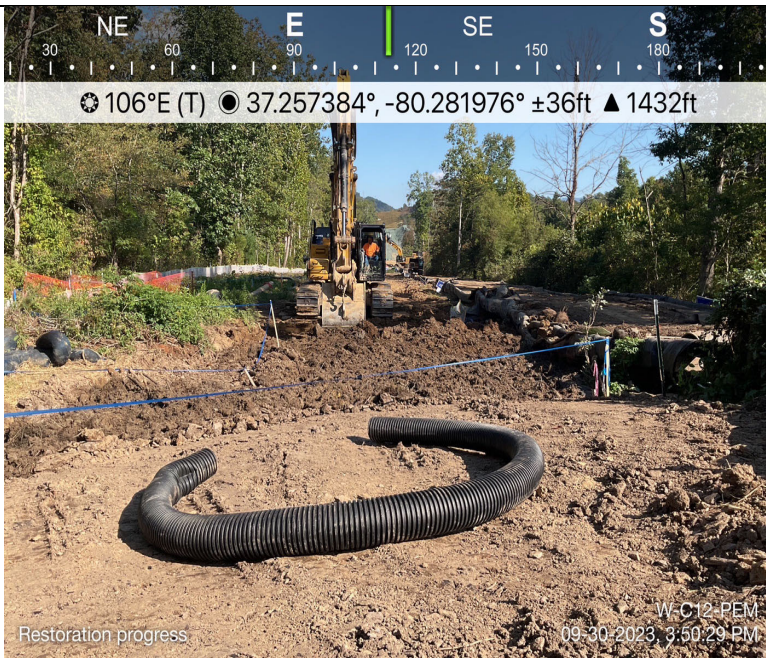
Photo Description: Top soil restoration of wetland.

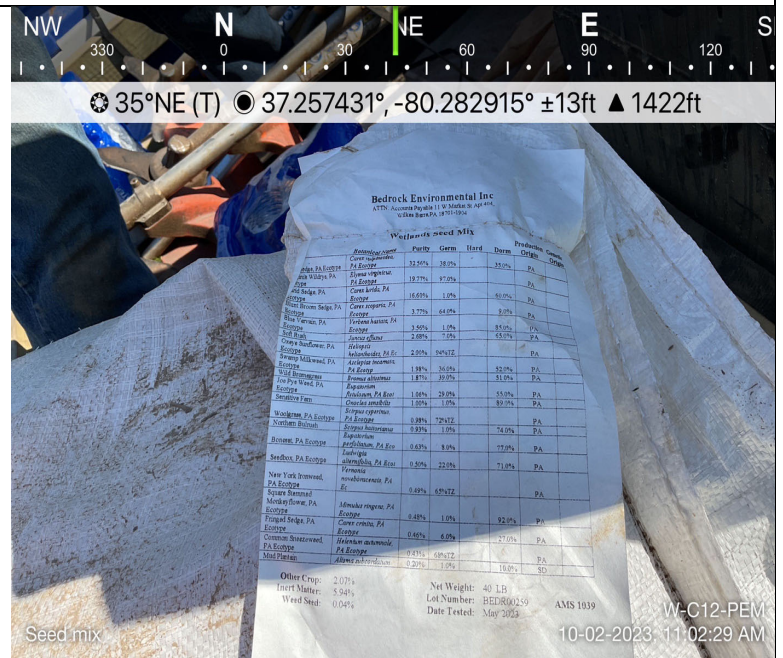
Photo Description: Seed tag for wetlands mixed with temporary rye seed.
