# WETLAND BIOLOGICAL CONDITIONS ENVIRONMENTAL AUDITOR REPORT

<b>Wetland ID:</b> W-C12	<b>Crossing Start Date:</b> 09/13/2023	<b>Crossing Completion Date:</b> 10/02/2023
<b>Milepost:</b> 229.4	<b>Pre-Con Assessment Date:</b> 09/11/2023	<b>Post-Con Assessment Date:</b> 10/02/2023
<b>Station:</b> 12121+33	<b>Cowardin Classification:</b> PFO (PEM, PFO, PSS, POW)	<b>Wetland Impact Area (sq ft.):</b> 2278.19
<b>County:</b> Montgomery

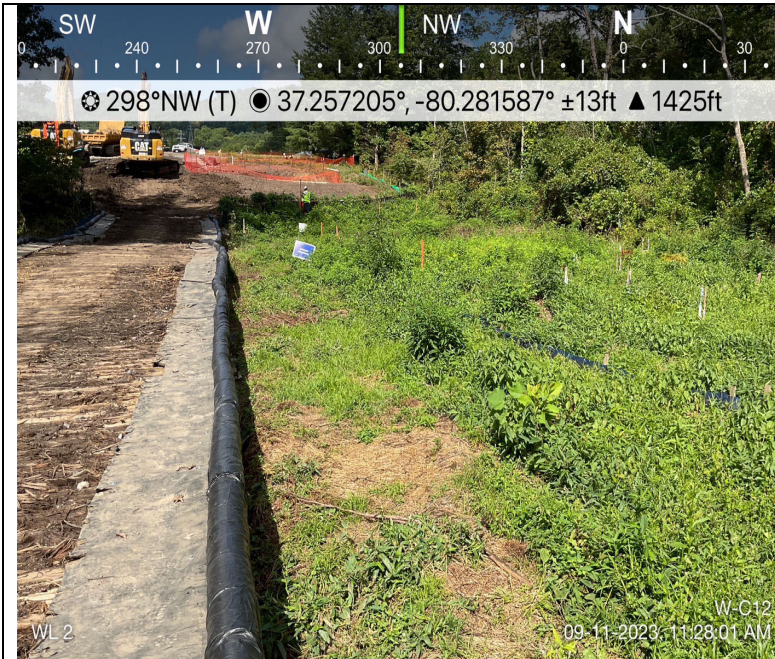
**Photo Description:** View of permitted resource impact area during pre-construction assessment.

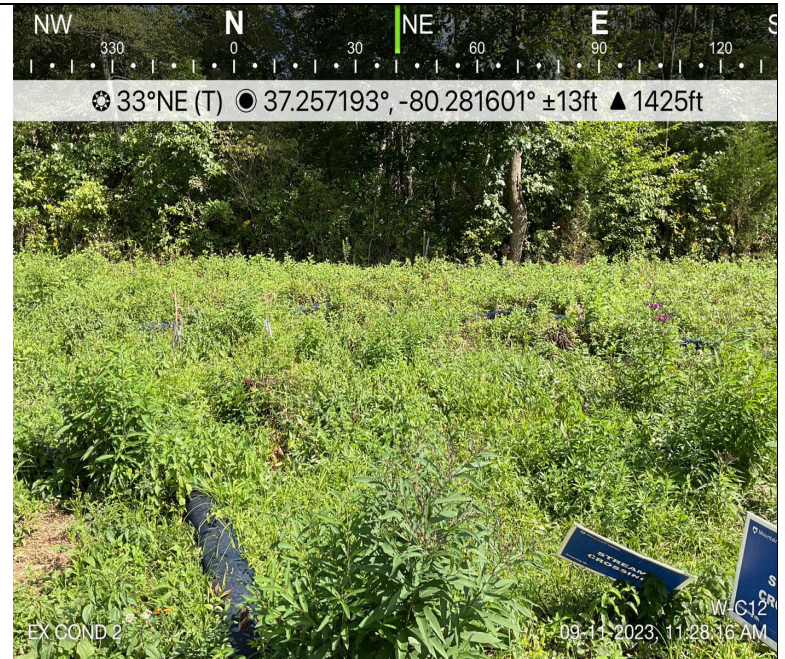
**Photo Description:** At edge of LOD, view of unpermitted resource area conditions during pre-construction assessment.

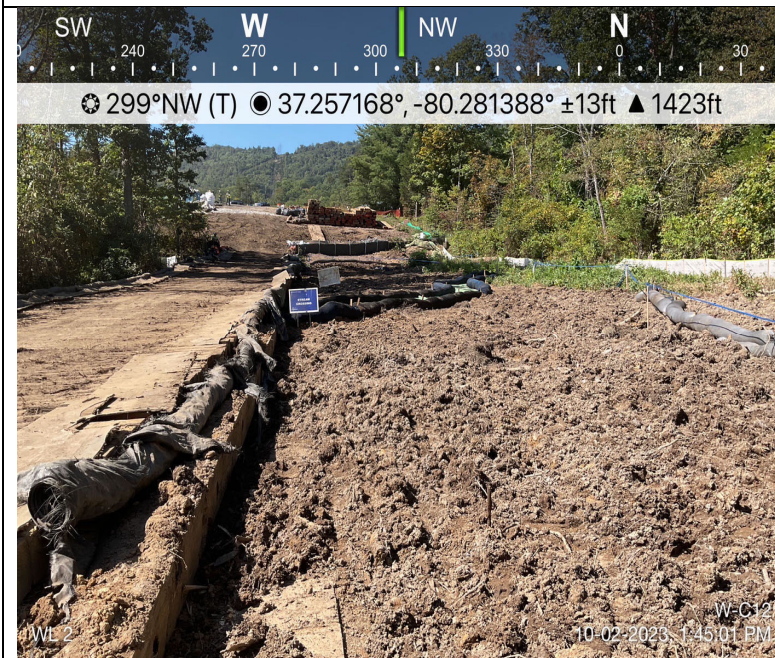
**Photo Description:** View of permitted resource impact area during post-construction assessment.

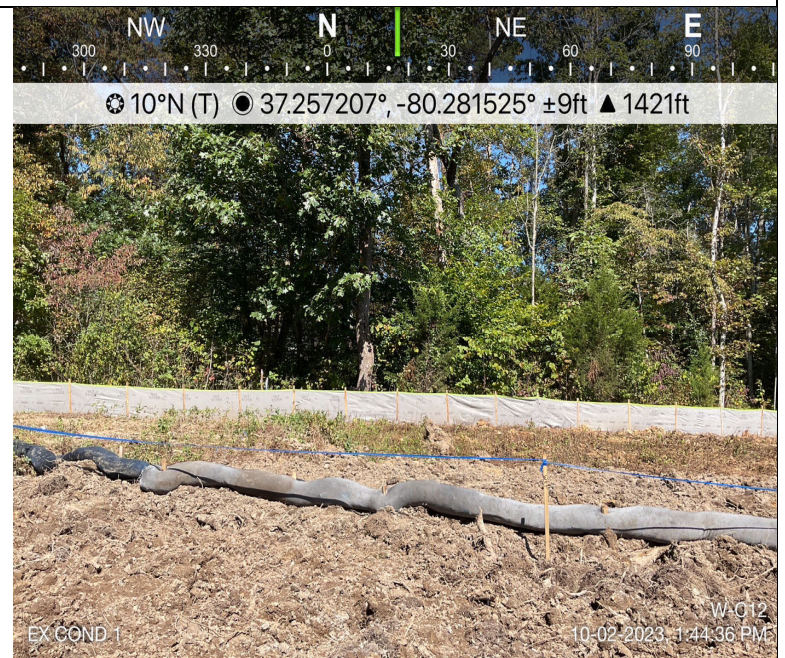
**Photo Description:** At edge of LOD, view of unpermitted resource area conditions during post-construction assessment.

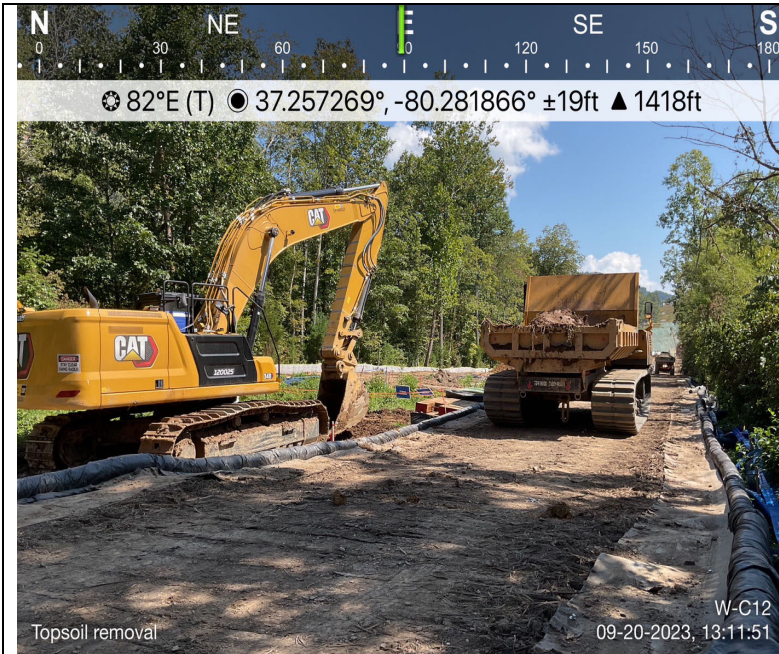
9/18/2023- Stripping topsoil in wetland. Soil segregated and stockpiled separately. -B. Fantauzzi

**Photo Description:** Top soil removal through wetland.

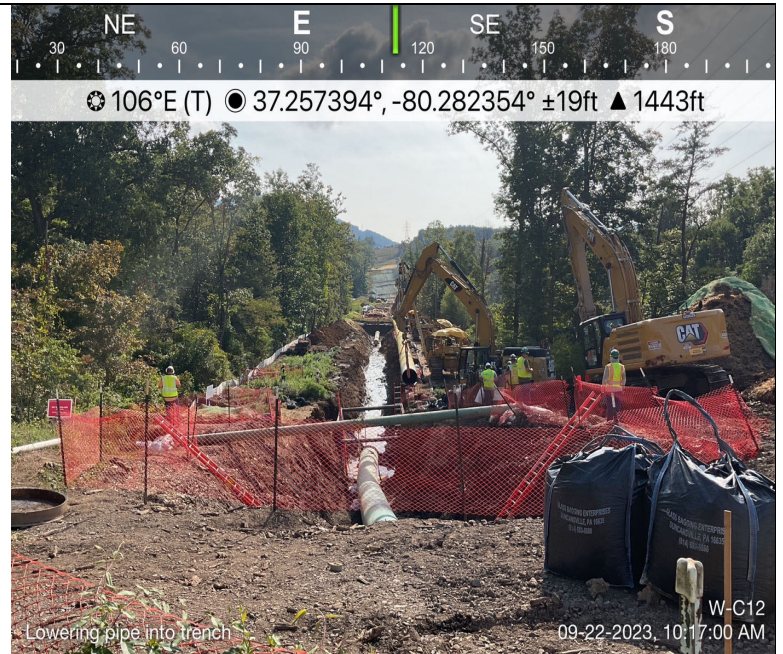
9/22/2023- Trenching completed and the pipe was lowered into the trench. Welding started. - S. Frost

**Photo Description:** Pipe installation into trench.

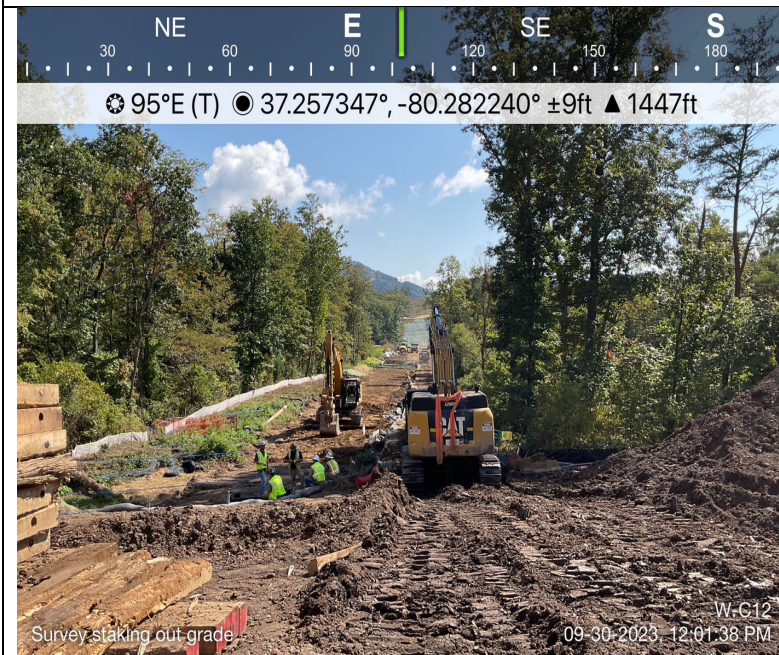
9/30/2023: Survey stakeout of resource and plan for restoration of soils.

**Photo Description:** Survey staking out for final grade and wetland boundaries.

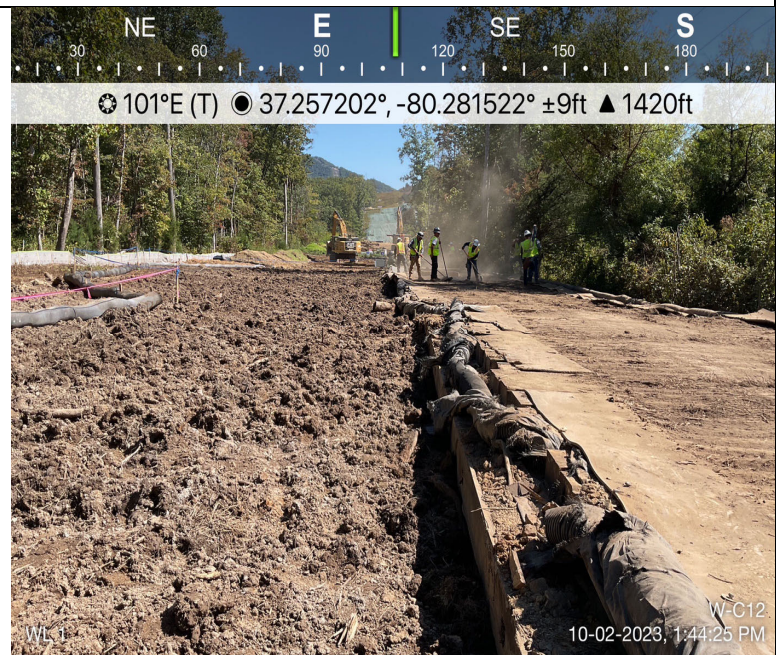
10/2/2023- Clean up of site. Seeding of wetland and stream completed. Post con assessment completed. - S. Frost

**Photo Description:** Final restoration and seeding of wetlands.
