WETLAND BIOLOGICAL CONDITIONS ENVIRONMENTAL AUDITOR REPORT

Wetland ID: W-CD12	Crossing Start Date: 10/23/2023	Crossing Completion Date: 10/28/2023
Milepost: 216.7	Pre-Con Assessment Date: 10/16/2023	Post-Con Assessment Date: 10/30/2023
Station: 11448+68	Cowardin Classification: PEM (PEM, PFO, PSS, POW)	Wetland Impact Area (sq ft.): 906.05
County: Giles

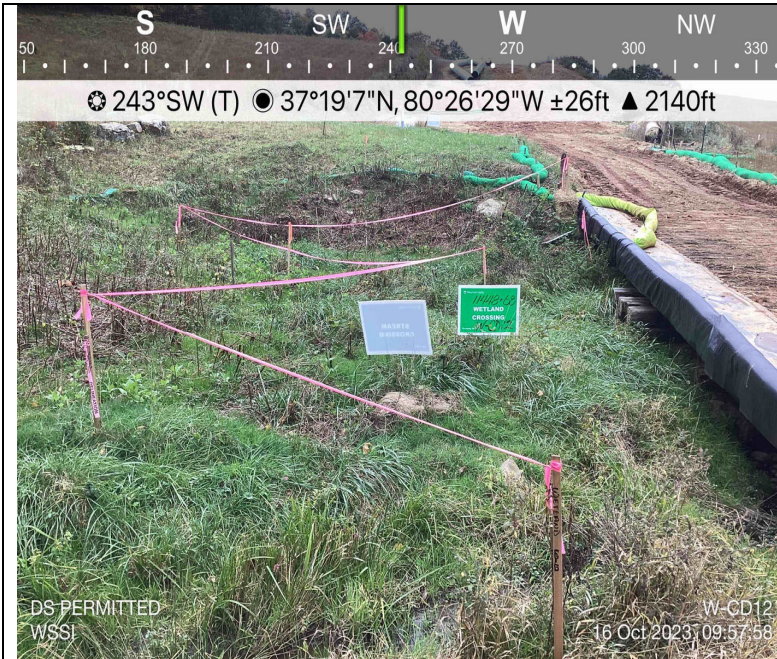
Photo Description: View of permitted resource impact area during pre-construction assessment.

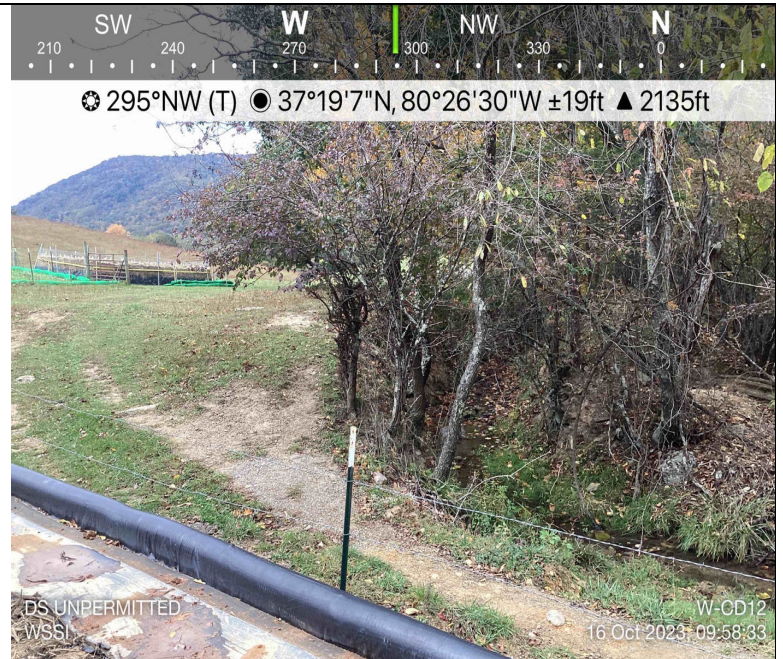
Photo Description: At edge of LOD, view of unpermitted resource area conditions during pre-construction assessment.

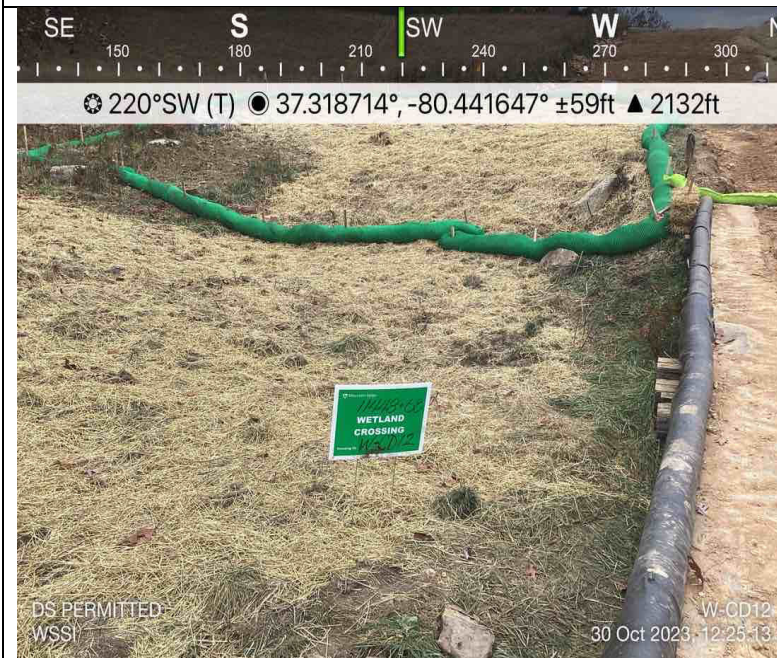
Photo Description: View of permitted resource impact area during post-construction assessment.

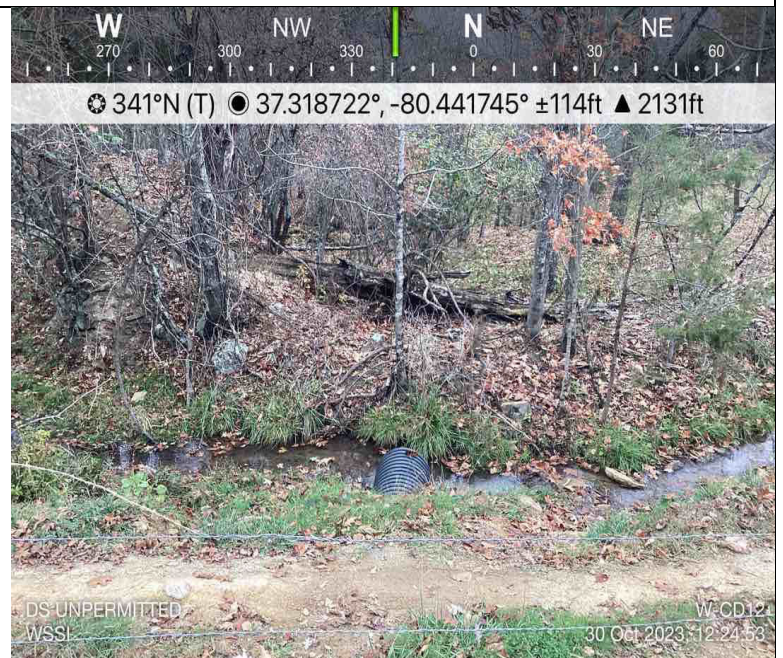
Photo Description: At edge of LOD, view of unpermitted resource area conditions during post-construction assessment.

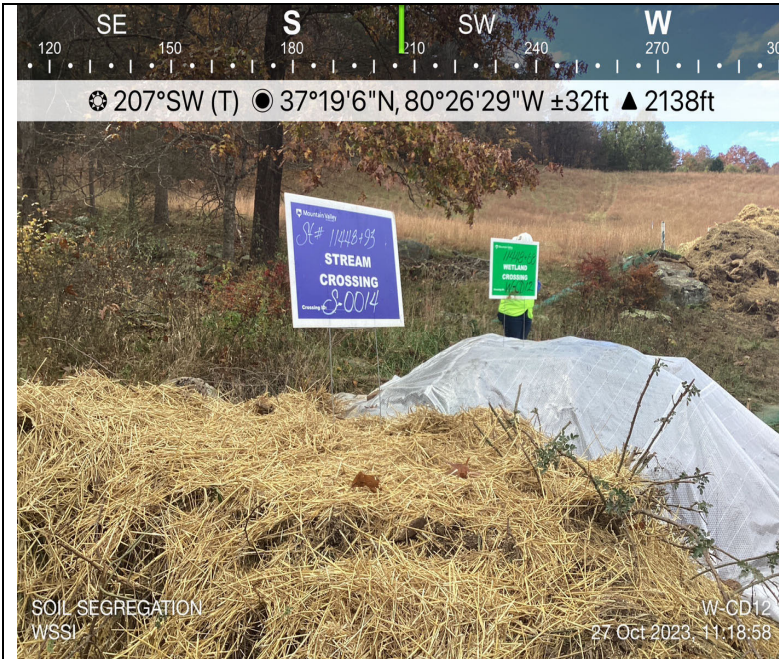
Photo Description: Wetland soils properly segregated.

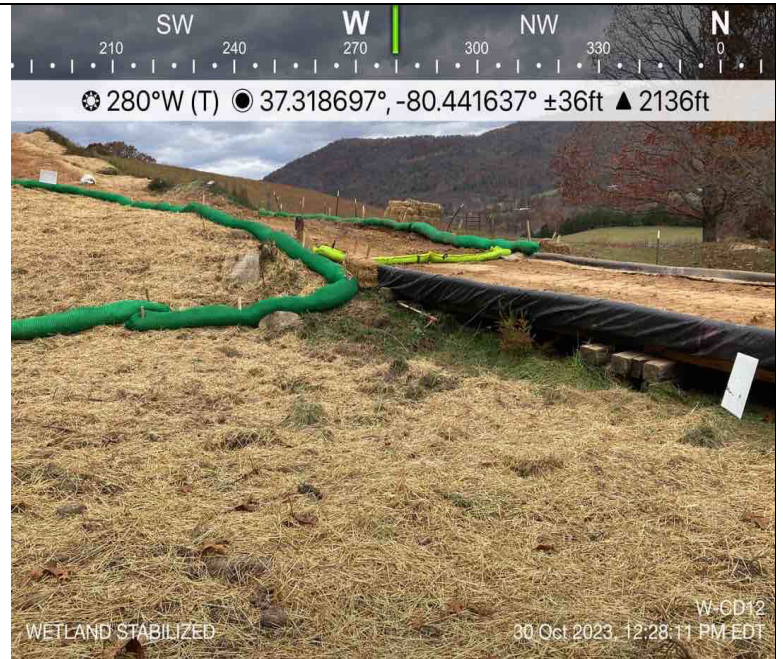
Photo Description: Wetland stabilized.

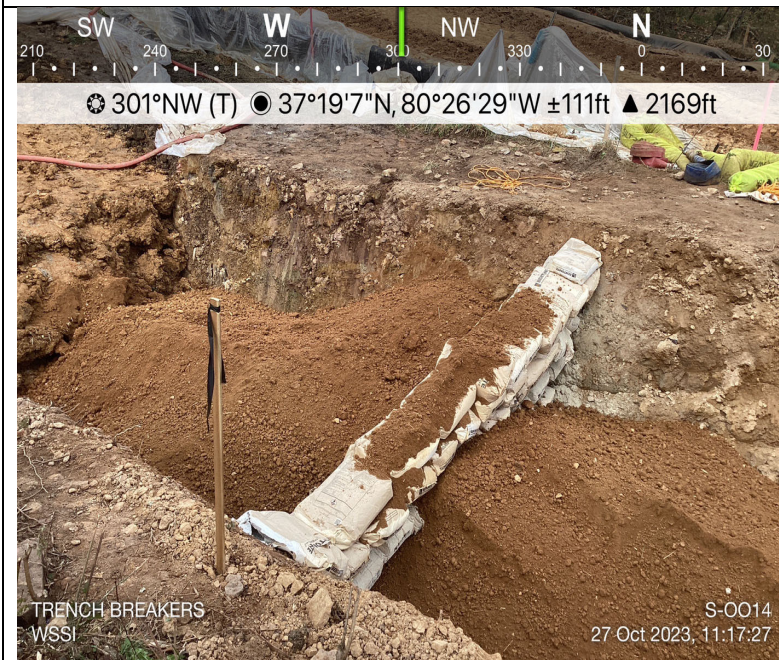
Photo Description: Trench breakers installed at stream/wetland crossing. Stream S-0014 is directly adjacent to wetland W-CD12.

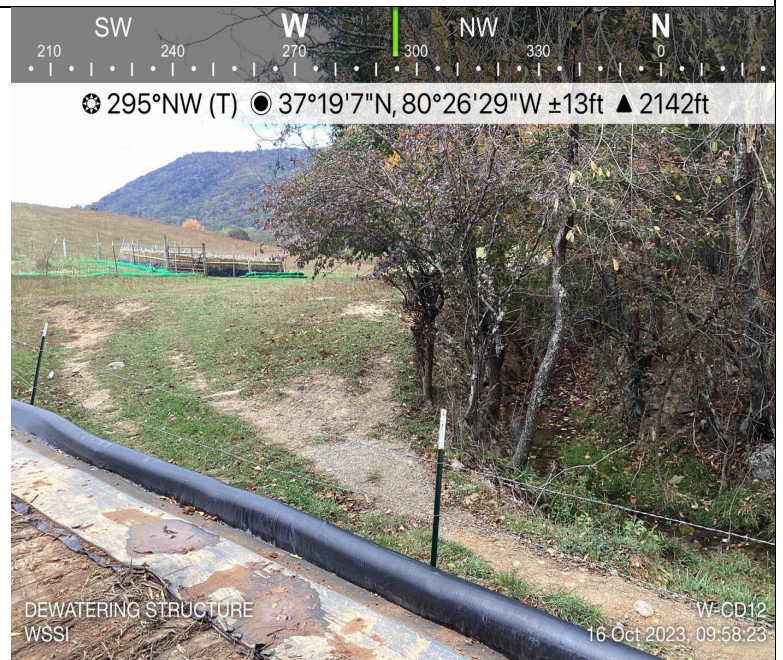
Photo Description: Dewatering structure located off ROW with land owner permission.
