WETLAND BIOLOGICAL CONDITIONS ENVIRONMENTAL AUDITOR REPORT

Wetland ID: W-CD5	Crossing Start Date: 09/29/2023	Crossing Completion Date: 10/11/2023
Milepost: 262.5	Pre-Con Assessment Date: 09/13/2023	Post-Con Assessment Date: 10/11/2023
Station: 13888+95	Cowardin Classification: PFO (PEM, PFO, PSS, POW)	Wetland Impact Area (sq ft.): 4948.42
County: Franklin

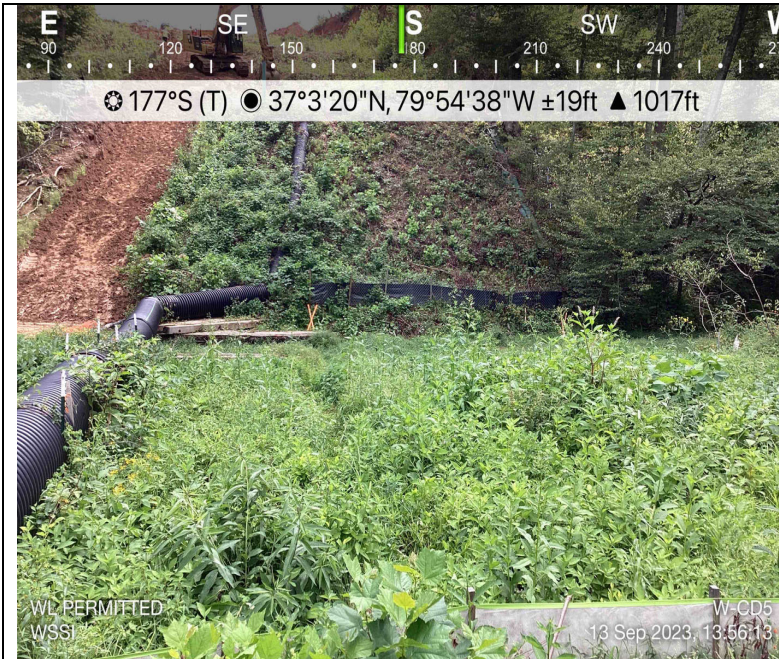
Photo Description: View of permitted resource impact area during pre-construction assessment.

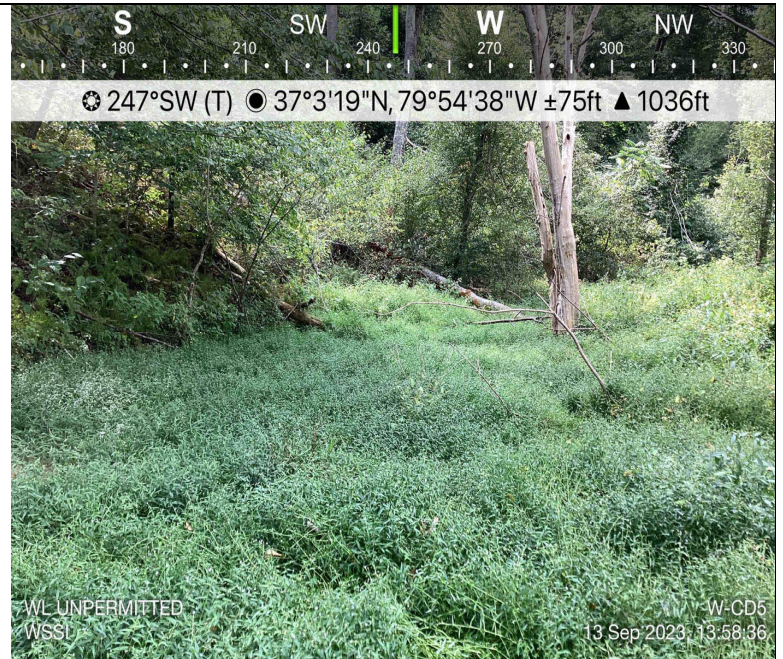
Photo Description: At edge of LOD, view of unpermitted resource area conditions during pre-construction assessment.

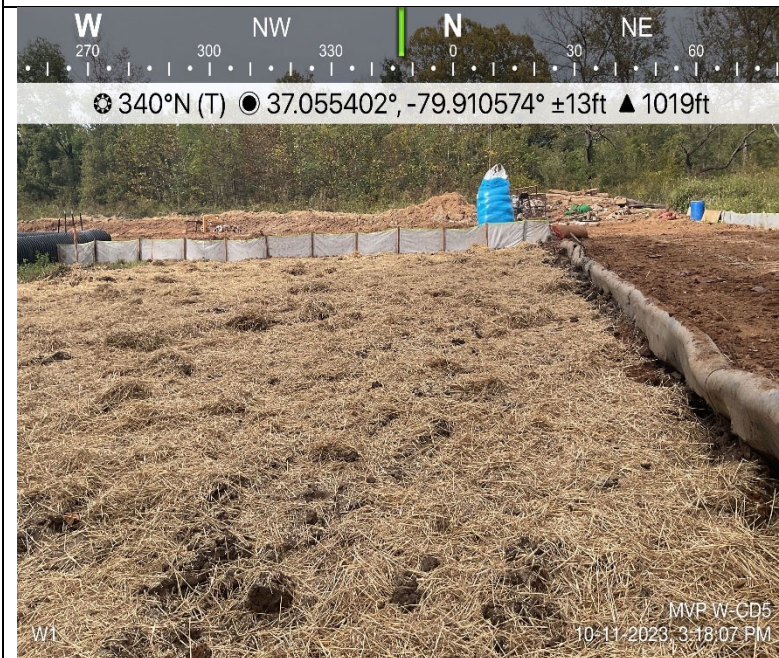
Photo Description: View of permitted resource impact area during post-construction assessment.

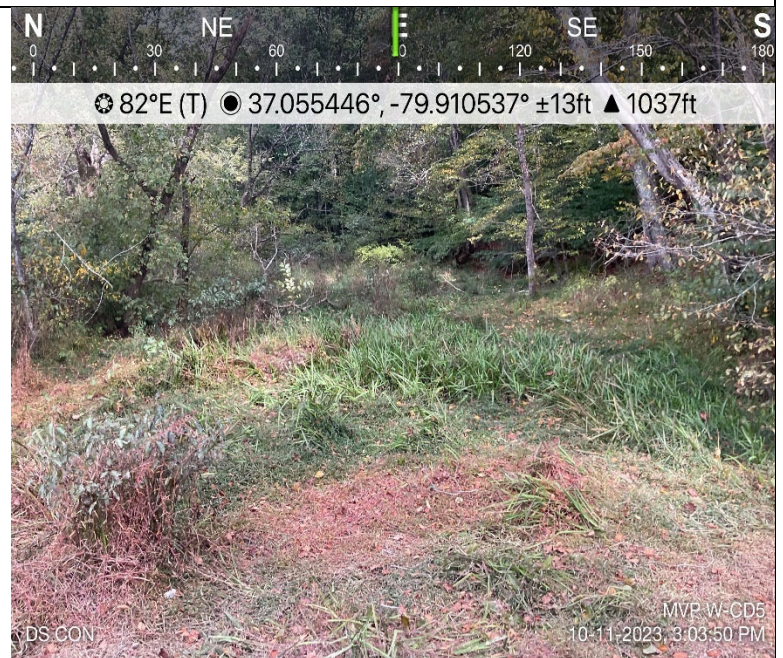
Photo Description: At edge of LOD, view of unpermitted resource area conditions during post-construction assessment.

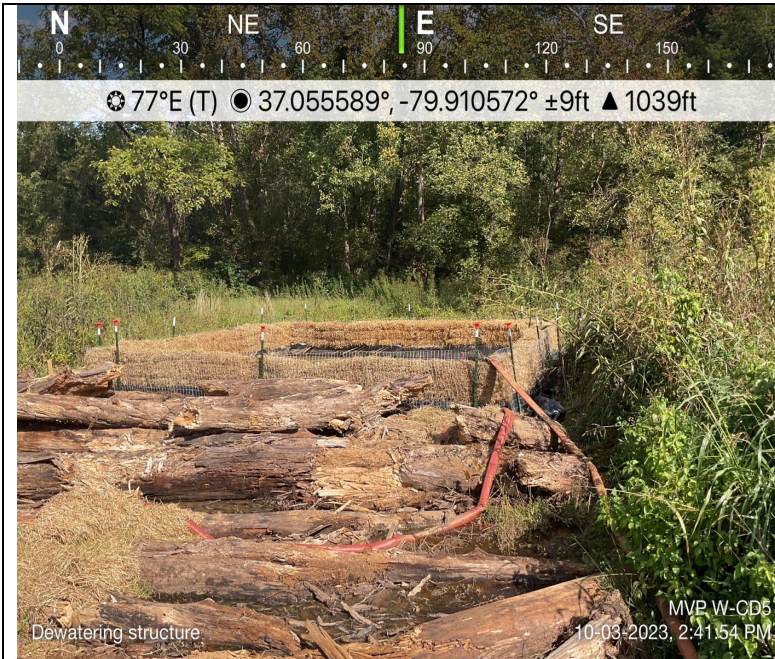
Photo Description: Dewatering structure for trenching

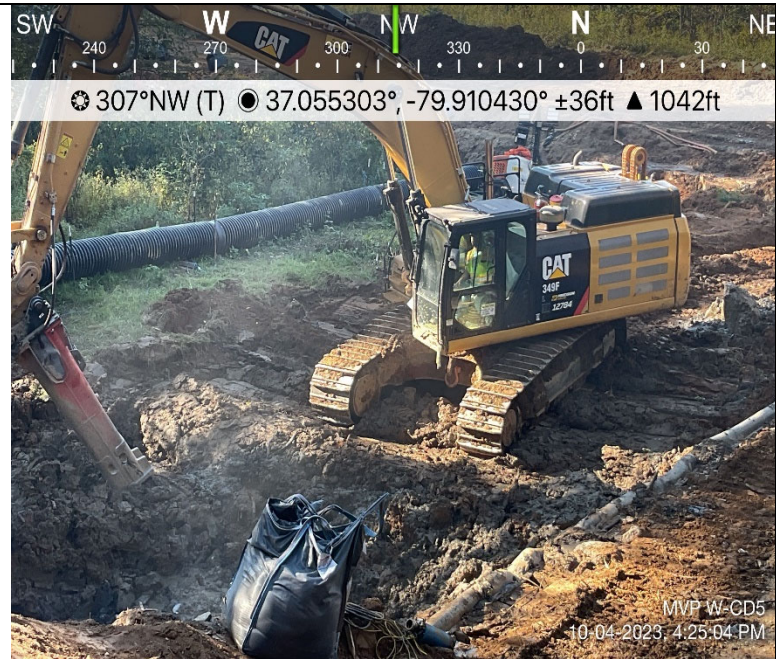
10-04-2023: MVP EI Jim Parker took over site. Removed wetland topsoil, hammering rock, excavator on timber mats within wetland area with no geotextile fabric underneath. Advised EI that spec says it need to be applied and EI replied that they will not be placing geotextile fabric under timber mat. Work has continued without geotextile. DEQ also advised that geotextile needs to be in place to EI and LEI. Hammering and removal of soil continued. Light plants have been set up for evening work. -D. Fraise

Photo Description: Excavator within wetland area on timber mats. No geotextile fabric observed under timber mats. DEQ reported. No unauthorized discharge or impacts to biological conditions observed.

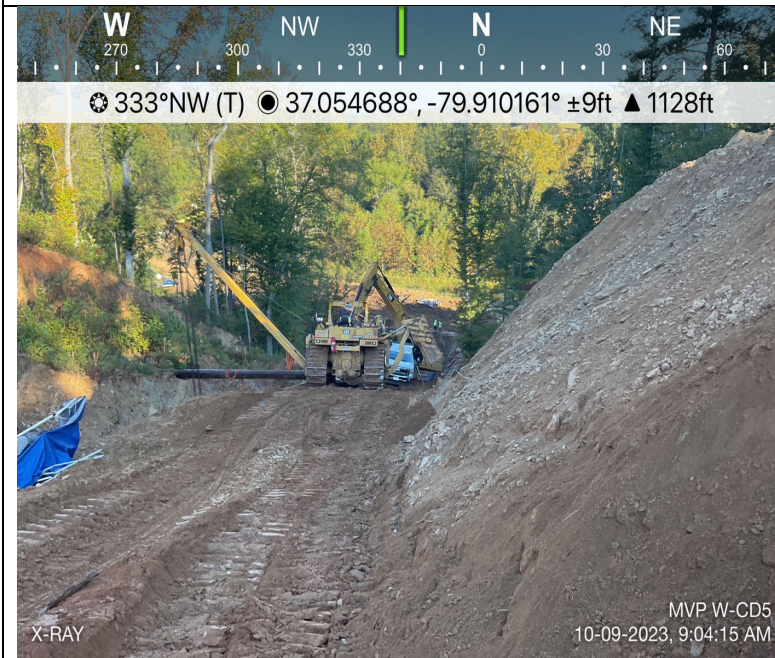
Photo Description: X-Ray QC of pipe welds.

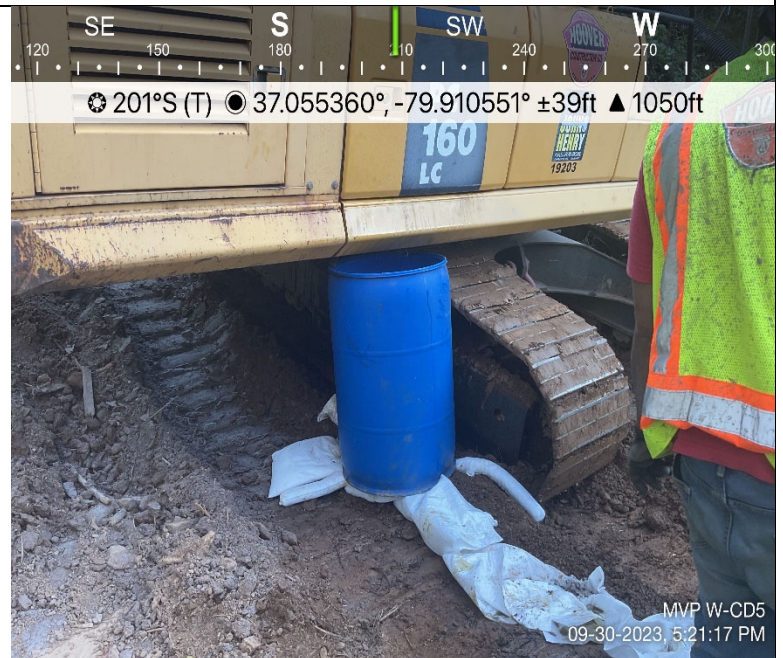
09-30-2023: Drilled and blasted upland buffer areas adjacent to wetland area. Petroleum spill from excavator on timber mat bridge. Crew immediately cleaned up spill and shoveled/removed contaminated material. No contamination or discharge to the environment was observed. -D. Fraise

Photo Description: Petroleum spill clean up and disposal of contaminated material. No unauthorized discharge or impacts to biological conditions observed.
