WETLAND BIOLOGICAL CONDITIONS ENVIRONMENTAL AUDITOR REPORT

Wetland ID: W-DD1	Crossing Start Date: 10/16/2023	Crossing Completion Date: 10/20/2023
Milepost: 272.1	Pre-Con Assessment Date: 09/29/2023	Post-Con Assessment Date: 10/20/2023
Station: 14390 +00	Cowardin Classification: PEM (PEM, PFO, PSS, POW)	Wetland Impact Area (sq ft.): 3541.43
County: Franklin

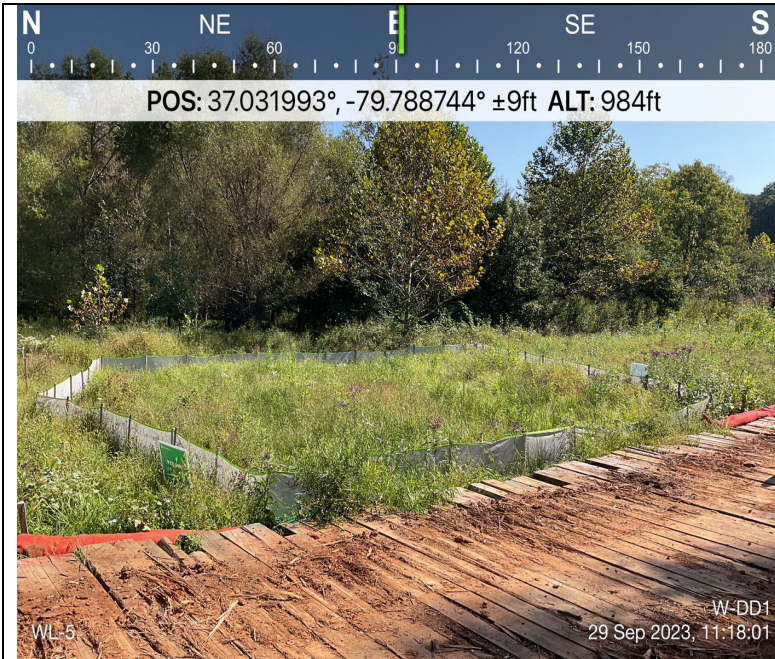
Photo Description: View of permitted resource impact area during pre-construction assessment.

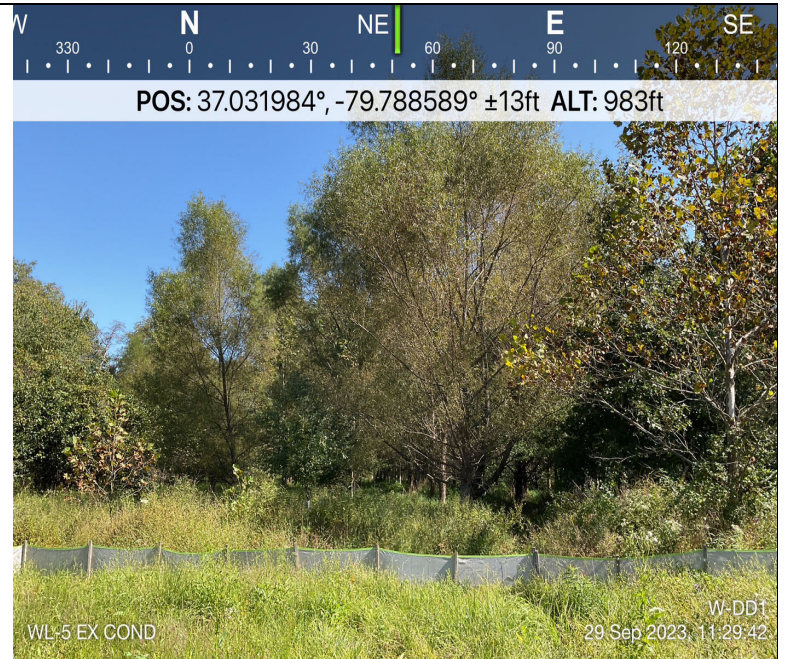
Photo Description: At edge of LOD, view of unpermitted resource area conditions during pre-construction assessment.

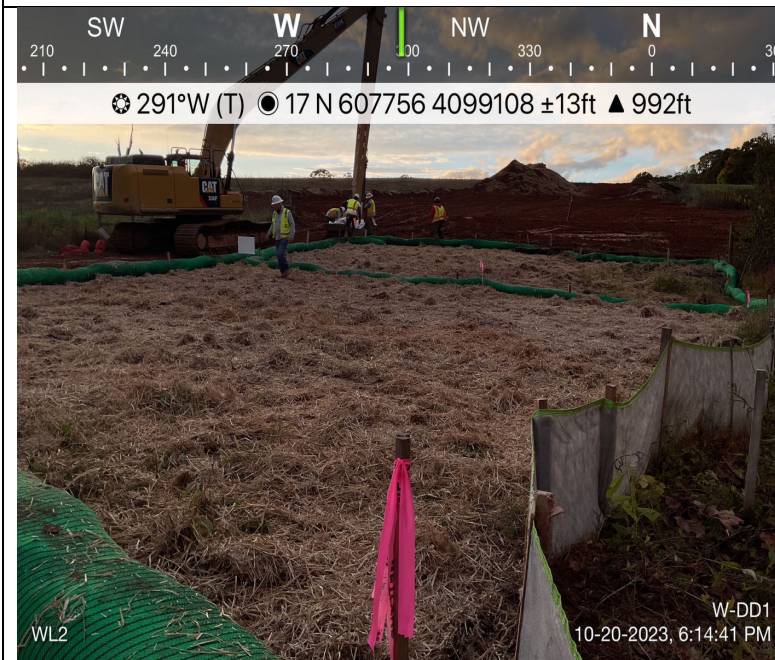
Photo Description: View of permitted resource impact area during post-construction assessment.

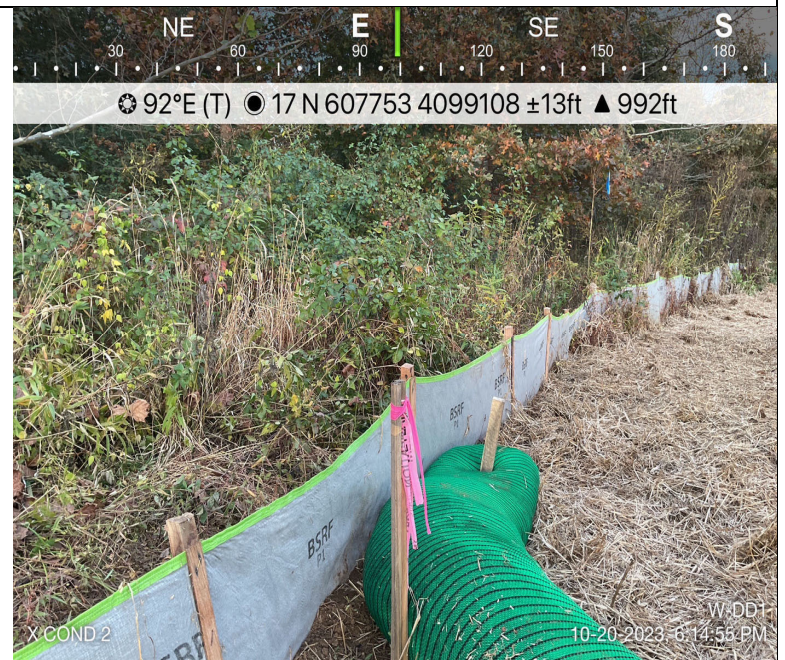
Photo Description: At edge of LOD, view of unpermitted resource area conditions during post-construction assessment.

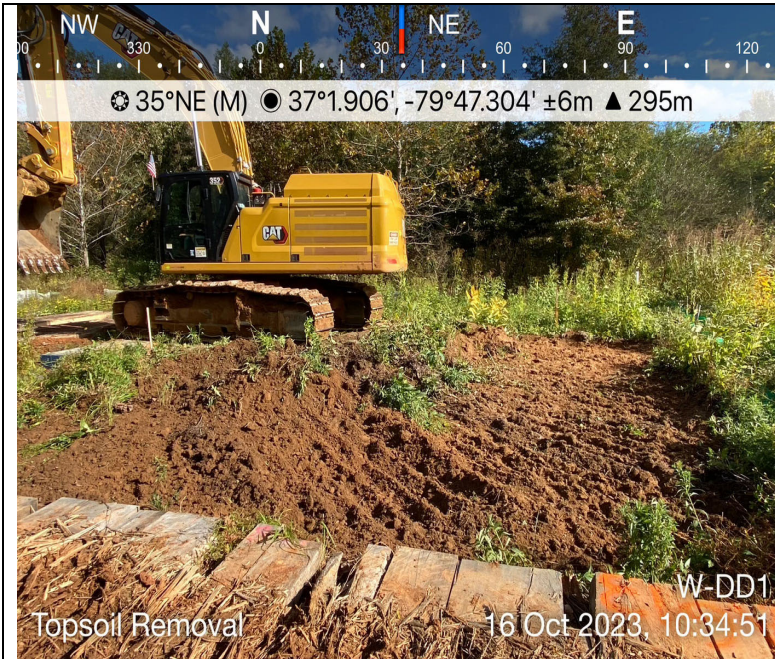
Photo Description: Removing top 12 inches of topsoil from W-DD1.

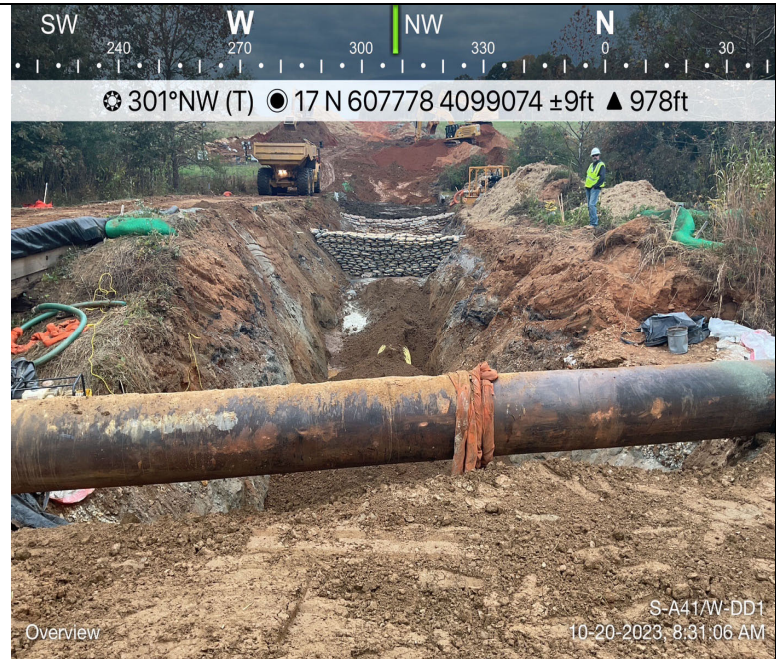
Photo Description: Trench breakers installed in W-DD1. Backfilling operations underway.

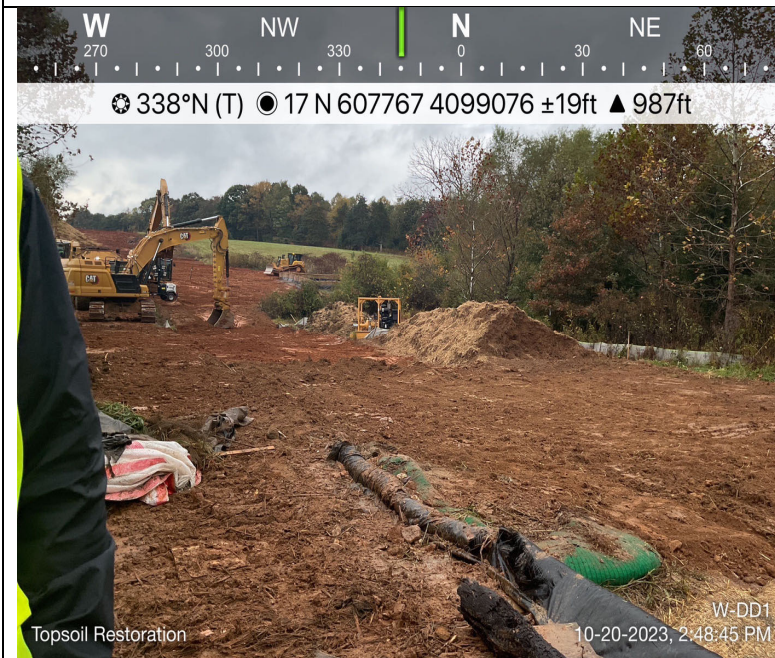
Photo Description: Restoration of the stockpiled topsoil to the impacted area.

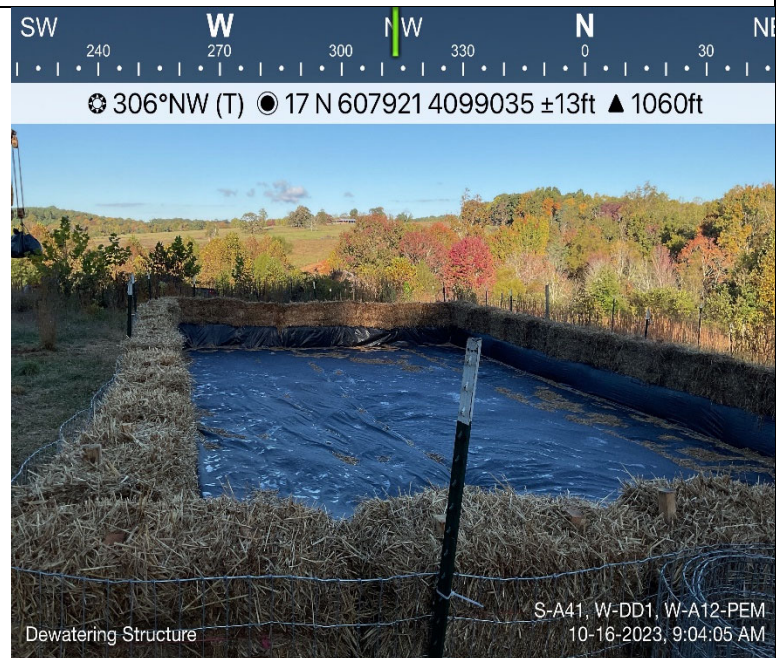
Photo Description: Dewatering structure installed for crossing activities at S-A41, W-A12-PEM & W-DD1.
