# WETLAND BIOLOGICAL CONDITIONS ENVIRONMENTAL AUDITOR REPORT

<b>H5Wetland ID:</b> W-H5	<b>Crossing Start Date:</b> 11/01/2023	<b>Crossing Completion Date:</b> 11/04/2023
<b>Milepost:</b> 290.2	<b>Pre-Con Assessment Date:</b> 10/24/2023	<b>Post-Con Assessment Date:</b> 11/06/2023
<b>Station:</b> 15348+29	<b>Cowardin Classification:</b> PEM (PEM, PFO, PSS, POW)	<b>Wetland Impact Area (sq ft.):</b> 9003.85
<b>County:</b> Pittsylvania

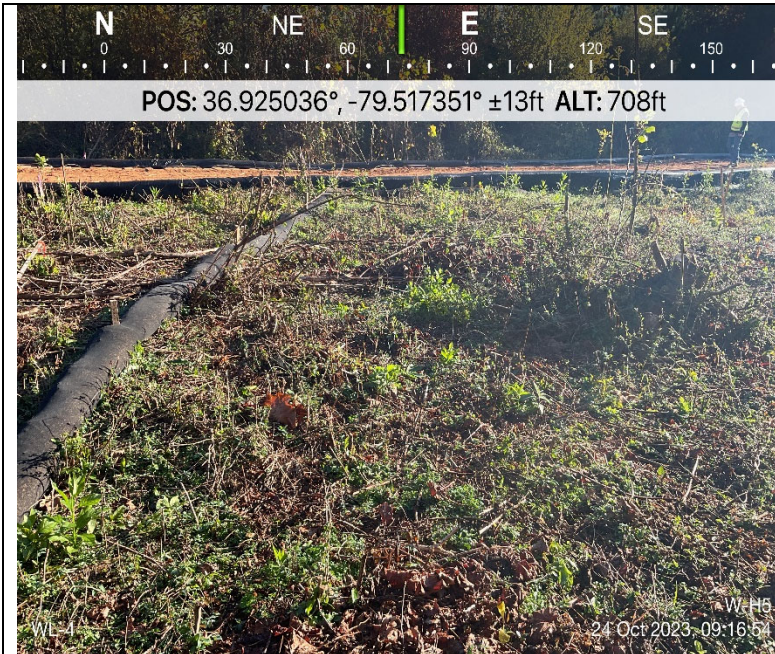
**Photo Description:** View of permitted resource impact area during pre-construction assessment.

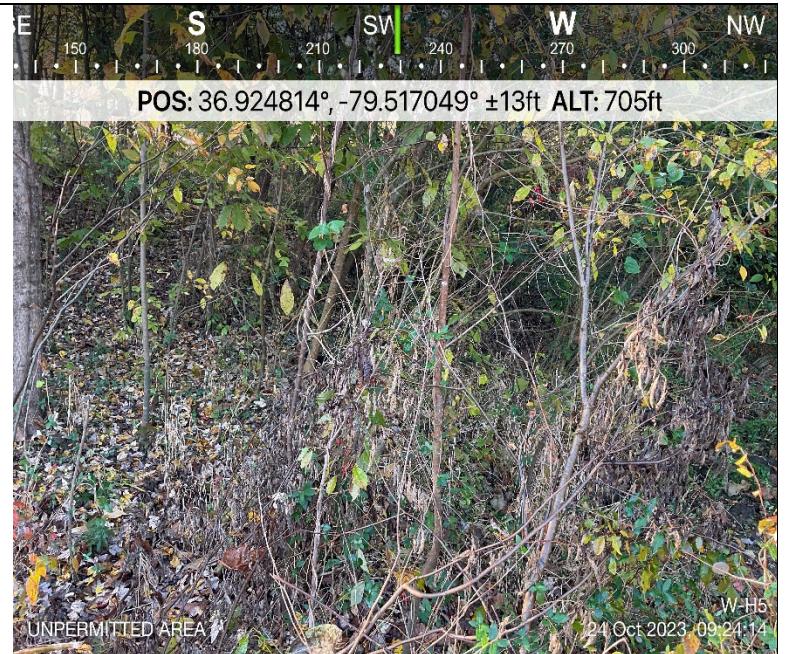
**Photo Description:** At edge of LOD, view of unpermitted resource area conditions during pre-construction assessment.

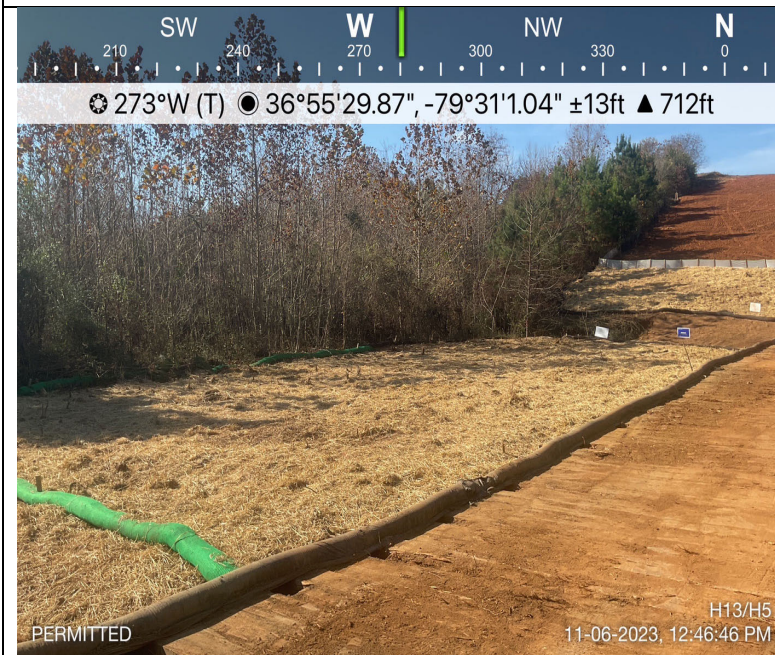
**Photo Description:** View of permitted resource impact area during post-construction assessment.

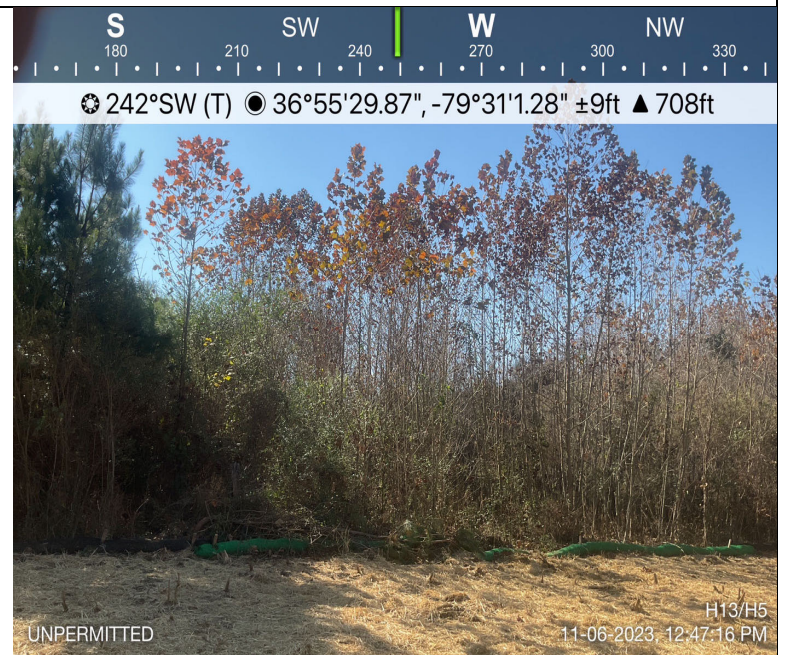
**Photo Description:** At edge of LOD, view of unpermitted resource area conditions during post-construction assessment.

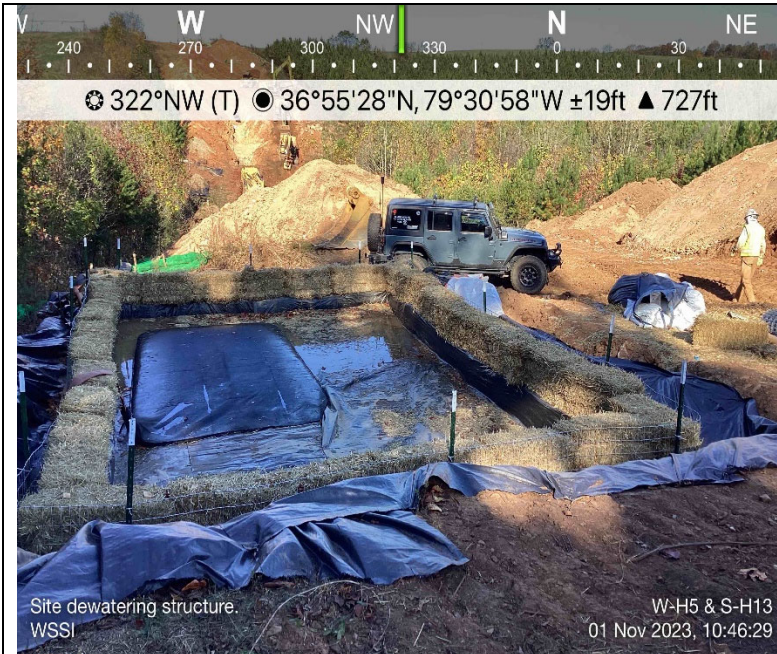
**Photo Description:** An overview of the dewatering structure.

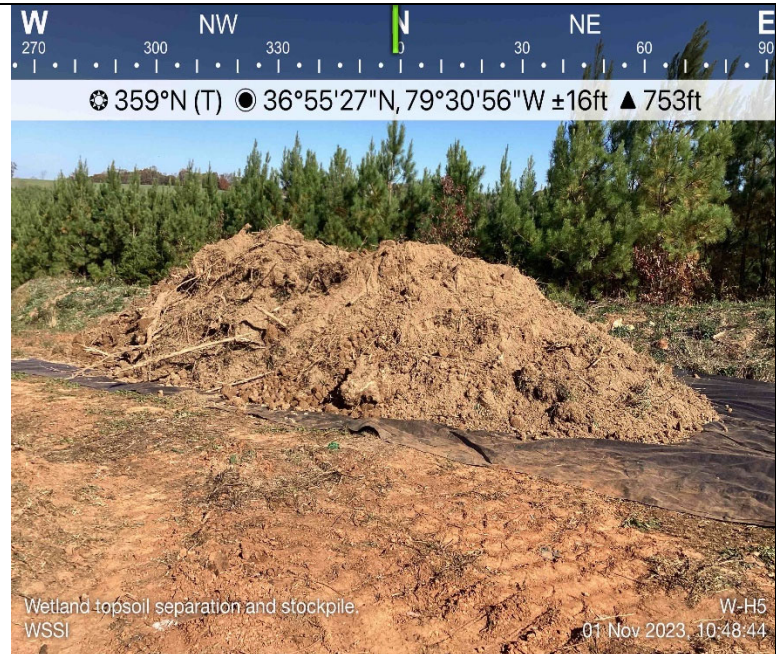
**Photo Description:** Wetland topsoil that has been separated and stockpiled.

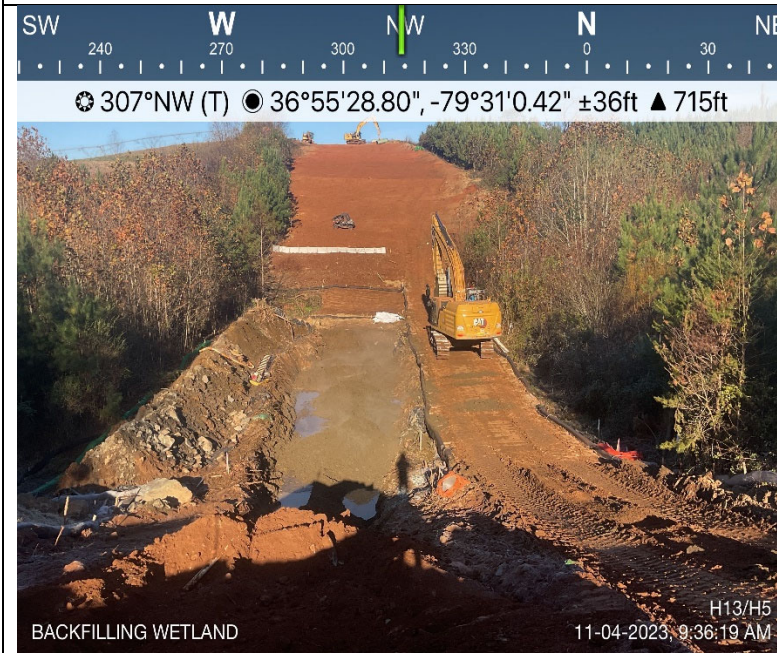
**Photo Description:** An overview of the wetland as it is being backfilled.

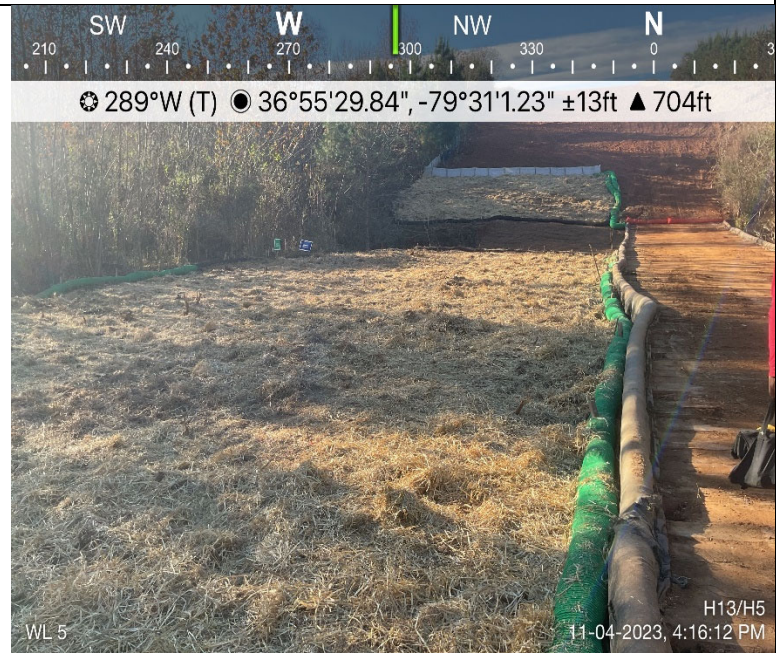
**Photo Description:** An overview of the wetland after restoration is complete.
