WETLAND BIOLOGICAL CONDITIONS ENVIRONMENTAL AUDITOR REPORT

Wetland ID: W-IJ46-PEM	Crossing Start Date: 09/13/2023	Crossing Completion Date: 09/16/2023
Milepost: 222.7	Pre-Con Assessment Date: 09/12/2023	Post-Con Assessment Date: 09/16/2023
Station: 11767+44	Cowardin Classification: PEM (PEM, PFO, PSS, POW)	Wetland Impact Area (sq ft.): 1280.66
County: Montgomery

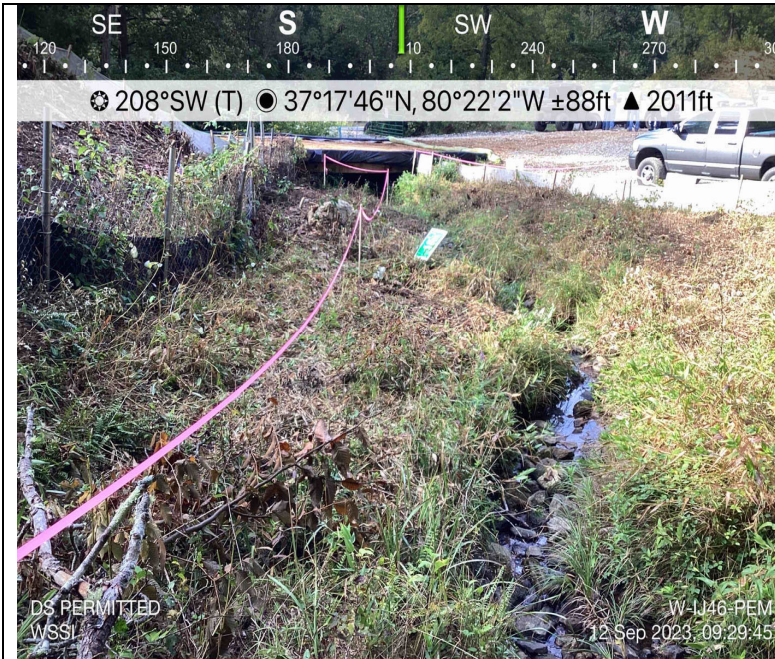
Photo Description: View of permitted resource impact area during pre-construction assessment.

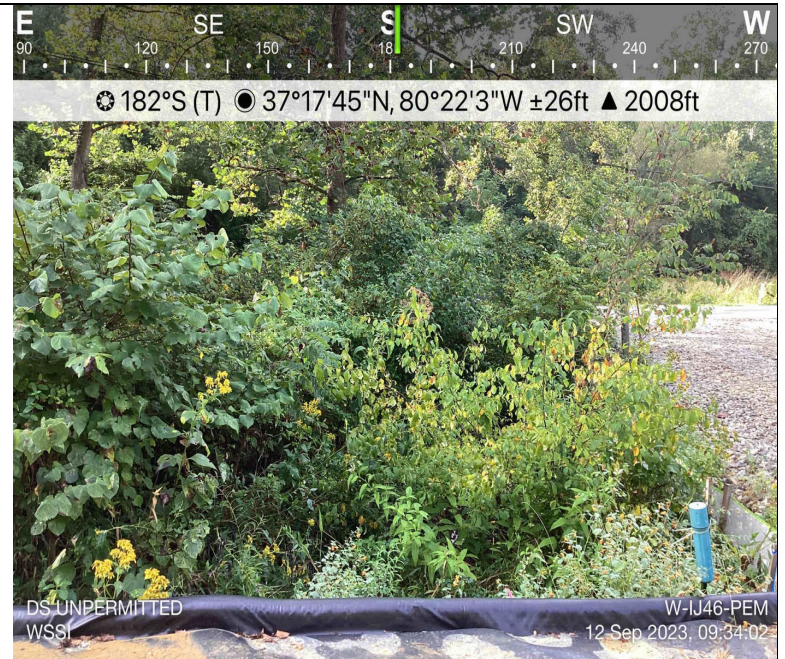
Photo Description: At edge of LOD, view of unpermitted resource area conditions during pre-construction assessment.

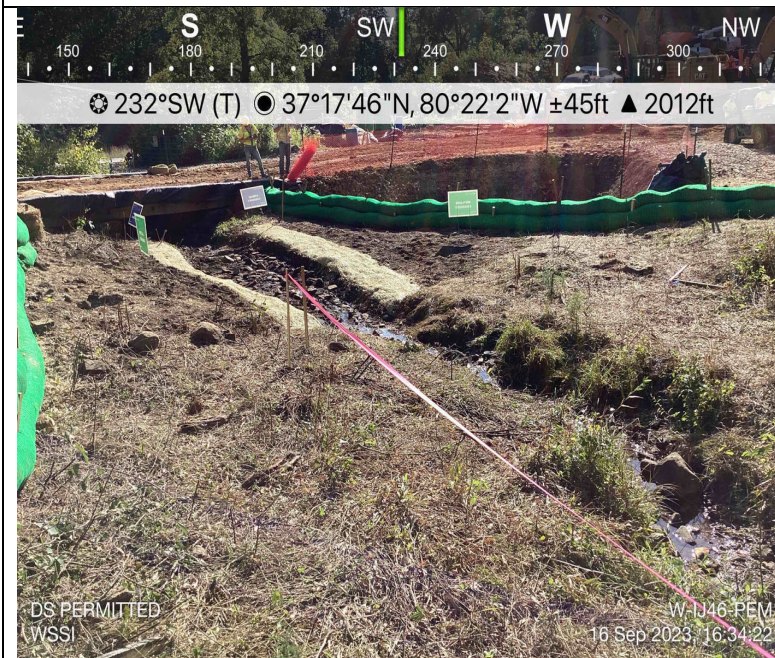
Photo Description: View of permitted resource impact area during post-construction assessment.

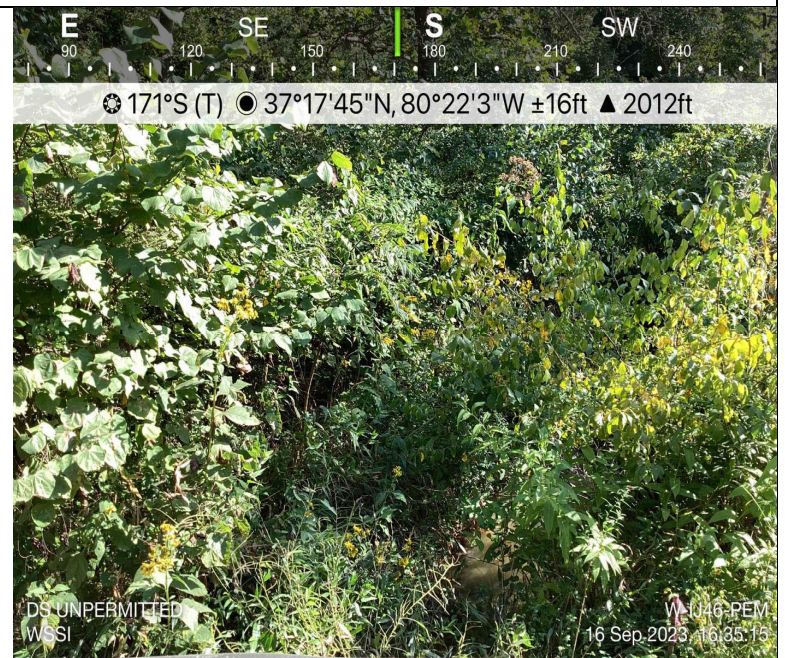
Photo Description: At edge of LOD, view of unpermitted resource area conditions during post-construction assessment.

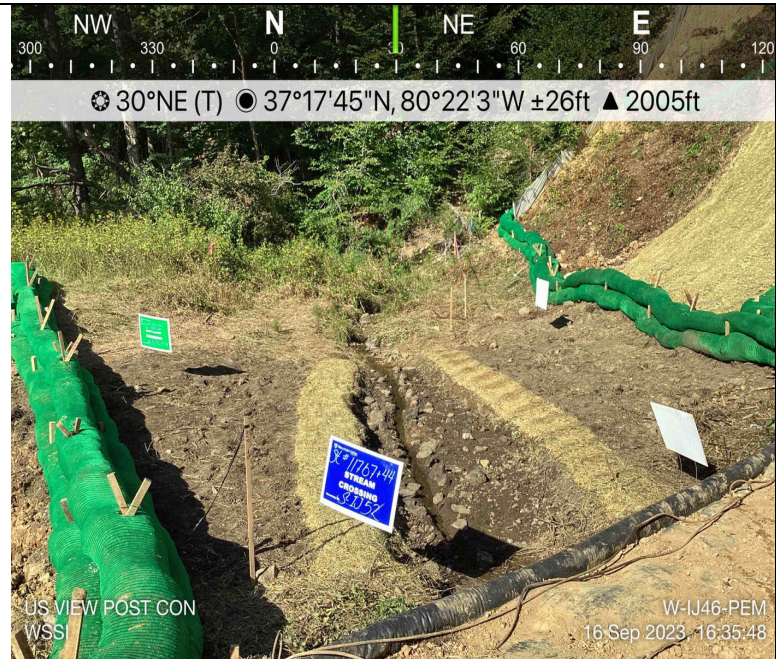
Photo Description: Upstream view of stream and wetland crossing post construction.

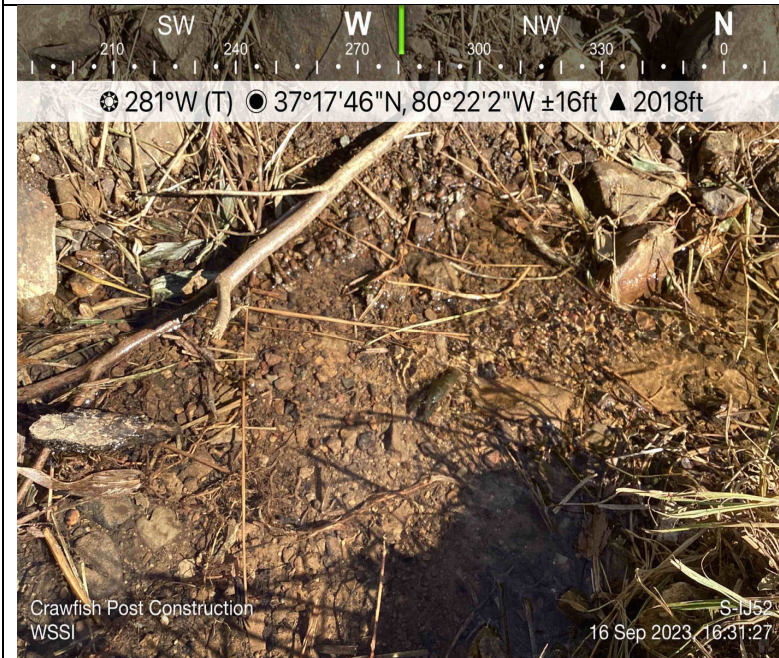
Photo Description: Wildlife re-entering resource area S-IJ52 next to W-IJ46 PEM post construction.
