# Wetland Biological Conditions EA Report

<b>Project Name</b>	H-600 Pipeline Spread A	<b>AFE</b>	124300129	<b>Spread</b>	H-600 Pipeline Spread A
<b>Contractor</b>	Precision	<b>Report #</b>	54		
<b>Environmental Auditor</b>	Devin Jen			<b>Date/Time</b>	9/18/2023 11:34 AM
<b>Wetland ID</b>	W-K43	<b>Crossing Start Date</b>	9/18/2023	<b>Crossing Completion Date</b>	10/28/2023
<b>Milepost</b>	31.38	<b>Pre-Con Assessment Date</b>	9/18/2023	<b>Post-Con Assessment Date</b>	10/28/2023
<b>Station</b>	1656+92	<b>Cowardin Classification</b>	PEM	<b>Wetland Impact Area(acres)</b>	0.2086
<b>State</b>	WV				
<b>County</b>	Harrison

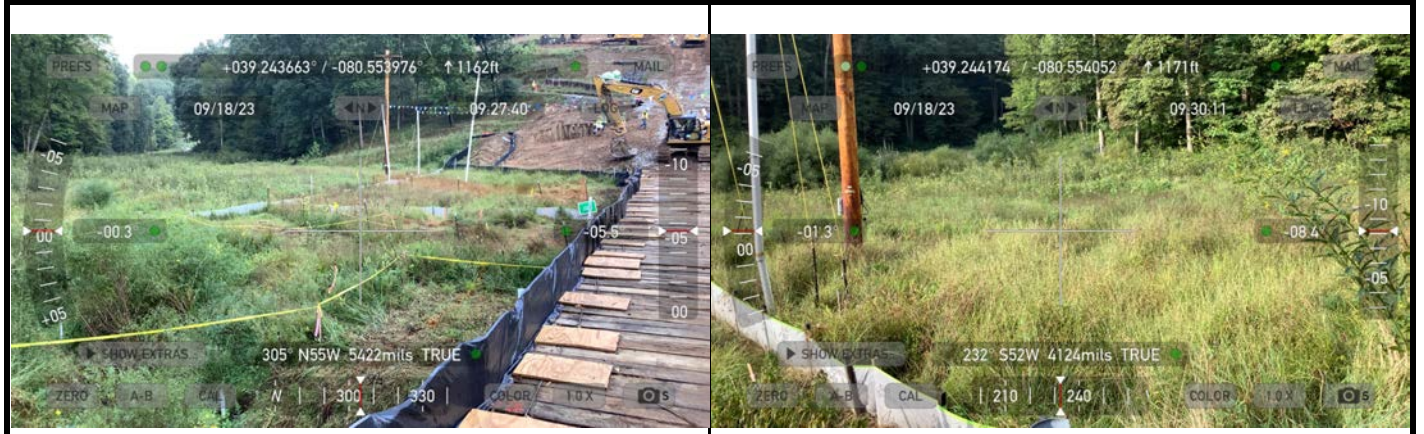
<b>GPS Location</b>	See photo.	<b>GPS Location</b>	See photo.
<b>Description</b>	View of permitted resource impact area during pre-construction assessment.	<b>Description</b>	At edge of LOD, view of unimpacted resource area conditions during pre-construction assessment.

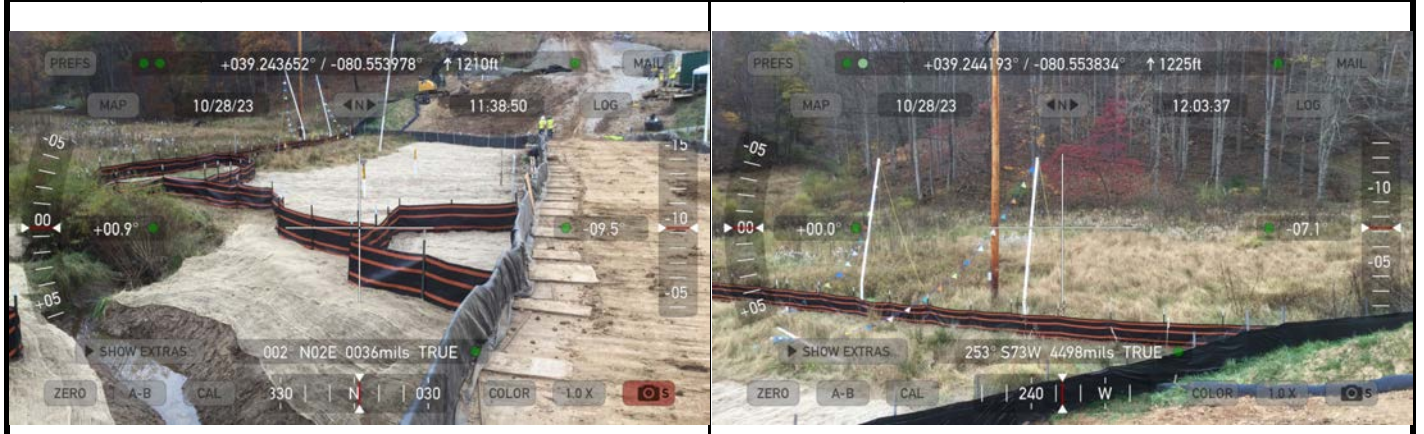
Post-construction assessment  
Conditions 18 and 19 were given a rating of 4 due to the of vegetation in the disturbed permitted impact area following the completion of the restoration. The W-K43 PEM topsoils have been properly stabilized and the disturbed area has been seeded with the appropriate permanent seed mix in accordance with Appendix B: Restoration Work Plan of the Mountain Valley Pipeline Comprehensive Stream and Wetland Monitoring, Restoration and Mitigation Framework.  
M. Huber

<b>GPS Location</b>	See photo	<b>GPS Location</b>	See photo
<b>Description</b>	View of permitted resource impact area during post-construction assessment.	<b>Description</b>	At edge of LOD, view of unimpacted resource area conditions during post-construction assessment.

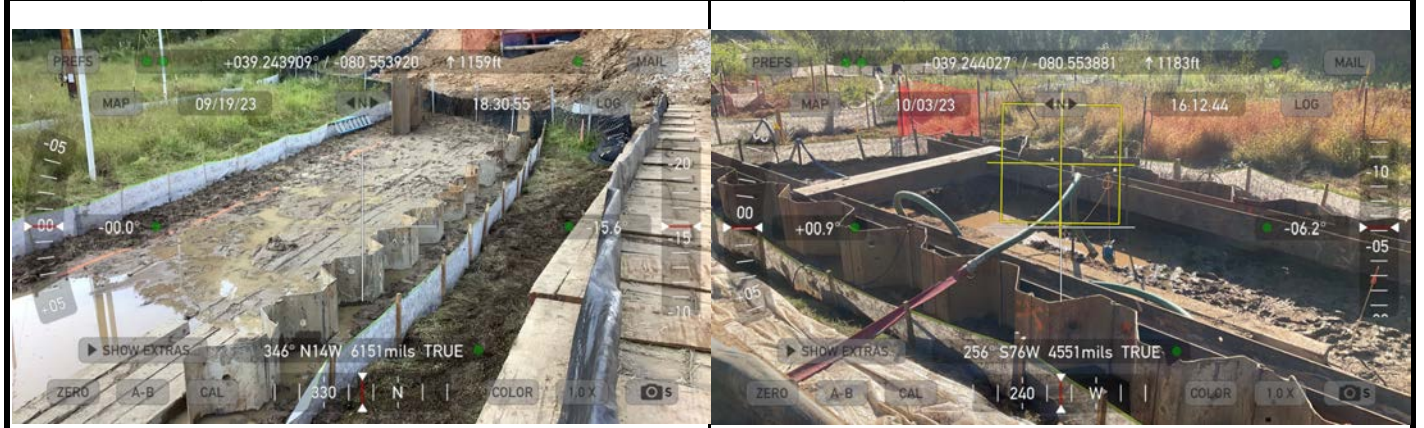
<b>GPS Location</b>	See photo.	<b>GPS Location</b>	See photo.
<b>Description</b>	The photo shows the progress the crew made on driving in the sheet piling on 9/19/2023	<b>Description</b>	This photo shows sheetpiling installed in the stream/wetland complex

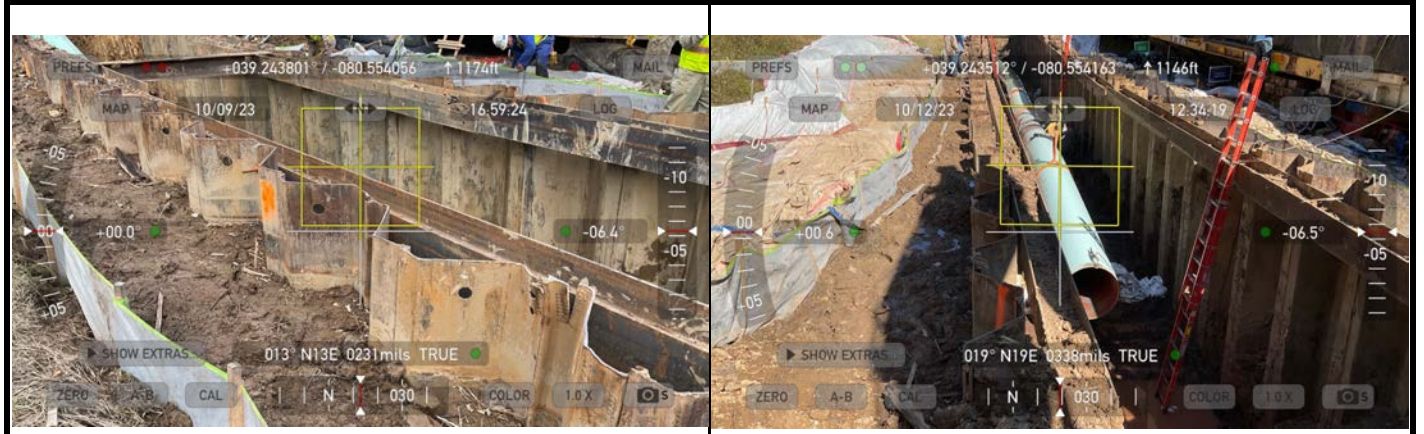
<b>GPS Location</b> See photo	<b>GPS Location</b> See photo
<b>Description</b> This photo shows the excavated trench through the stream/wetland complex	<b>Description</b> This photo shows the contractor working on installing the pipe

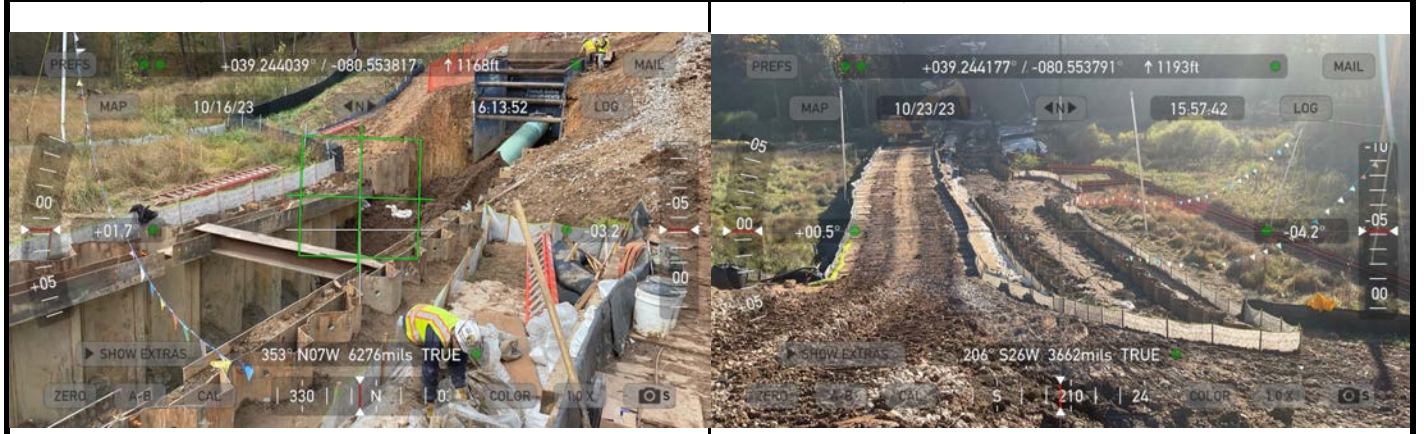
<b>GPS Location</b> See photo	<b>GPS Location</b> See photo
<b>Description</b> This photo shows the partially backfilled trench through the stream/wetland complex	<b>Description</b> This photo shows the backfilled trench through the stream/wetland complex

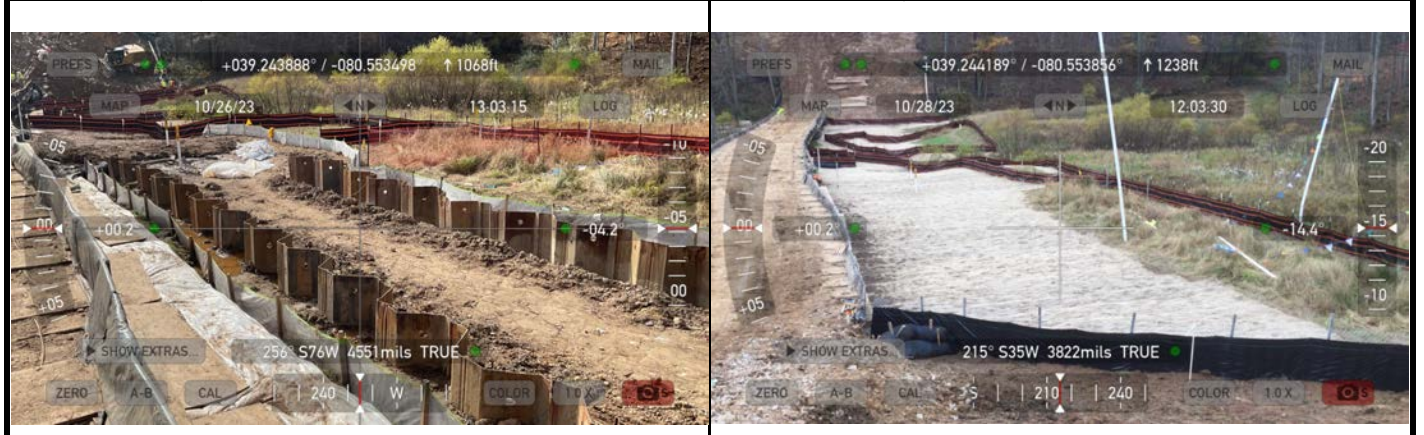
<b>GPS Location</b> See photo	<b>GPS Location</b> See photo
<b>Description</b> This photo shows the backfilled trench through the stream/wetland complex	<b>Description</b> This photo shows the restored wetland
