# Wetland Biological Conditions EA Report

<b>Project Name</b>	H-600 Pipeline Spread A	<b>AFE</b>	124300129	<b>Spread</b>	H-600 Pipeline Spread A
<b>Contractor</b>	Precision	<b>Report #</b>	55		
<b>Environmental Auditor</b>	Devin Jen			<b>Date/Time</b>	9/18/2023 12:38 PM
<b>Wetland ID</b>	W-K44	<b>Crossing Start Date</b>	9/21/2023	<b>Crossing Completion Date</b>	10/26/2023
<b>Milepost</b>	31.42	<b>Pre-Con Assessment Date</b>	9/18/2023	<b>Post-Con Assessment Date</b>	10/27/2023
<b>Station</b>	1658+91	<b>Cowardin Classification</b>	PEM	<b>Wetland Impact Area(acres)</b>	0.0671
<b>State</b>	WV				
<b>County</b>	Harrison

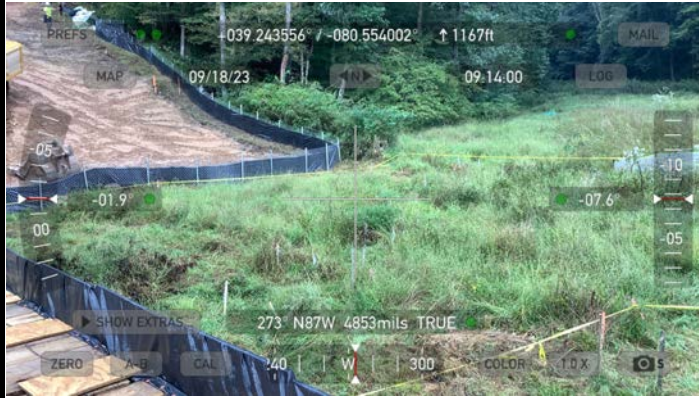
<b>GPS Location</b>	See photo
<b>Description</b>	View of permitted resource impact area during pre-construction assessment.

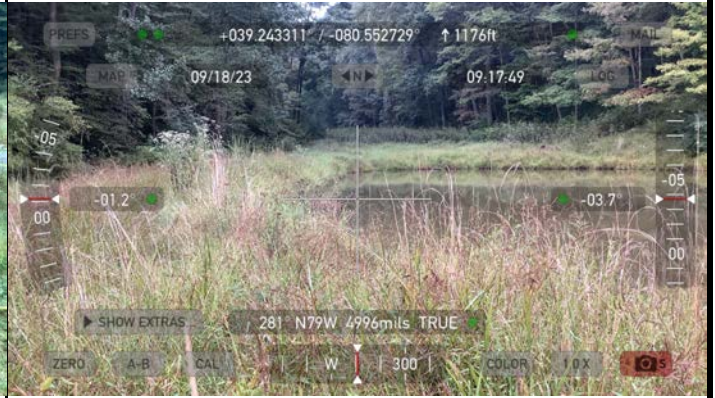
<b>GPS Location</b>	See photo
<b>Description</b>	At edge of LOD, view of unimpacted resource area conditions during pre-construction assessment.

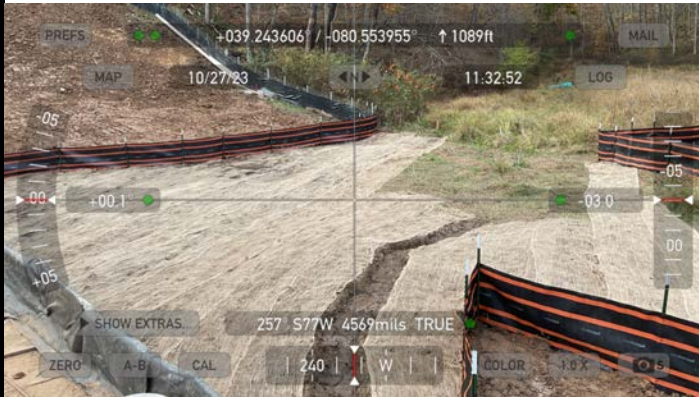
Post construction assessment  
Conditions 18 and 19 were given a rating of 4 during post-construction assessment due to lack of vegetation in the disturbed permitted impact area following the completion of the crossing efforts. The W-K44 wetland topsoils have been properly restored and the disturbed area has been seeded with the appropriate permanent seed mix in accordance with Appendix B: Restoration Work Plan of the Mountain Valley Pipeline Comprehensive Stream and Wetland Monitoring, Restoration and Mitigation Framework. -M. Kastan

<b>GPS Location</b>	See photo
<b>Description</b>	View of permitted resource impact area during post-construction assessment.

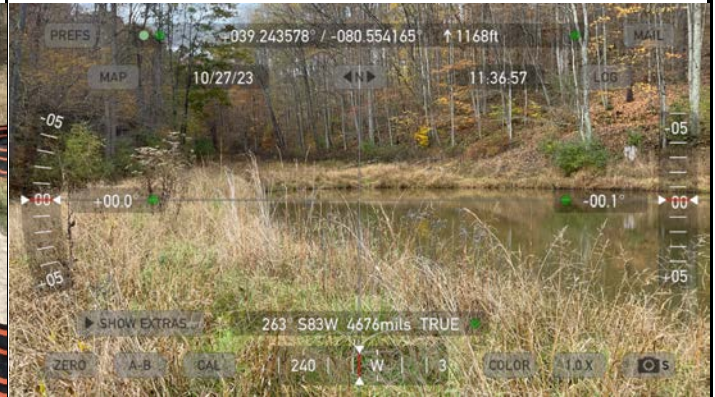
<b>GPS Location</b>	See photo
<b>Description</b>	At edge of LOD, view of unimpacted resource area conditions during post-construction assessment.

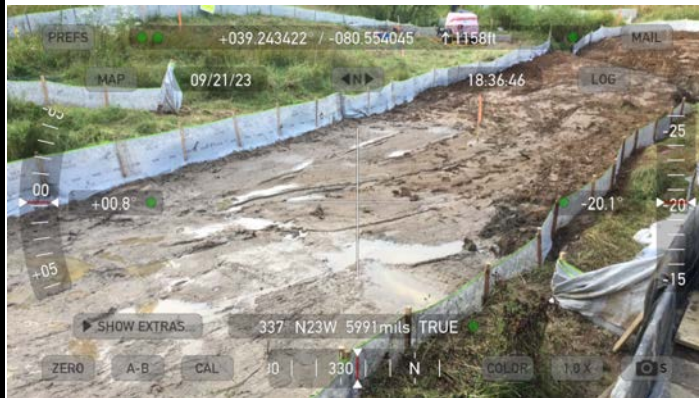
<b>GPS Location</b>	See photo
<b>Description</b>	This photo shows the wetland area following removal of topsoil

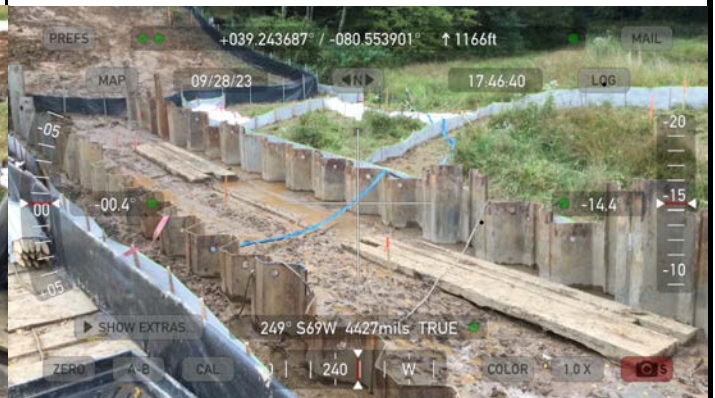
<b>GPS Location</b>	See photo
<b>Description</b>	This photo shows sheet piling installed in the wetland

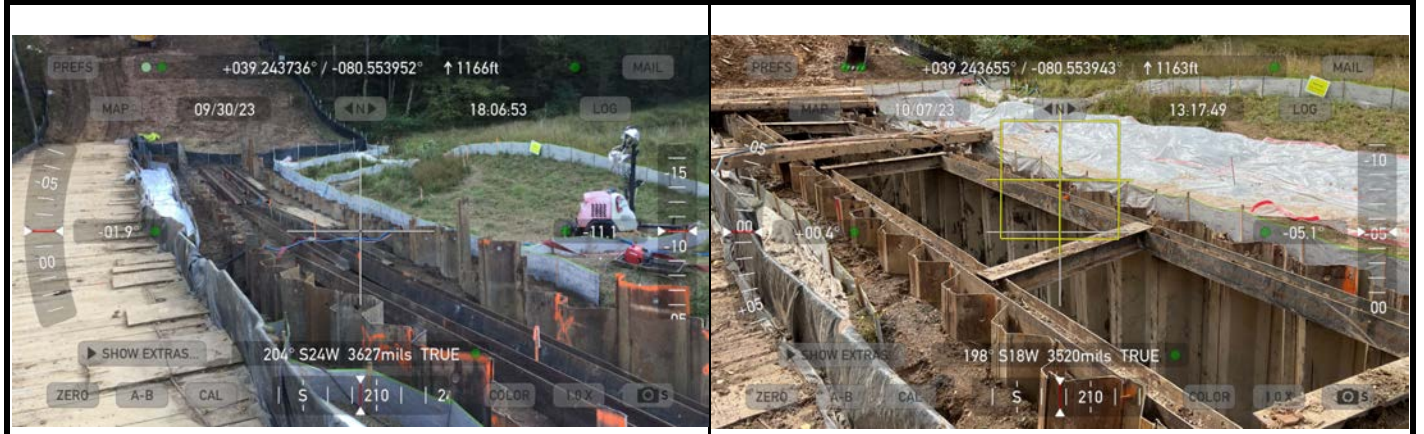
<b>GPS Location</b>	See photo	<b>GPS Location</b>	See photo
<b>Description</b>	This photo shows sheet piling installed in the wetland	<b>Description</b>	This photo shows the trench excavated in the wetland

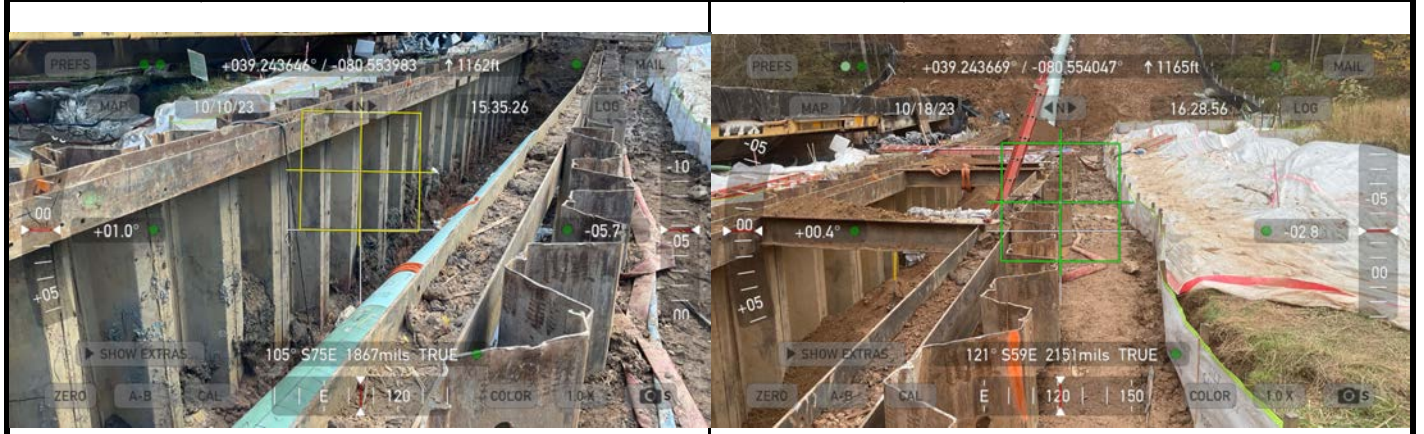
<b>GPS Location</b>	See photo	<b>GPS Location</b>	See photo
<b>Description</b>	This photo shows the pipe installed in the wetland	<b>Description</b>	This photo shows the partially backfilled trench in the wetland

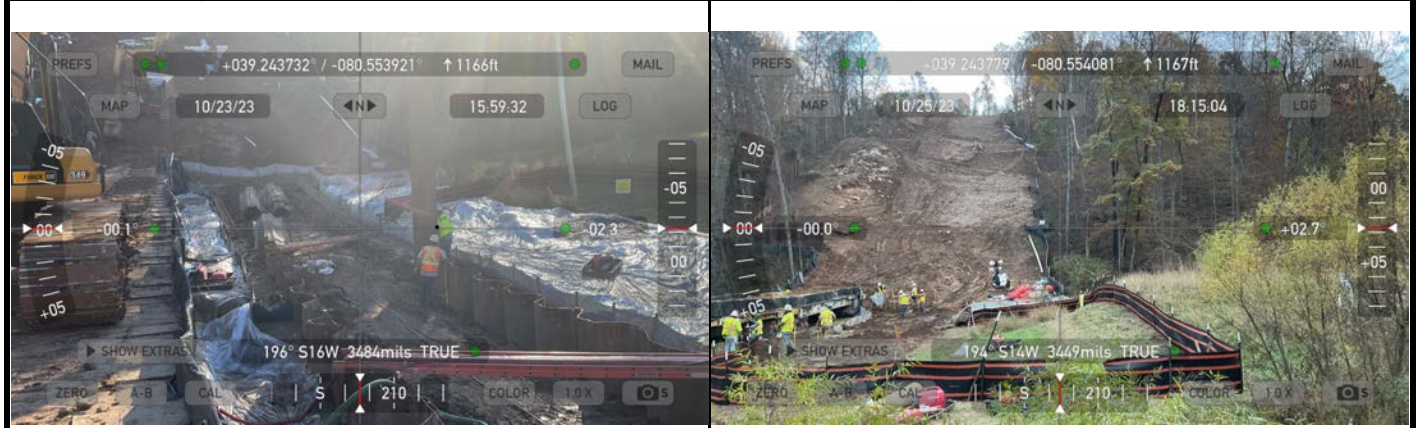
<b>GPS Location</b>	See photo	<b>GPS Location</b>	See photo
<b>Description</b>	This photo shows sheet piling being removed from the wetland	<b>Description</b>	This photo shows the wetland being restored following completion of the crossing
