# Wetland Biological Conditions EA Report

<b>Project Name</b>	H-600 Pipeline Spread F	<b>AFE</b>	124300135	<b>Spread</b>	H-600 Pipeline Spread F
<b>Contractor</b>	Price Gregory	<b>Report #</b>	81		
<b>Environmental Auditor</b>	Jessica Yeager			<b>Date/Time</b>	10/10/2023 11:20 AM
<b>Wetland ID</b>	W-K7	<b>Crossing Start Date</b>	10/11/2023	<b>Crossing Completion Date</b>	11/6/2023
<b>Milepost</b>	154.80	<b>Pre-Con Assessment Date</b>	10/10/2023	<b>Post-Con Assessment Date</b>	11/6/2023
<b>Station</b>	8173+44	<b>Cowardin Classification</b>	PEM	<b>Wetland Impact Area(acres)</b>	0.3206
<b>State</b>	WV				
<b>County</b>	Greenbrier

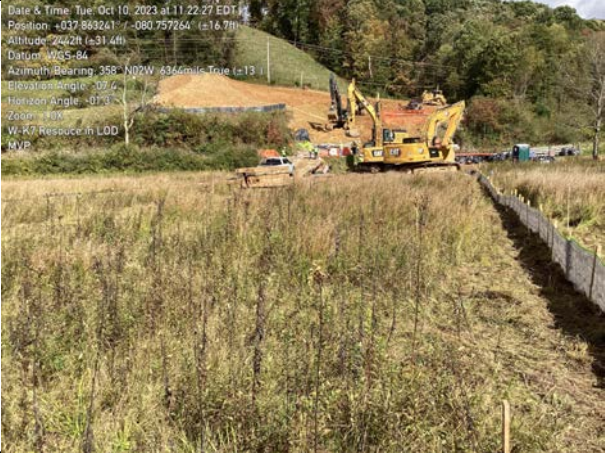
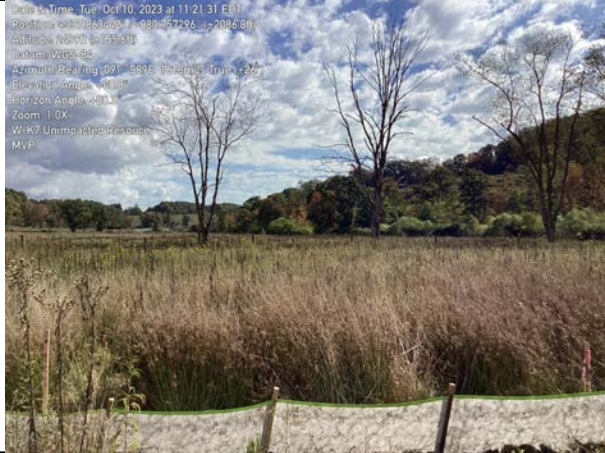
<p><small>Date &amp; Time: Tue, Oct 10, 2023 at 11:22:27 EDT Position: +037.863261° / -080.757264° (-16.7H) Altitude: 242.2ft (-31.4ft) Datum: WGS-84 Azimuth Bearing: 358° N02W 836mils True (+13.1) Elevation Angle: -09.7° Horizon Angle: -01.3° Zoom: 1.0x W-K? Unimpacted Resource Area MVP</small></p>

<p><small>Date &amp; Time: Tue, Oct 10, 2023 at 11:21:31 EDT Position: +037.863261° / -080.757264° (-16.7H) Altitude: 242.2ft (-31.4ft) Datum: WGS-84 Azimuth Bearing: 291° S89E 1020mils True (+22.5) Elevation Angle: -08.8° Horizon Angle: -00.3° Zoom: 1.0x W-K? Unimpacted Resource Area MVP</small></p>			
<b>GPS Location</b>	See Photo	<b>GPS Location</b>	See Photo		
<b>Description</b>	View of permitted resource impact area during pre-construction assessment.	<b>Description</b>	At edge of LOD, view of unimpacted resource area conditions during pre-construction assessment.

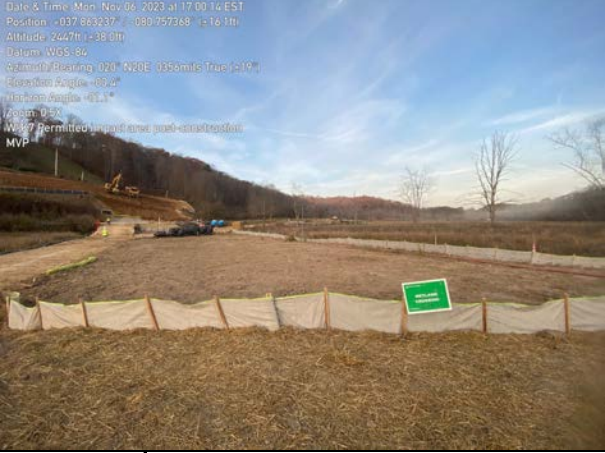
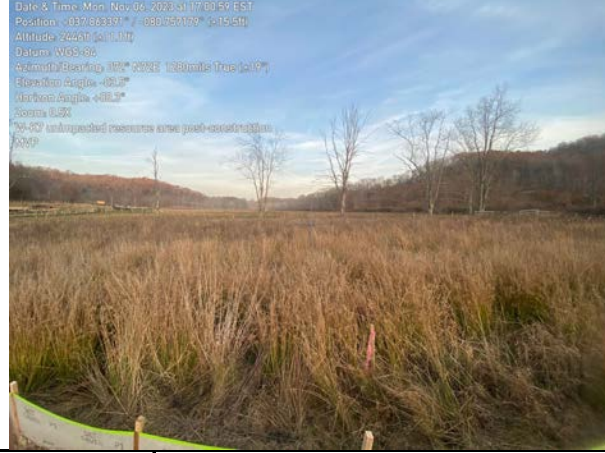
18. Crossing and riparian areas have been recently restored. These areas will be monitored until 80% vegetative coverage has been achieved and areas that do not have 80% vegetative cover within 30 days will be reseeded.

<p><small>Date &amp; Time: Mon, Nov 05, 2023 at 17:00:14 EDT Position: +037.863337° / -080.758768° (-16.7H) Altitude: 242.7ft (-38.0ft) Datum: WGS-84 Azimuth Bearing: 020° N02E 0356mils True (+19.7) Elevation Angle: -09.2° Horizon Angle: -01.1° Zoom: 0.2x W-K? Permitted Impact Area post-construction MVP</small></p>

<p><small>Date &amp; Time: Mon, Nov 05, 2023 at 17:00:59 EDT Position: +037.863337° / -080.758768° (-16.7H) Altitude: 242.7ft (-38.0ft) Datum: WGS-84 Azimuth Bearing: 191° S09E 1280mils True (+19.7) Elevation Angle: -08.2° Horizon Angle: -01.1° Zoom: 0.2x W-K? Unimpacted Resource Area post-construction MVP</small></p>			
<b>GPS Location</b>	See Photo	<b>GPS Location</b>	See Photo		
<b>Description</b>	View of permitted resource impact area during post-construction assessment.	<b>Description</b>	At edge of LOD, view of unimpacted resource area conditions during post-construction assessment.

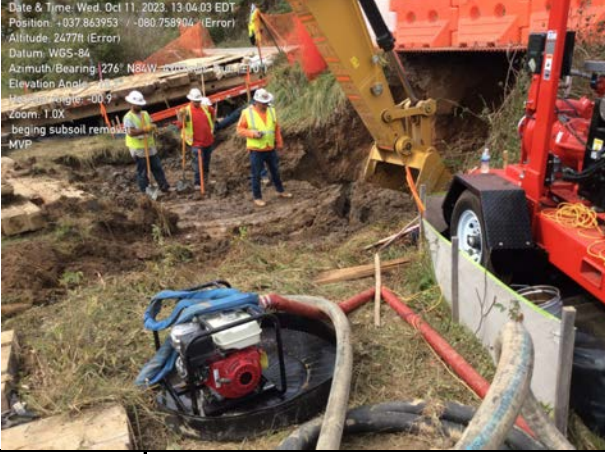
10-11-2023 - Previously trenched under road to edge of aquatic resource. Mats utilized to remove topsoil from northern most portion of the wetland (Photo 1). Topsoil segregated in work area (Photo 2). Begin excavation of subsoil, hammering, and dewatering of trench.

<p><small>Date &amp; Time: Wed, Oct 11, 2023, 13:04:03 EDT Position: +037.863953° / -080.758904° (-16.7H) Altitude: 247.7ft (Error) Datum: WGS-84 Azimuth Bearing: 276° N82W 1000mils True (+20.0) Elevation Angle: -00.3° Horizon Angle: -03.2° Zoom: 1.0x W-K? Wetland Topsoil Removal MVP</small></p>

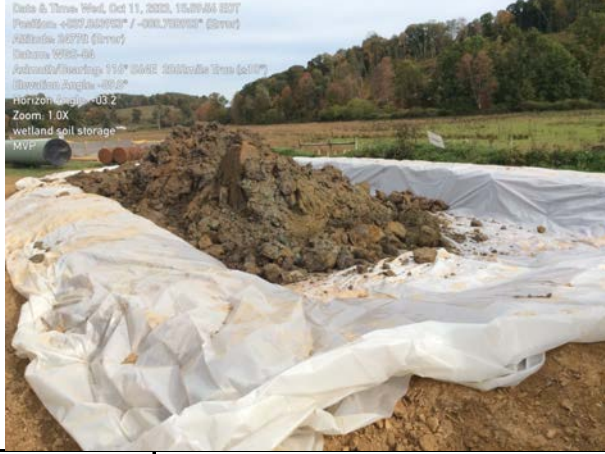
<p><small>Date &amp; Time: Wed, Oct 11, 2023, 15:07:04 EDT Position: +037.863953° / -080.758904° (-16.7H) Altitude: 247.7ft (Error) Datum: WGS-84 Azimuth Bearing: 191° S09E 1280mils True (+19.7) Elevation Angle: -03.2° Horizon Angle: -03.2° Zoom: 1.0x W-K? Wetland Soil Storage MVP</small></p>			
<b>GPS Location</b>	See Photo	<b>GPS Location</b>	See Photo		
<b>Description</b>	Photo 1: Removal of wetland topsoil in northern portion of the aquatic resource area.	<b>Description</b>	Photo 2: Segregated wetland topsoil.

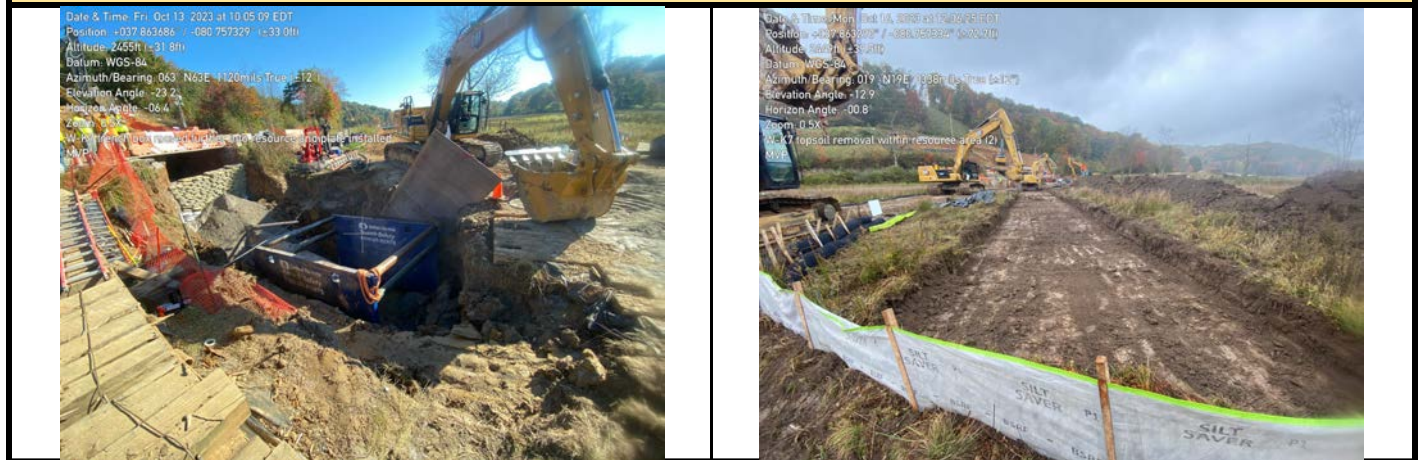
10/13/2023 - Concrete trench breaker construction (Photo 3) and pumping water ongoing in trench. Sand added to trench. Filling of trench upgradient of wetland (below road surface and on ROW above road). Trench box moved further into resource. Steel plate inserted in trench at northern end of aquatic resource area. Concrete pumped into gap between trench breakers (under road, outside of aquatic resource area).

10/14/2023-10/18/2023 - Timber mats replaced. Topsoil removed from remainder of resource (Photo 4). Excavating trench from north to south to end of resource. Ongoing pumping and hammering. Sandbag bedding placed in excavated portion of trench. Pipe temporarily placed in trench (10/18/2023).

<b>GPS Location</b>	See Photo	<b>GPS Location</b>	See Photo
<b>Description</b>	Photo 3: Concrete trench breakers under construction, filling trench, and moving trench box and plates.	<b>Description</b>	Photo 4: Removal of topsoil from remaining wetland area.

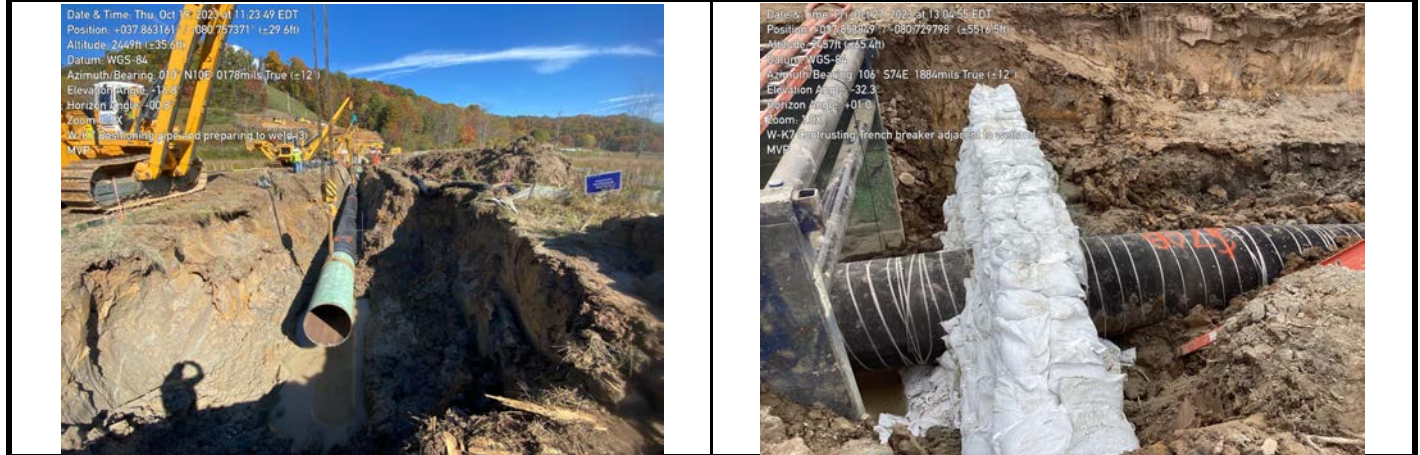
10/19/2023 - Pumping water on-going in the trench. Loose soil removed from trench. Pipe lowered into trench in resource area (Photo 5). Began welding. Sandbags bedding and soil added to trench for cushion. Second trench box installed (southern end of resource). Steel plates added. Backfilling of the trench initiated.

10/27/2023 - Pumping water ongoing in the trench. Trench breaker constructed (Photo 6) and backfilling adjacent to aquatic resource. Test stick moved to outside wetland boundary.

<b>GPS Location</b>	See Photo	<b>GPS Location</b>	See Photo
<b>Description</b>	Photo 5: Placing and positioning pipe through aquatic resource area.	<b>Description</b>	Photo 6: Downgradient (southern) trench breaker adjacent to aquatic resource.

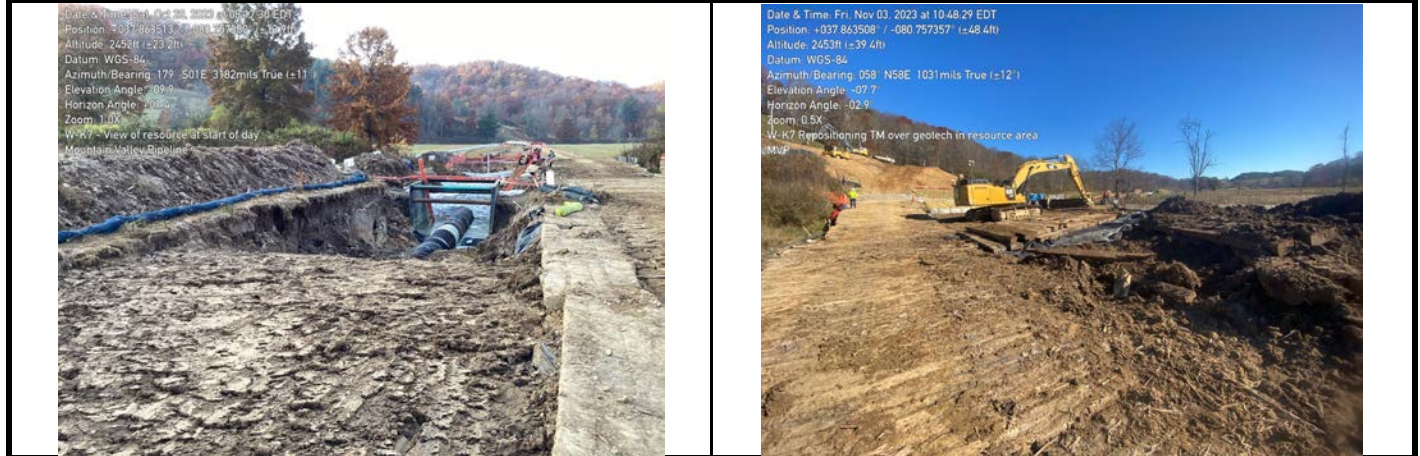
10/28/2023 - Pumping water ongoing in the trench. Height added to trench breakers adjacent to aquatic resource. Backfilling of trench in and adjacent to aquatic resource (Photo 7). Survey onsite. Restoration of adjacent aquatic resource initiated.

11/3/2023 - Continue moving timber mats in resource area (Photo 8) and laying geotech in timber mat area. Restoring topsoil in resource area.

<b>GPS Location</b>	See Photo	<b>GPS Location</b>	See Photo
<b>Description</b>	Photo 7: Backfilling of aquatic resource.	<b>Description</b>	Photo 8: Replacing timber mats and restoring wetland topsoil.
