# Wetland Biological Conditions EA Report

<b>Project Name</b>	H-600 Pipeline Spread F	<b>AFE</b>	124300135	<b>Spread</b>	H-600 Pipeline Spread F
<b>Contractor</b>	Price Gregory	<b>Report #</b>	107		
<b>Environmental Auditor</b>	Luke Fultz	<b>Date/Time</b>	10/26/2023 3:44 PM		
<b>Wetland ID</b>	W-K9-PEM-1	<b>Crossing Start Date</b>	11/9/2023	<b>Crossing Completion Date</b>	11/17/2023
<b>Milepost</b>	155.19	<b>Pre-Con Assessment Date</b>	10/26/2023	<b>Post-Con Assessment Date</b>	11/17/2023
<b>Station</b>	8194+28	<b>Cowardin Classification</b>	PEM	<b>Wetland Impact Area(acres)</b>	0.0354
<b>State</b>	WV				
<b>County</b>	Greenbrier

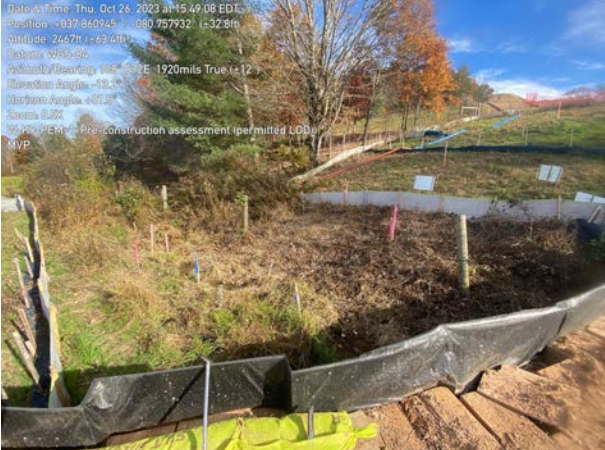
<p><small>Date &amp; Time: Thu, Oct 26, 2023 at 15:49:08 EDT Position: -83.7860945° / -080.757932° (-32.28ft) Altitude: 2667ft (+63.6ft) Datum: WGS-84 Azimuth/Bearing: 104° 30'E 1920mils True (+12°) Elevation Angle: -13.2° Horizontal Angle: 407.2° Zoom: 0.5X W-K9-PEM-1 Pre-construction assessment (permitted LOD) MVP</small></p>

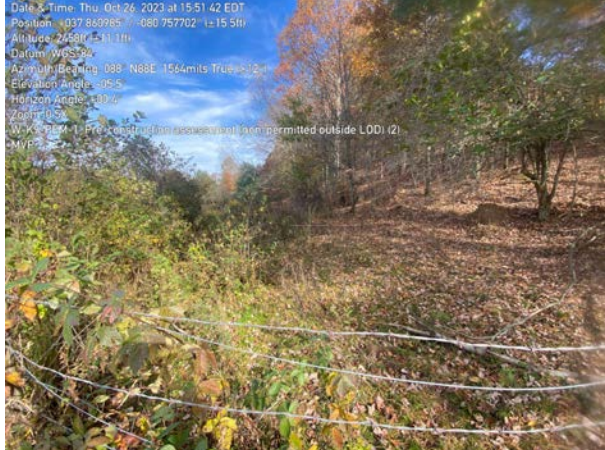
<p><small>Date &amp; Time: Thu, Oct 26, 2023 at 15:51:42 EDT Position: -83.7860965° / -080.757702° (-15.5ft) Altitude: 2450ft (+51.1ft) Datum: WGS-84 Azimuth/Bearing: 088° N88E 1554mils True (+12°) Elevation Angle: 505.5° Horizontal Angle: 439.2° Zoom: 0.5X W-K9-PEM-1 Pre-construction assessment (permitted outside LOD) (2) MVP</small></p>
<b>GPS Location</b> See Photo	<b>GPS Location</b> See Photo
<b>Description</b> View of permitted resource impact area during pre-construction assessment.	<b>Description</b> At edge of LOD, view of unimpacted resource area conditions during pre-construction assessment.

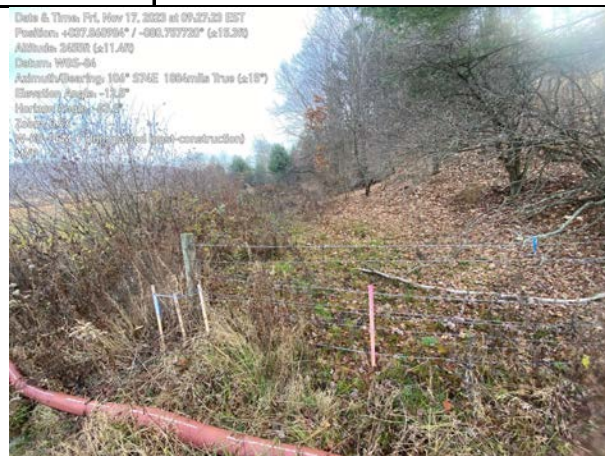
<p><small>Date &amp; Time: Fri, Nov 17, 2023 at 09:27:53 EST Position: -83.7860967° / -080.757738° (-15.3ft) Altitude: 2450ft (+51.1ft) Datum: WGS-84 Azimuth/Bearing: 104° 30'E 1884mils True (+15°) Elevation Angle: -13.2° Horizontal Angle: 40.3° Zoom: 0.5X W-K9-PEM-1 Permitted impact (post-construction) MVP</small></p>
<b>GPS Location</b> See Photo	<b>GPS Location</b> See Photo
<b>Description</b> View of permitted resource impact area during post-construction assessment.	<b>Description</b> At edge of LOD, view of unimpacted resource area conditions during post-construction assessment.

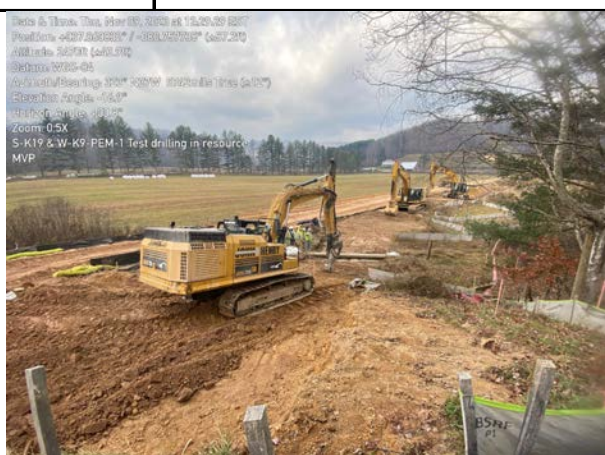
11/9/2023 - Reviewed Pre-Construction Assessment completed on 10/26/2023. No changes observed. Excavated wetland topsoil (Photo 1) and segregated in upland area. Test drilling in aquatic resource area (Photo 2). Work ongoing at other locations at this site.

<p><small>Date &amp; Time: Thu, Nov 02, 2023 at 12:03:09 EST Position: -83.7860967° / -080.757700° (-49.7ft) Altitude: 2450ft (+51.1ft) Datum: WGS-84 Azimuth/Bearing: 104° 30'E 1882mils True (+15°) Elevation Angle: -01.8° Horizontal Angle: 40.3° Zoom: 0.5X S-K19 &amp; W-K9-PEM-1 Test drilling in resource MVP</small></p>
<b>GPS Location</b> See Photo	<b>GPS Location</b> See Photo
<b>Description</b> Photo 1: Wetland topsoil excavated.	<b>Description</b> Photo 2: Test drilling in aquatic resource area.

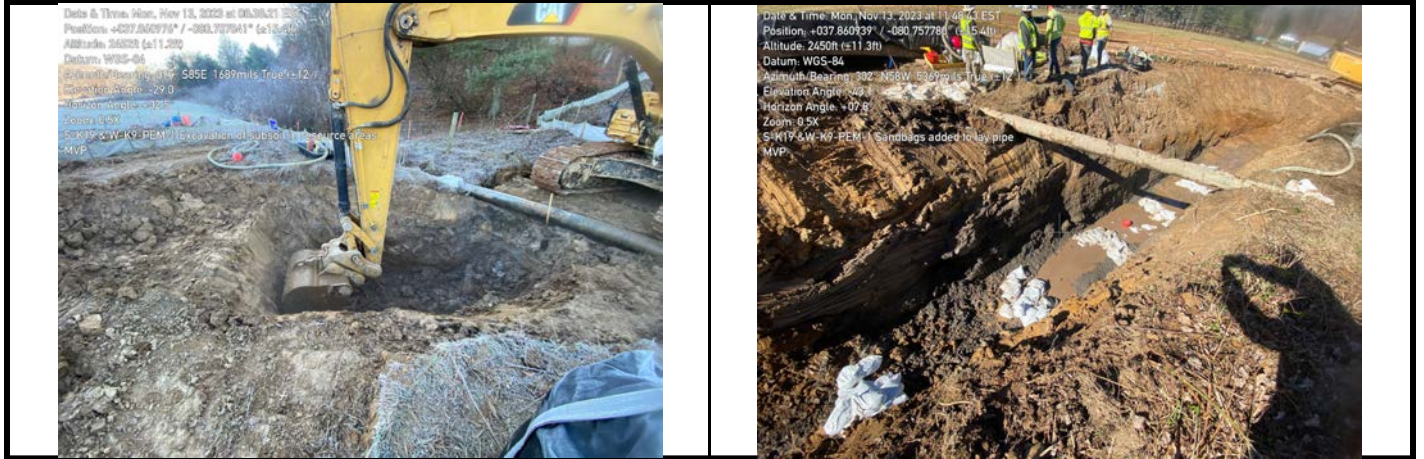
11/13/2023 - Timber mats put in place to begin excavation of aquatic resource. Excavation of trench through aquatic resource (Photo 3). Pumped water from trench in aquatic resource area and then repeated as needed. Sandbags for padding added in trench (Photo 4). Pipe placed in trench through aquatic resource area and prepared for welding (Photo 5). Welding and x-ray of connection outside of aquatic resource area.

<b>GPS Location</b>	See Photo	<b>GPS Location</b>	See Photo
<b>Description</b>	Photo 3: Excavating trench in aquatic resource area. Equipment on timber mats.	<b>Description</b>	Photo 4: Adding sandbag padding to trench in aquatic resource area.

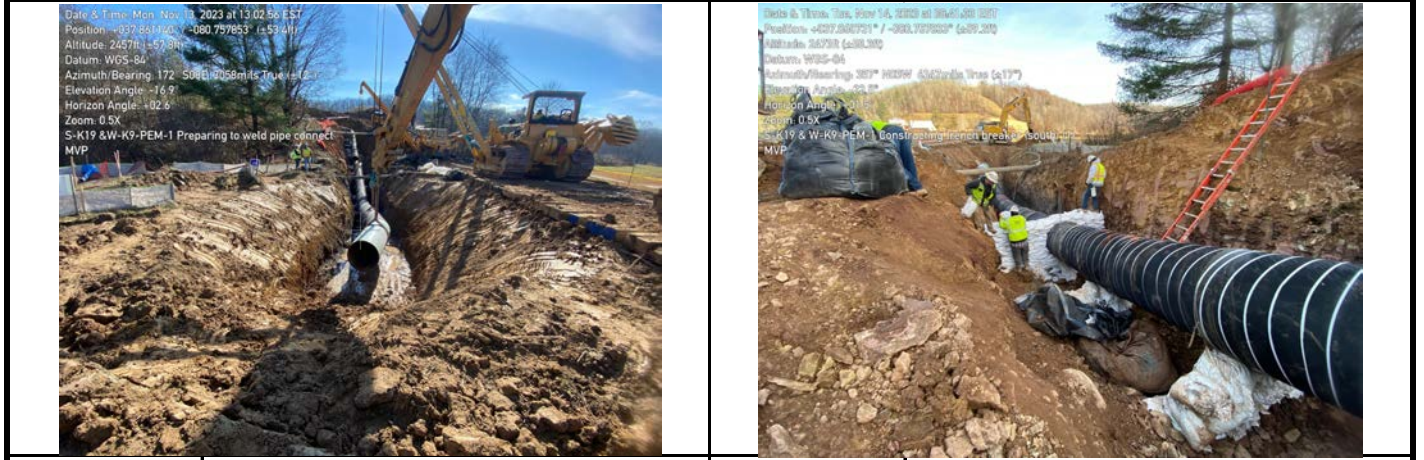
11/14/2023 - Pumping water from trench in aquatic resource area. Construction of trench breaker on the southern side of the aquatic resource area (Photo 6). Began backfilling.

<b>GPS Location</b>	See Photo	<b>GPS Location</b>	See Photo
<b>Description</b>	Photo 5: Lowering pipe into trench through aquatic resource area and preparing for welding.	<b>Description</b>	Photo 6: Construction of trench breaker on the southern side of aquatic resource area.

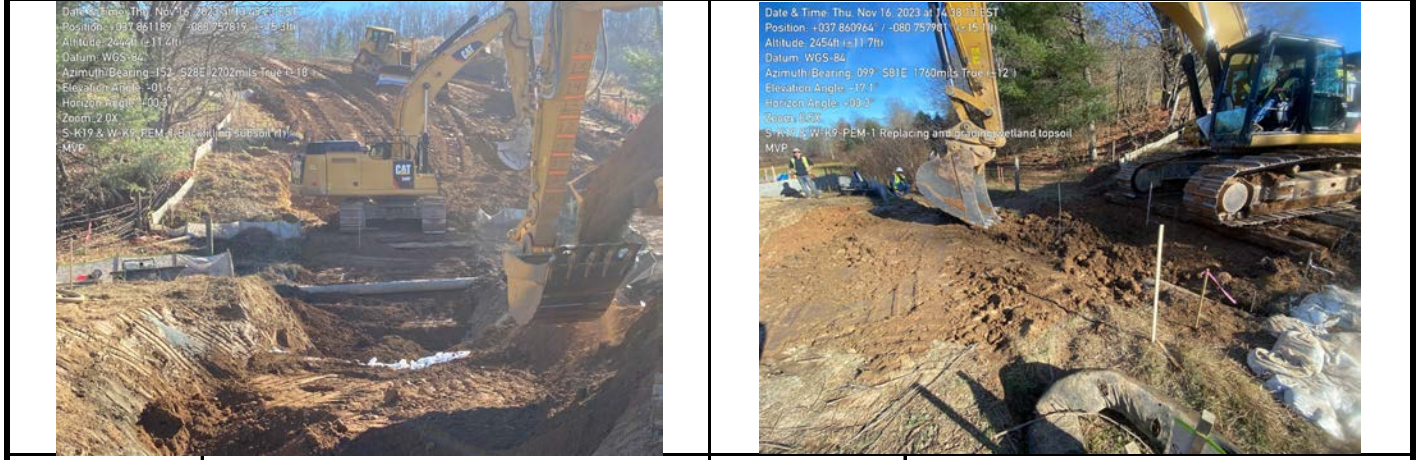
11/16/2023 - Pumping water from trench in aquatic resource area. Construction of trench breaker on the northern side of the aquatic resource area. Continued backfilling subsoils in aquatic resource area (Photo 7). Survey onsite shooting pre-restoration soil levels. Restored and contoured wetland topsoil (Photo 8). Seeding completed and jute added. Reseeding completed. Dark. Final check and assessment to be completed in the morning when visibility is better.

<b>GPS Location</b>	See Photo	<b>GPS Location</b>	See Photo
<b>Description</b>	Photo 7: Backfilling in aquatic resource area.	<b>Description</b>	Photo 8: Restoring and grading wetland topsoil.
