# Wetland Biological Conditions EA Report

<b>Project Name</b>	H-600 Pipeline Spread E	<b>A/E</b>	124300134	<b>Spread</b>	H-600 Pipeline Spread E
<b>Contractor</b>	Price Gregory	<b>Report #</b>	56		
<b>Environmental Auditor</b>	Charles Haden			<b>Date/Time</b>	9/19/2023 8:03 AM
<b>Wetland ID</b>	W-M23	<b>Crossing Start Date</b>	10/7/2023	<b>Crossing Completion Date</b>	10/19/2023
<b>Milepost</b>	137.01	<b>Pre-Con Assessment Date</b>	9/19/2023	<b>Post-Con Assessment Date</b>	10/19/2023
<b>Station</b>	7234+05	<b>Cowardin Classification</b>	PEM	<b>Wetland Impact Area(acres)</b>	0.0616
<b>State</b>	WV				
<b>County</b>	Greenbrier

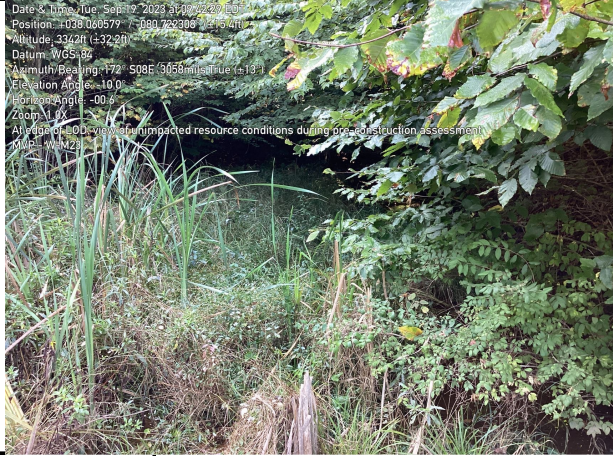
Pre-Construction Notes  
 Pre-Construction Meeting - 9/18/2023  
 Timber mat bridge in place prior to assessment.  
 17. Standing water, soil saturation, and high water table observed in soil test pit.

<p><small>Date &amp; Time: Tue, Sep 19, 2023 at 05:06:06 EDT Position: +038.060726° / -080.722308° (+16.0ft) Altitude: 333.7ft (+37.6ft) Datum: WGS-84 Azimuth/Bearing: 106° S74E 1884mils True (+13°) Elevation Angle: +1.3° Horizon Angle: +00.0° Zoom: 1.0X View of permitted impact area during pre-construction assessment MVP - W-M23</small></p>
