WETLAND BIOLOGICAL CONDITIONS ENVIRONMENTAL AUDITOR REPORT

Wetland ID: W-MM17	Crossing Start Date: 09/29/2023	Crossing Completion Date: 10/03/2023
Milepost: 283.4	Pre-Con Assessment Date: 09/27/2023	Post-Con Assessment Date: 10/03/2023
Station: 14991+12	Cowardin Classification: PEM (PEM, PFO, PSS, POW)	Wetland Impact Area (sq ft.): 296.21
County: Franklin

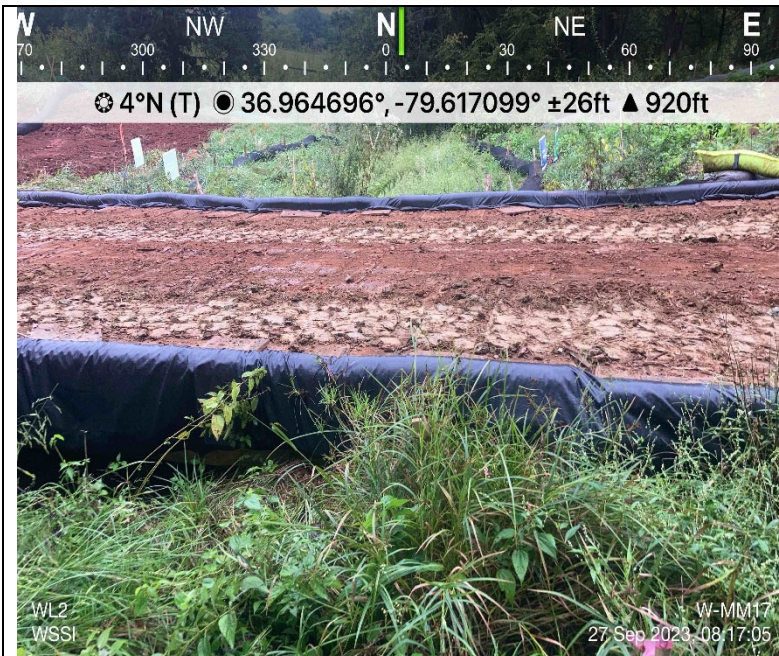
Photo Description: View of permitted resource impact area during pre-construction assessment. Majority of wetland impact area is under timber mat bridge.

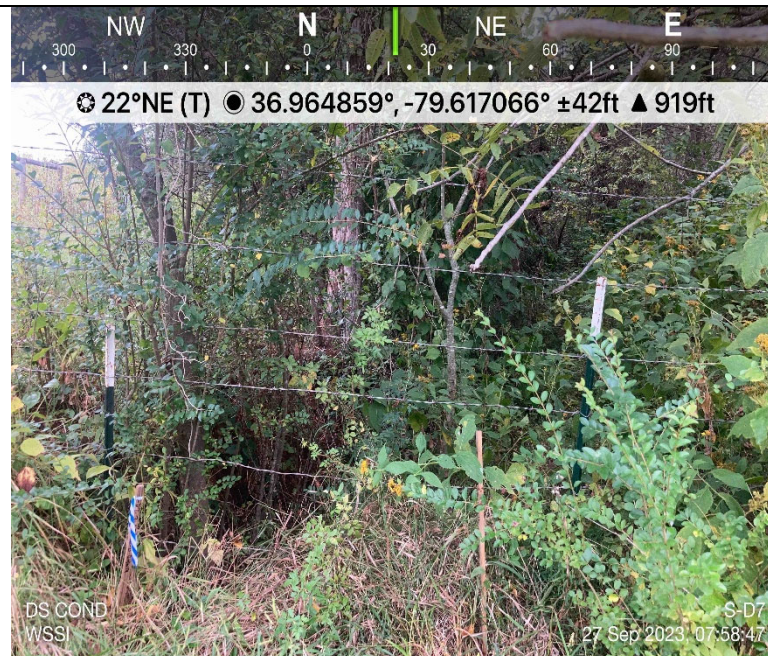
Photo Description: At edge of LOD, view of unpermitted resource area conditions during pre-construction assessment. Delineation indicates W-MM17 converges with S-D7 within temporary impact area.

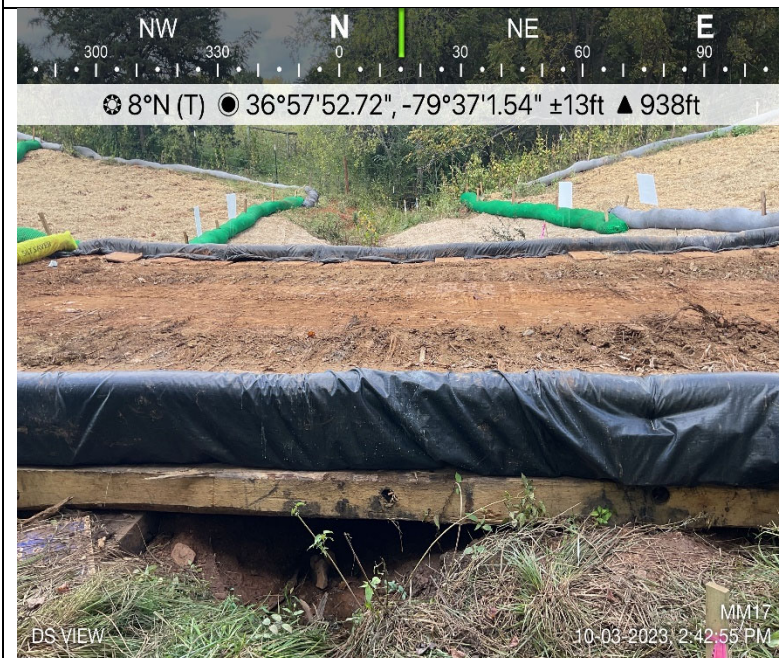
Photo Description: View of permitted resource impact area during post-construction assessment.

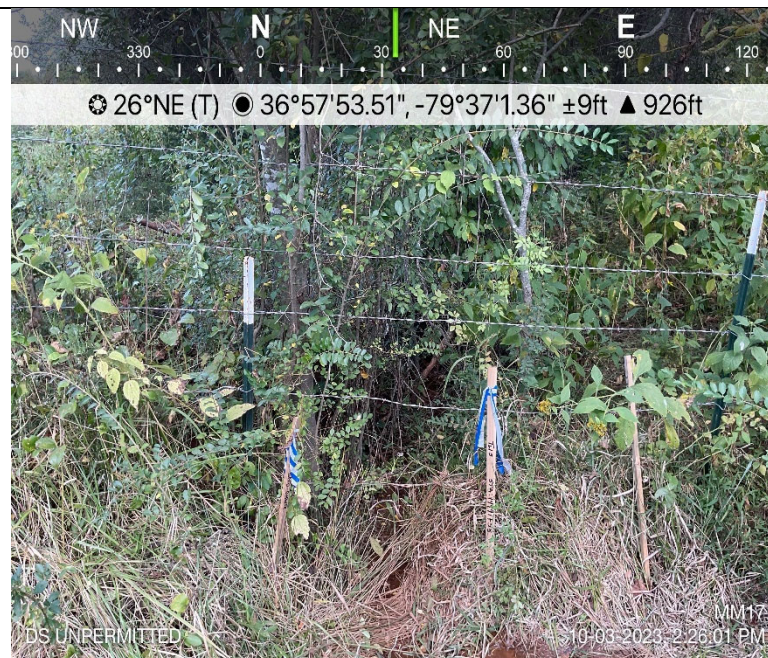
Photo Description: At edge of LOD, view of unpermitted resource area conditions during post-construction assessment. Delineation indicates W-MM17 converges with S-D7 within temporary impact area.

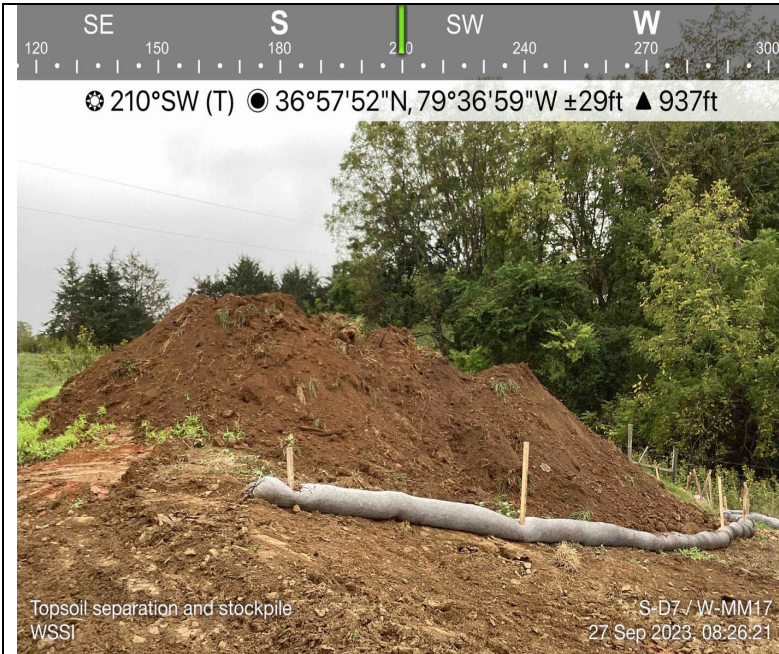
Photo Description: Buffer zone topsoil stockpiled separately from wetland topsoil.

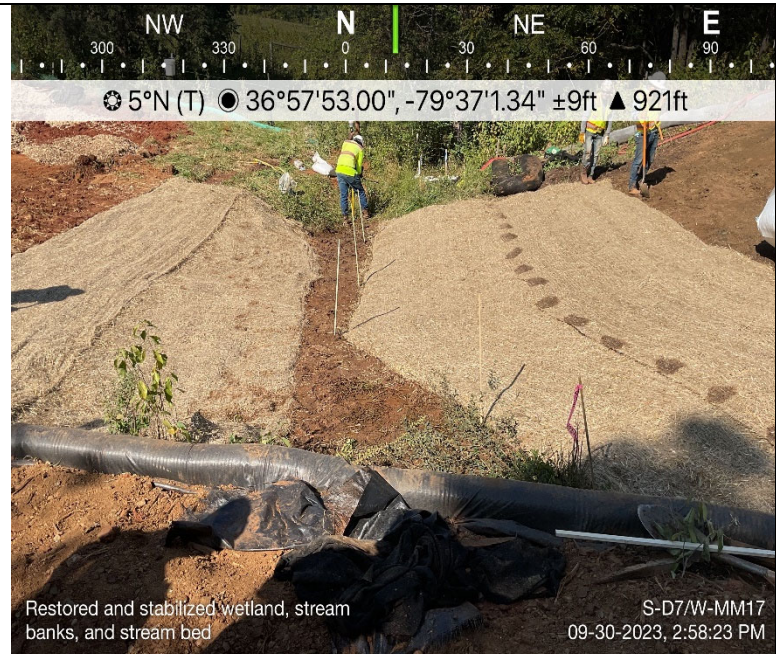
Photo Description: Restoration of wetland and stream resources.

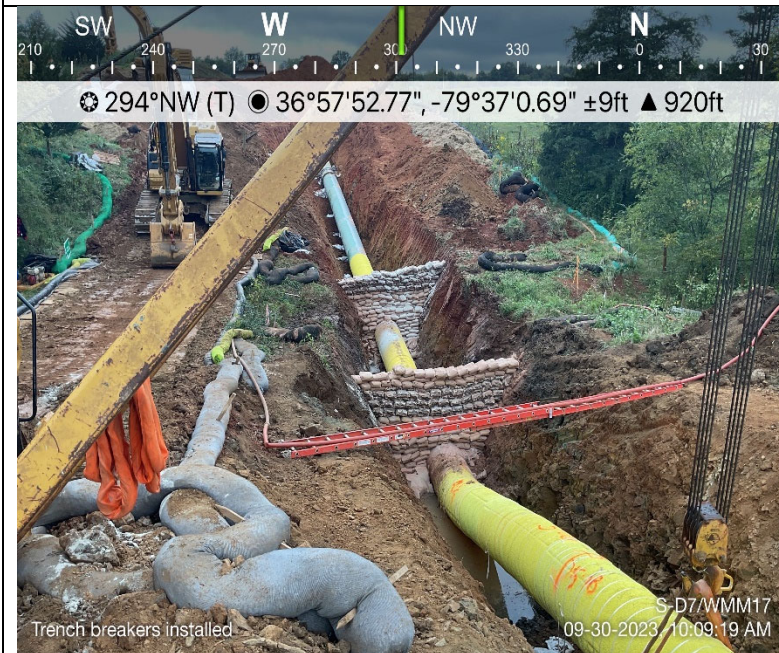
Photo Description: Trenchbreaker installations.

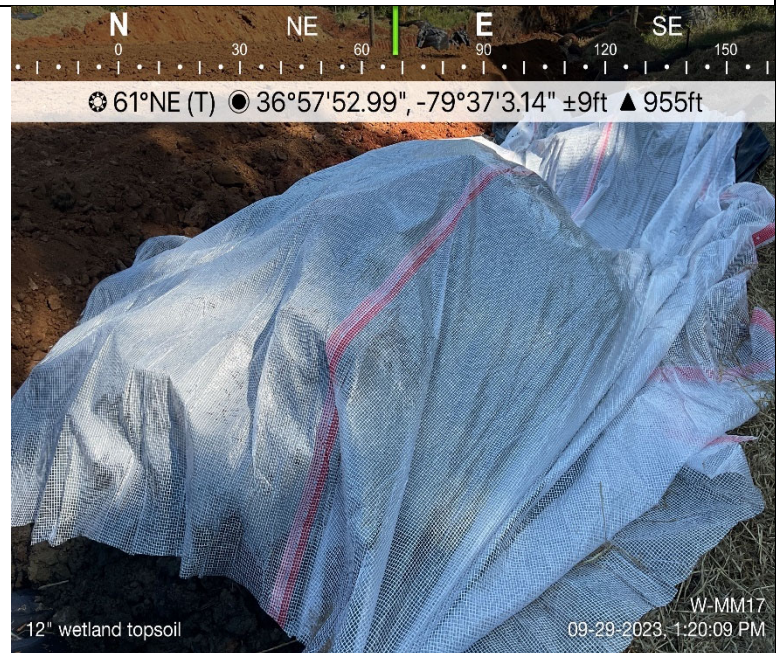
Photo Description: Wetland topsoil stockpiled and wrapped separately from subsoils.
