WETLAND BIOLOGICAL CONDITIONS ENVIRONMENTAL AUDITOR REPORT

Wetland ID: W-ST2-PEM	Crossing Start Date: 08/23/2023	Crossing Completion Date: 09/20/2023
Milepost: 246.5	Pre-Con Assessment Date: 08/21/2023	Post-Con Assessment Date: 09/20/2023
Station: 13023+95	Cowardin Classification: PEM (PEM, PFO, PSS, POW)	Wetland Impact Area (sq ft.): 4974.55
County: Franklin

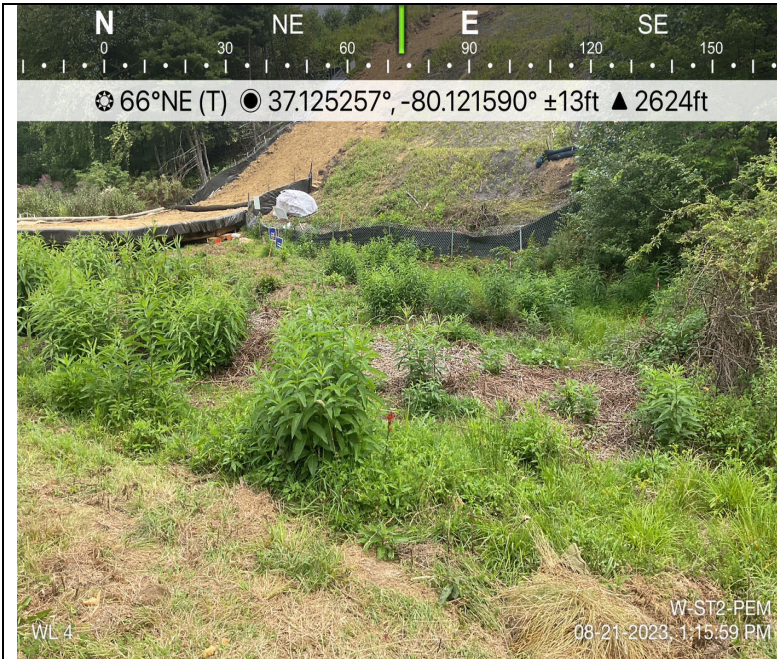
Photo Description: View of permitted resource impact area during pre-construction assessment.

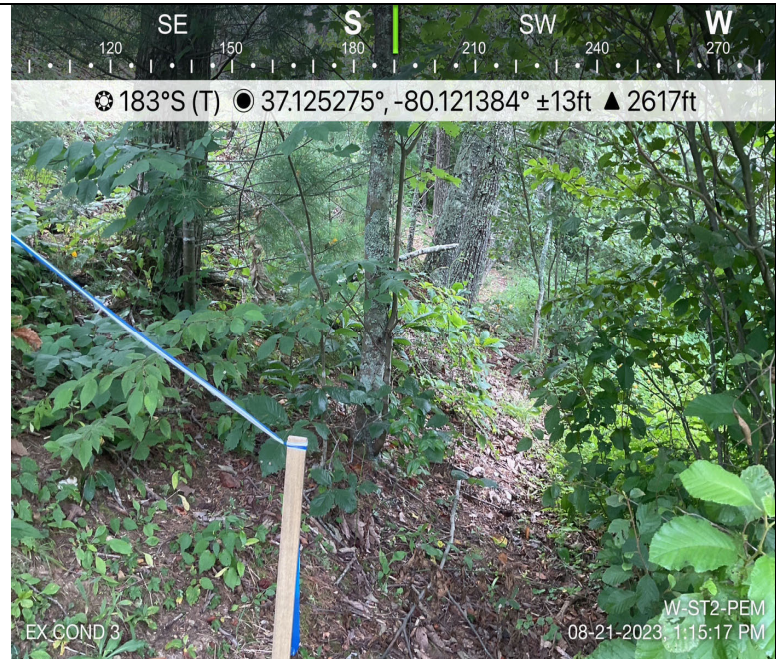
Photo Description: At edge of LOD, view of unpermitted resource area conditions during pre-construction assessment.

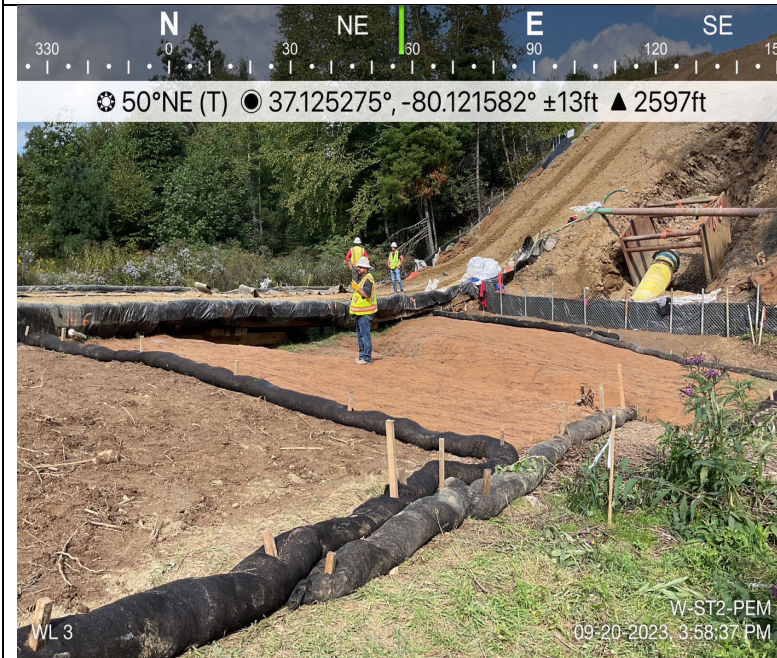
Photo Description: View of permitted resource impact area during post-construction assessment.

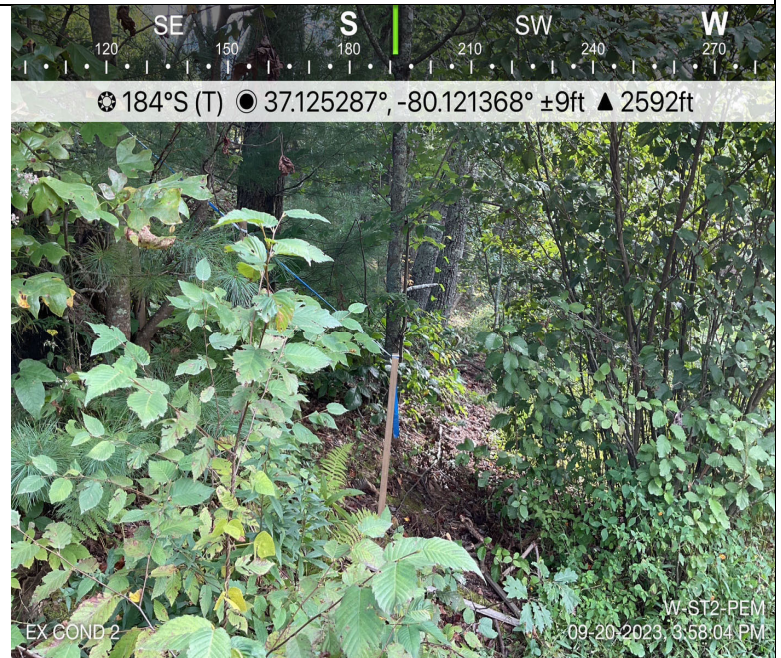
Photo Description: At edge of LOD, view of unpermitted resource area conditions during post-construction assessment.

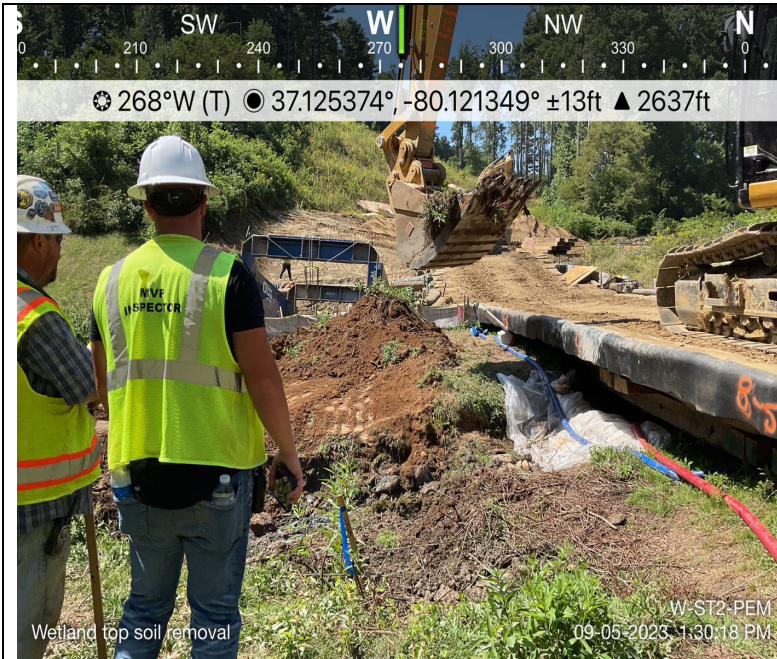
Photo Description: Wetland topsoil removal prior to trenching.

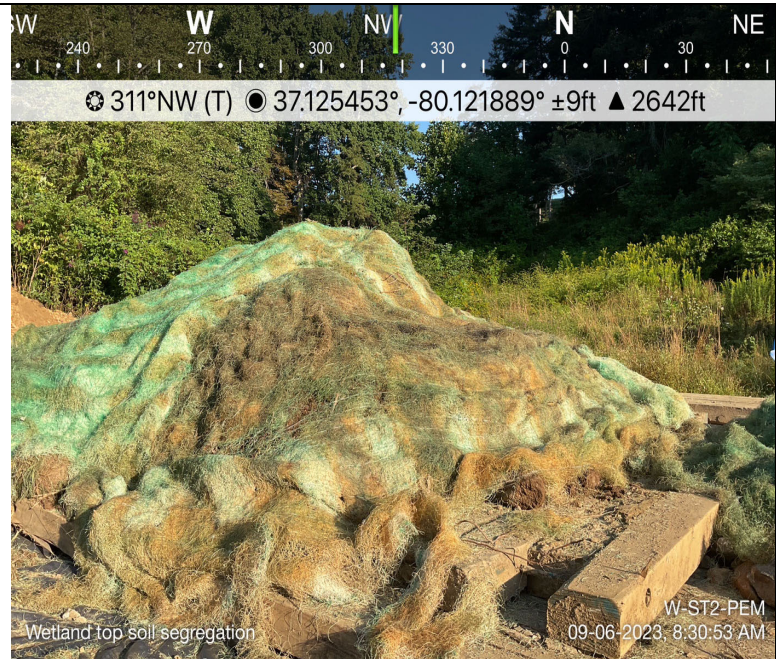
Photo Description: Wetland topsoil segregated and stockpiled separately from subsoil and S-G24 & S-G25 streambed substrate.

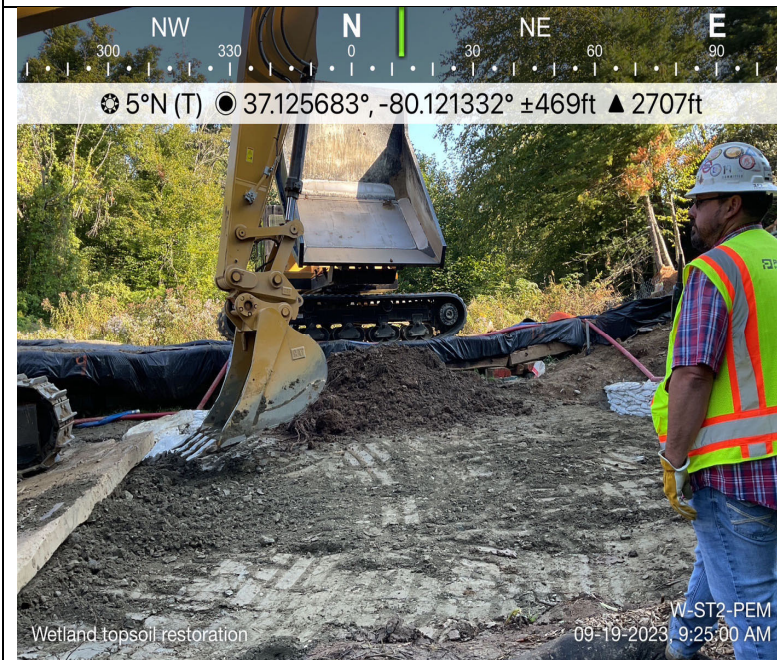
Photo Description: Restoring wetland topsoil.

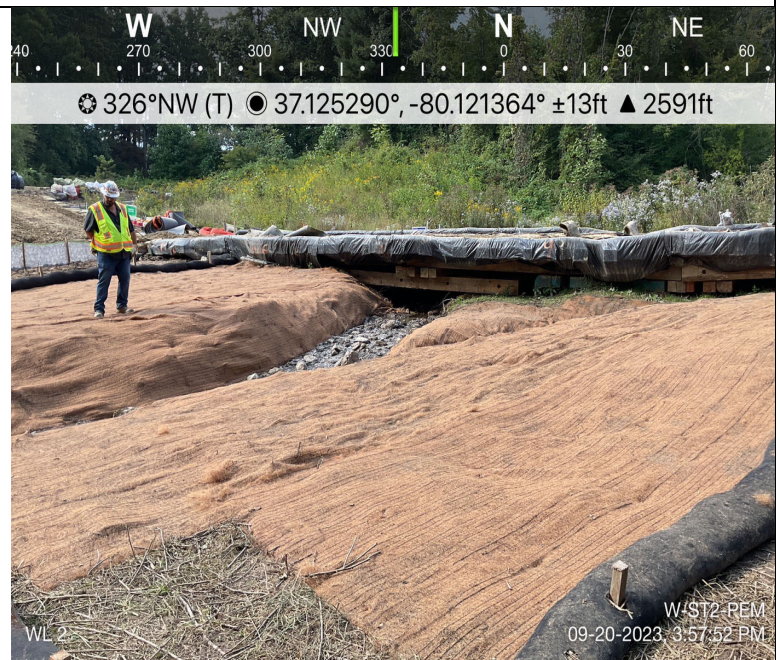
Photo Description: View of final stabilization and restoration of work area.
