Wetland Biological Conditions EA Report

Project Name	H-600 Pipeline Spread F	AFE	124300135	Spread	H-600 Pipeline Spread F
Contractor	Price Gregory	Report #	104		
Environmental Auditor	Tim Ferguson	Date/Time	10/26/2023 12:34 PM		
Wetland ID	W-UV4	Crossing Start Date	10/31/2023	Crossing Completion Date	11/9/2023
Milepost	155.73	Pre-Con Assessment Date	10/26/2023	Post-Con Assessment Date	11/9/2023
Station	8222+54	Cowardin Classification	PSS	Wetland Impact Area(acres)	0.0885
State	WV				
County	Greenbrier

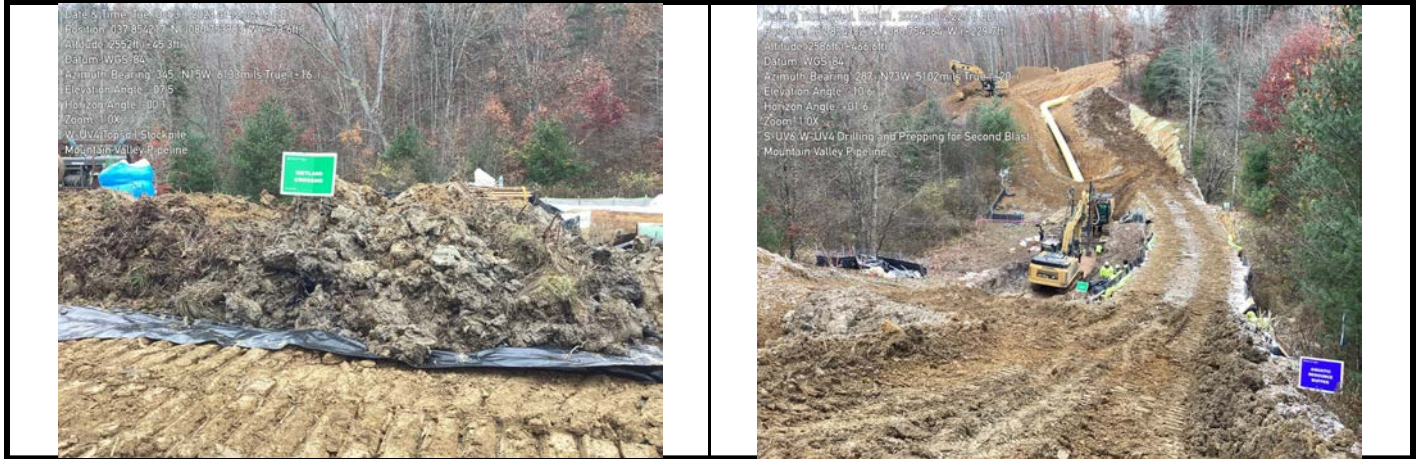
10/31/2023 - Minor precipitation in previous 24 hours (<0.1 inches). Top 12 inches of wetland topsoil removed (Photo 2). Topsoil segregated and stored in upland area (Photo 3). Light rain. Excavation of trench and hammering in resource area. Drilling for blasting through aquatic resource and placement of blasting mats. Blasting. Welding ongoing outside of aquatic resource area.

GPS Location See Photo	GPS Location See Photo
Description Photo 3: Wetland topsoil segregated in upland area.	Description Photo 4: Prepping (drilling) for second blast.

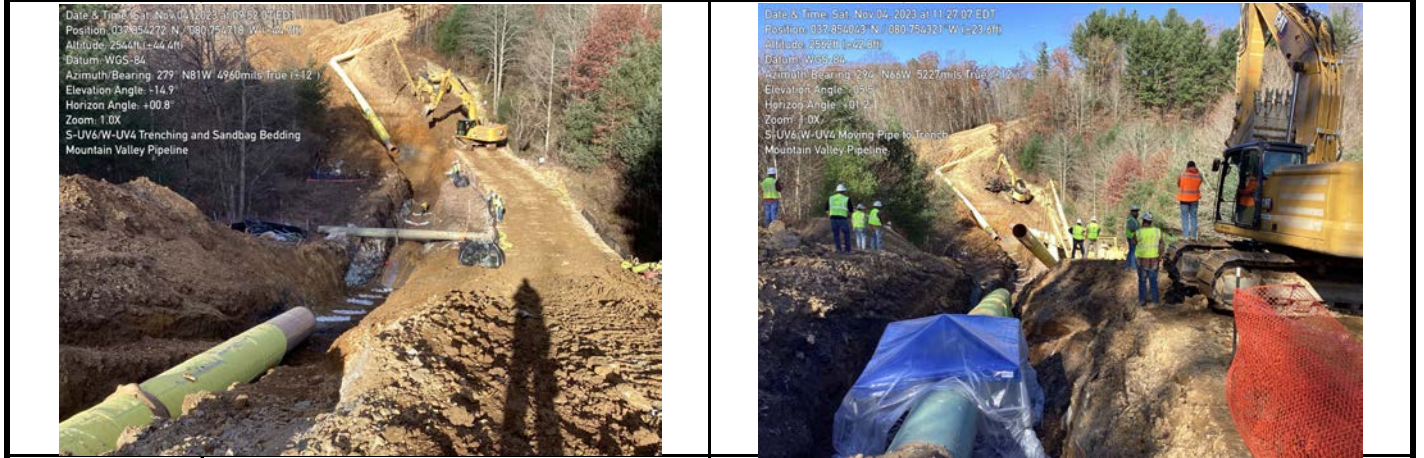
11/4/2023 - Pumping from trench in aquatic resource area. Drilling and hammering of rock in resource area. Trench excavation and spoil relayed to upland area. Sandbag bedding placed in pipe (Photo 5). Prepping to move pipe. Finish applying rock shield. Transport and lower pipe into trench in aquatic resource area.

GPS Location See Photo	GPS Location See Photo
Description Photo 5: Sandbags in trench for pipe bedding.	Description Photo 6: Lowering pipe into trench.

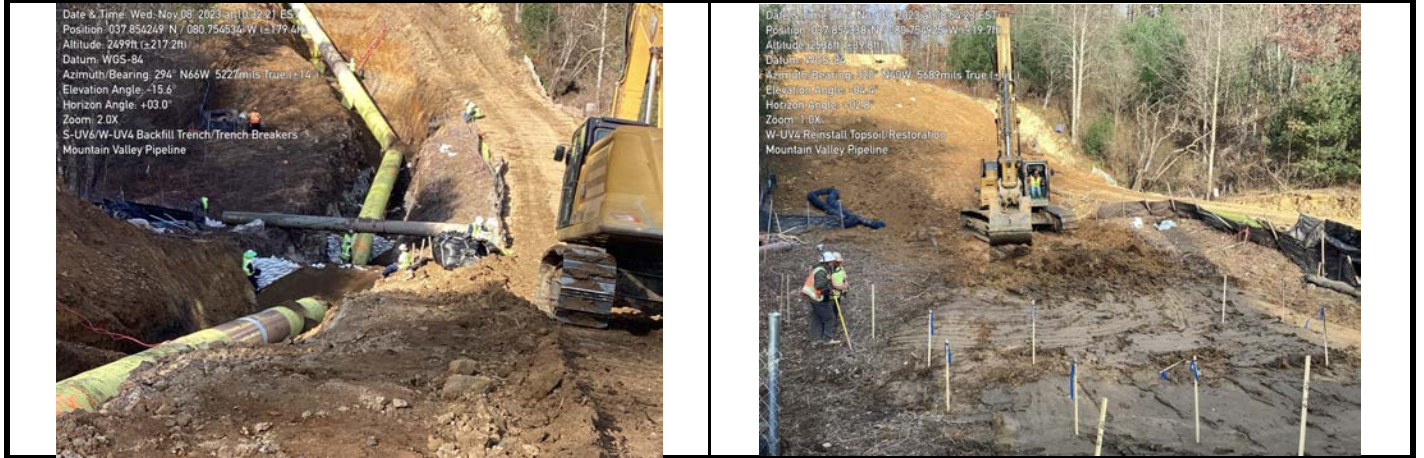
11/8/2023 - Trench breakers installed. Backfilling around trench breakers (Photo 7). Shaker bucket used for padding. Sand blasting and coating outside of aquatic resource area. Survey onsite to evaluate aquatic resource elevations.

11/9/2023 - Restored wetland subsoil and topsoil (Photo 8). Survey onsite and survey completed. Wetland seeded. Wetland restoration completed.

GPS Location See Photo	GPS Location See Photo
Description Photo 7: Trench breakers and backfilling with padding dirt.	Description Photo 8: Restoring wetland topsoil.
