STREAM BIOLOGICAL CONDITIONS ENVIRONMENTAL AUDITOR REPORT

Stream ID: S-A32	Crossing Start Date: 10/27/2023	Crossing Completion Date: 11/12/2023
Milepost: 205.9	Pre-Con Assessment Date: 10/21/2023	Post-Con Assessment Date: 11/13/2023
Station: 10882+91	Stream Classification: Perennial (Perennial, Intermittent, Ephemeral)	Bankfull Width (ft.): 16
County: Giles	303(d) Impairment Listing: Not Impaired	Riffle:Pool Complexes Present? No

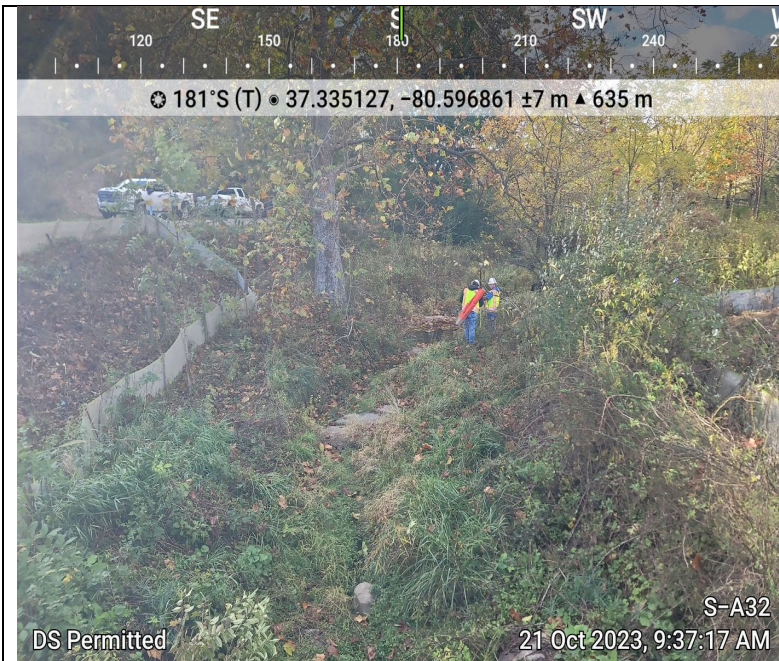
Photo Description: Downstream view of permitted impact area during pre-construction assessment.

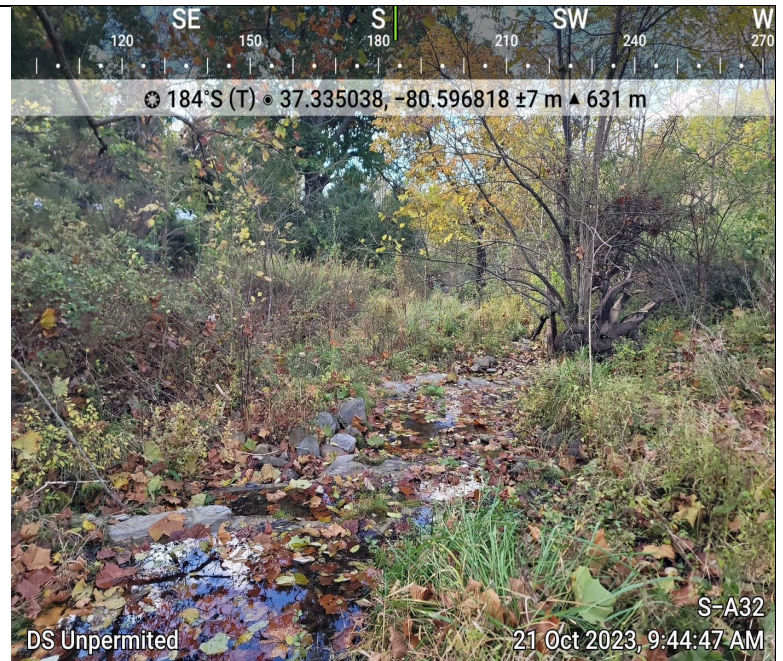
Photo Description: Conditions of the downstream area outside the ROW during pre-construction assessment.

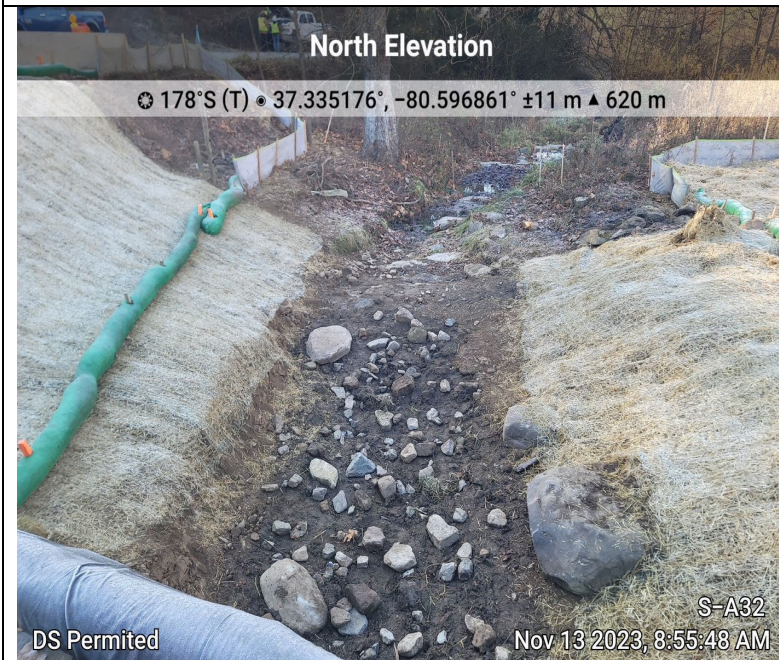
11/12/23- Final contouring and topsoil restoration complete. Seed and stabilization applied to buffer zones and stream channel. Dam and pump removed and flow restored. No biological impacts to the stream observed. -C. Stanley

Photo Description: Downstream view of permitted impact area during post-construction assessment.

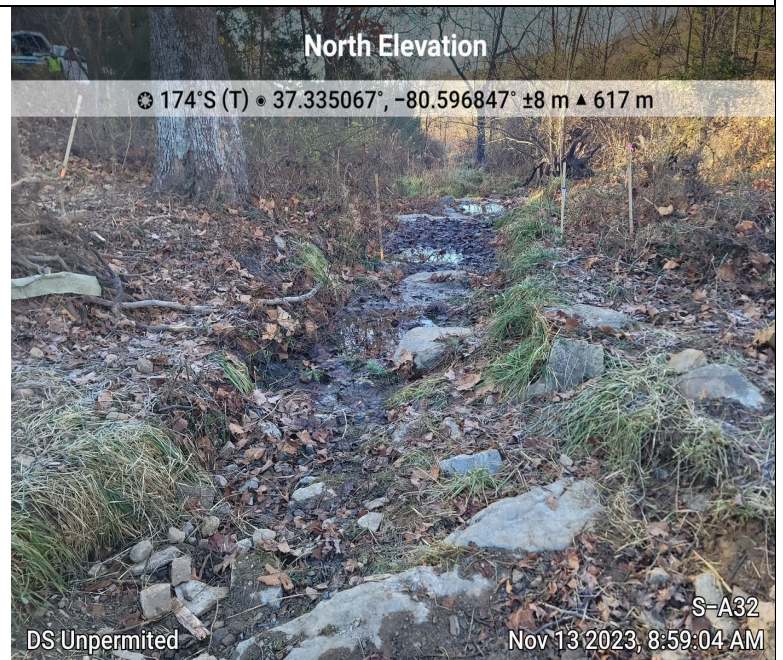
Photo Description: Conditions of the downstream area outside the ROW during post-construction assessment.

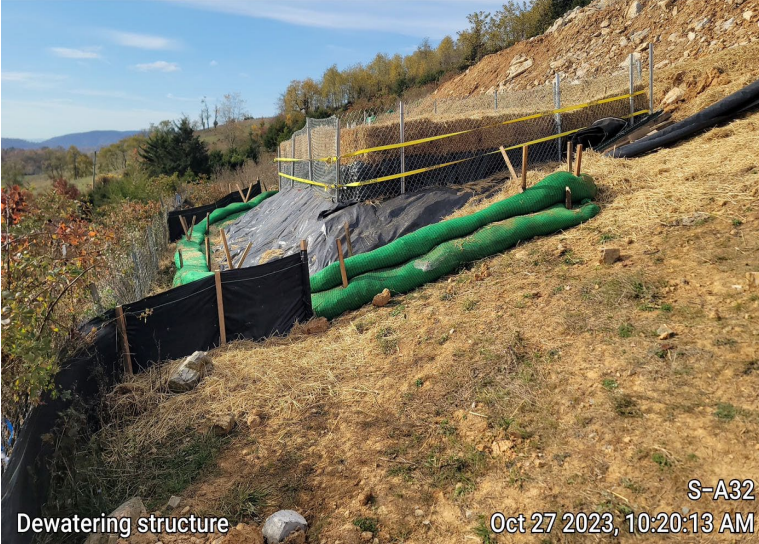
10/27/23- Dam and pump around installed. Energy dissipator installed. Dewatering structure constructed on site. Top soil properly segregated and stabilized. Stream substrate segregated in bags. -C. Stanley

Dewatering structure

Photo Description: Dewatering structure

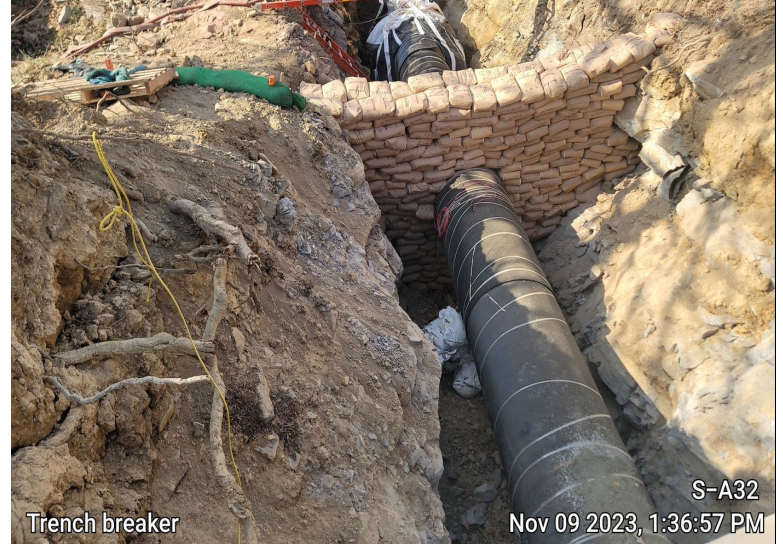
11/9/23- Finished sand blasting, finished coating and installed trench breakers. Clean water pump around remains functional. Started padding in the stream buffer. -C. Stanley

Trench breaker

Photo Description: Trench breakers

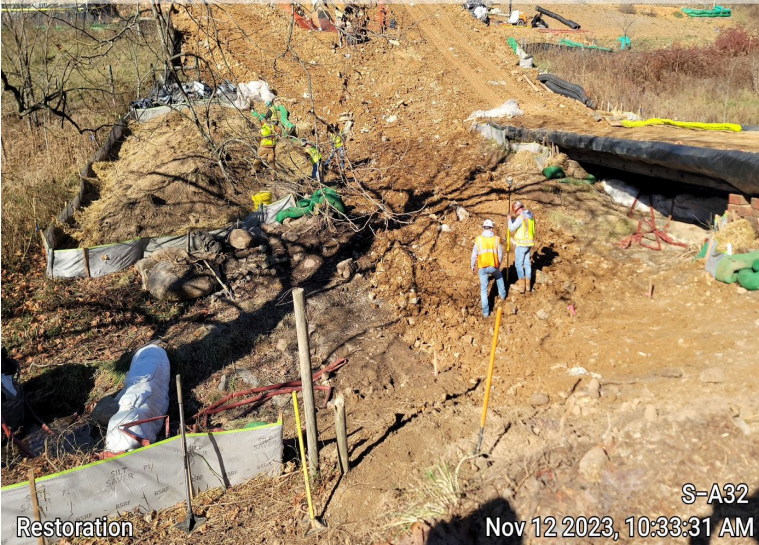
Restoration

Photo Description: Final contouring, preconstruction contours stakeout.

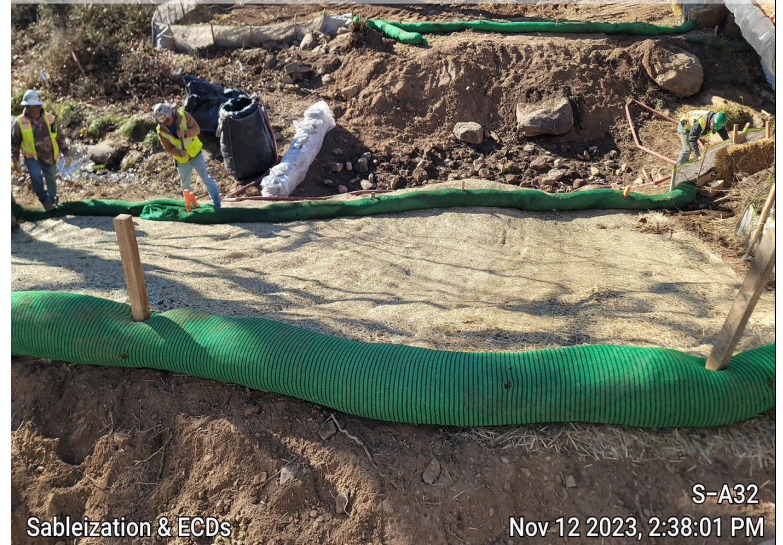
Sableization & ECDs

Photo Description: Final stabilization
