Stream Biological Conditions EA Report

Project Name	H-600 Pipeline Spread F	AFE	124300135	Spread	H-600 Pipeline Spread F
Contractor	Price Gregory	Report #	383		
Environmental Auditor	O'Brien Jonathon	Date/Time	11/16/2023 8:59 AM		
Stream ID	S-A60	Crossing Start Date	11/16/2023	Crossing Completion Date	11/20/2023
Milepost	182.63	Pre-Con Assessment Date	11/16/2023	Post-Con Assessment Date	11/20/2023
Station	9642+85	Bankfull Width (ft.)	9.9	Riffle:Pool Complexes Present?	No
State	WV	Stream Classification	Perennial		
County	Monroe	303(d) Impairment Listing	No

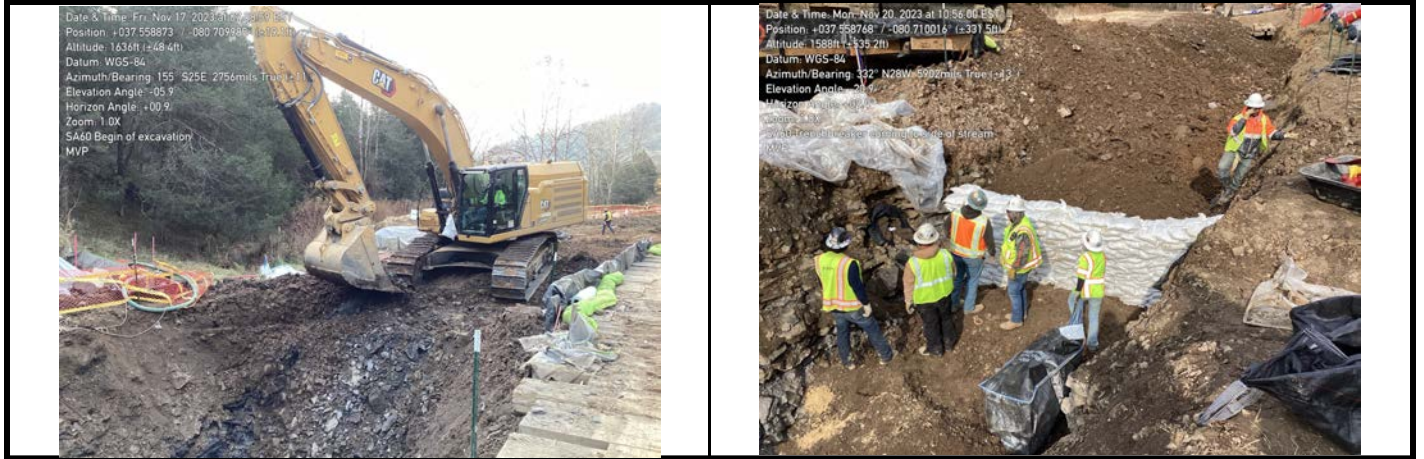
GPS Location See Photo	GPS Location See Photo
Description Photo 3: Begin excavation in aquatic resource area.	Description Photo 4: Building trench breaker adjacent to aquatic resource area.

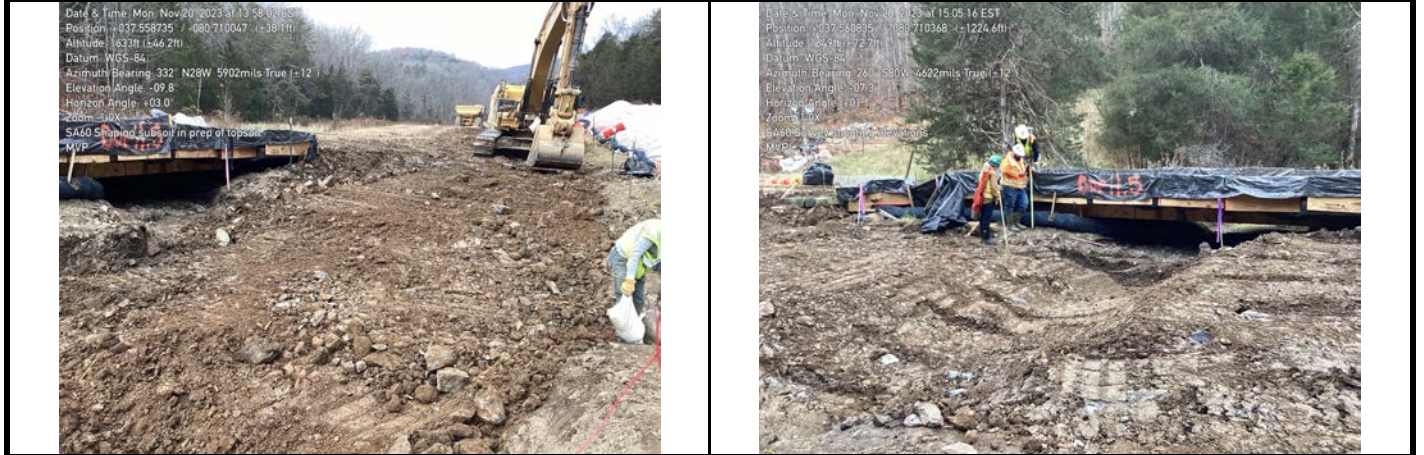
GPS Location See Photo	GPS Location See Photo
Description Photo 5: Shaping subsoil.	Description Photo 6: Survey shooting elevations.

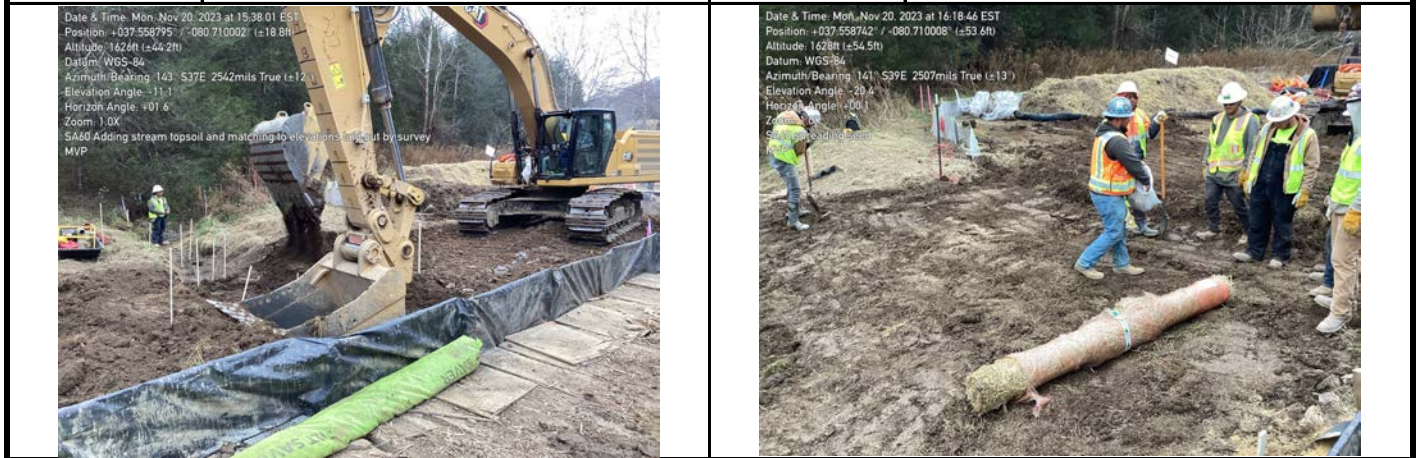
GPS Location See Photo	GPS Location See Photo
Description Photo 7: Adding topsoil and contouring to meet elevations.	Description Photo 8: Spreading seed in buffer.
