# STREAM BIOLOGICAL CONDITIONS ENVIRONMENTAL AUDITOR REPORT

<b>Stream ID:</b> S-AB8	<b>Crossing Start Date:</b> 11/14/2023	<b>Crossing Completion Date:</b> 11/17/2023
<b>Milepost:</b> 281.8	<b>Pre-Con Assessment Date:</b> 10/30/2023	<b>Post-Con Assessment Date:</b> 11/18/2023
<b>Station:</b> 14881+45	<b>Stream Classification:</b> Intermittent (Perennial, Intermittent, Ephemeral)	<b>Bankfull Width (ft.):</b> 4
<b>County:</b> Franklin	<b>303(d) Impairment Listing:</b> Not Impaired	<b>Riffle:Pool Complexes Present?</b> No

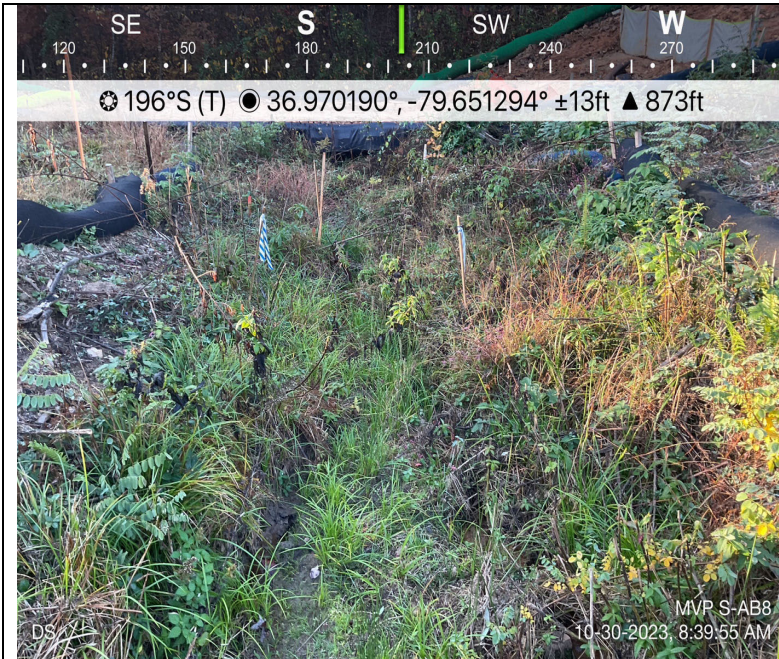
Item #8: Portions of the stream banks exhibited signs of erosion during the pre-construction assessment. Those areas were graded out during restoration to ensure long term stability of the banks, and where necessary graded to a 3:1 slope.

**Photo Description:** Downstream view of permitted impact area during pre-construction assessment.

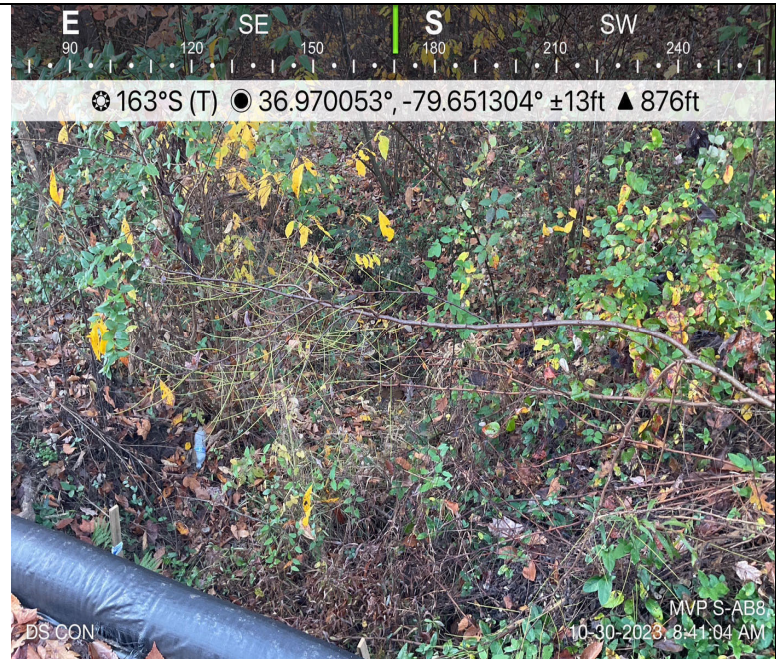
**Photo Description:** Conditions of the downstream area outside the ROW during pre-construction assessment.

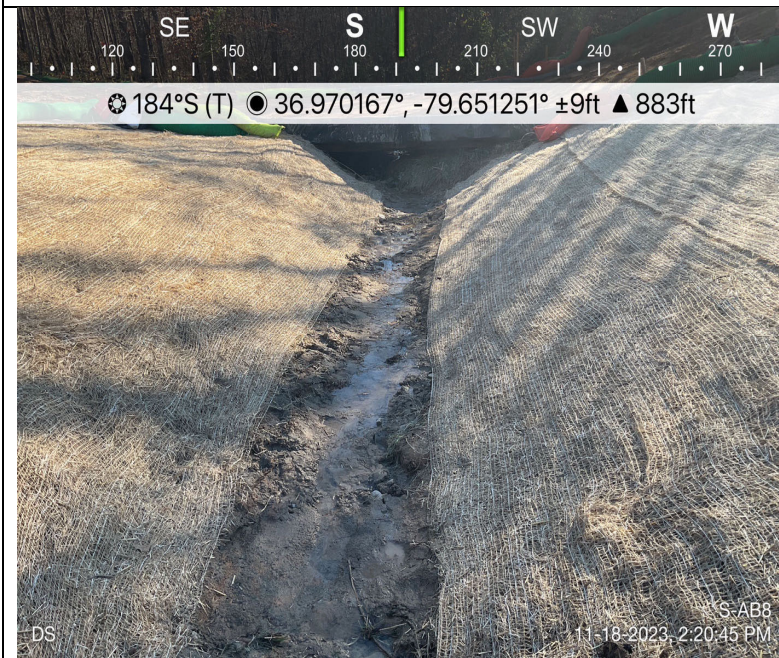
No impact to biological conditions or unauthorized discharge, were observed during the crossing activities.

**Photo Description:** Downstream view of permitted impact area during post-construction assessment.

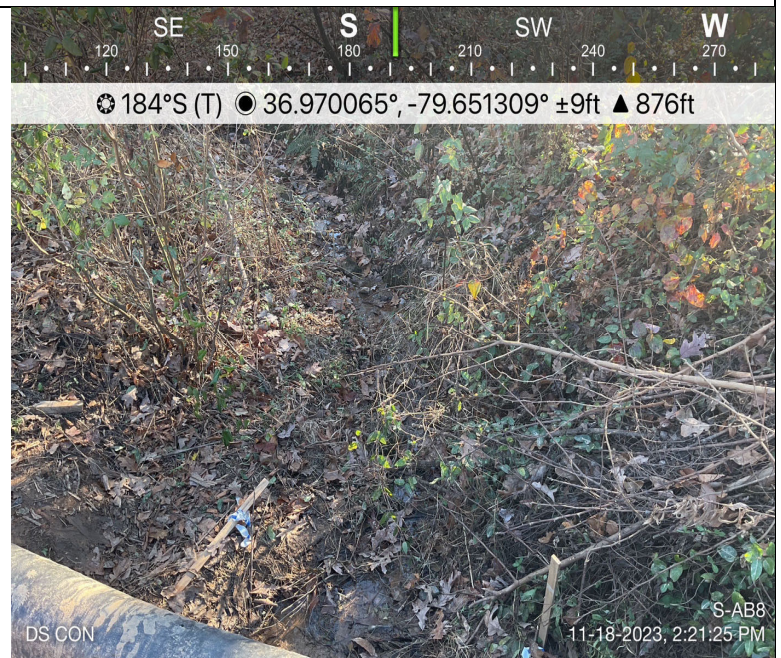
**Photo Description:** Conditions of the downstream area outside the ROW during post-construction assessment.

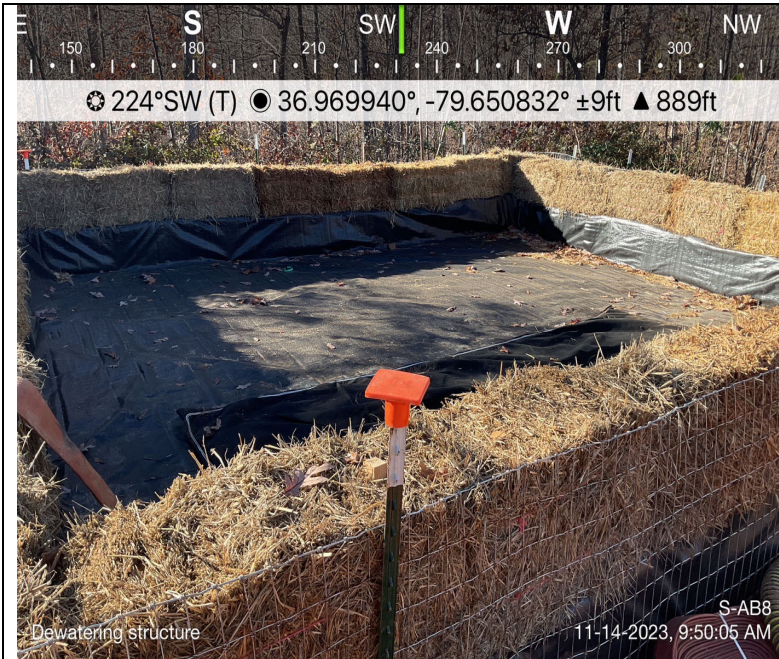
**Photo Description:** Dewatering structure

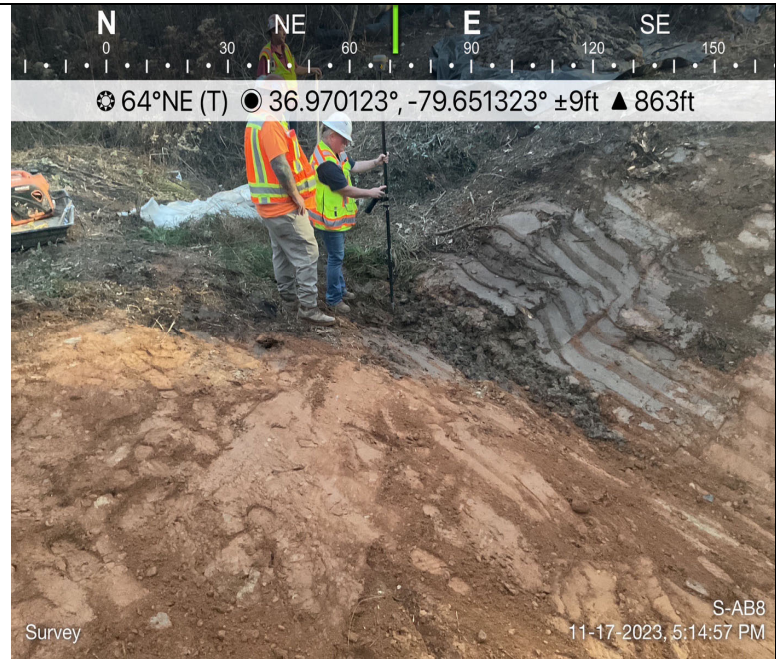
**Photo Description:** Survey for reconstruction of stream

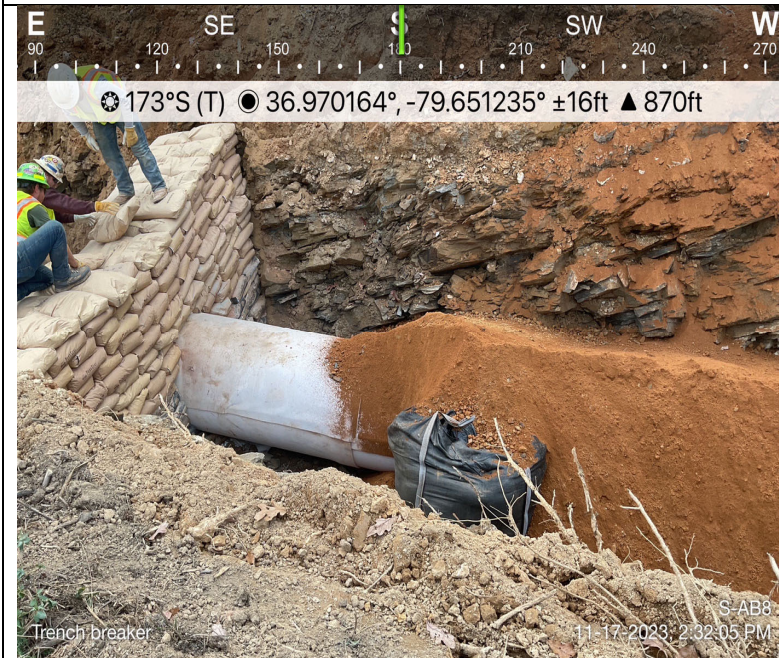
**Photo Description:** Trench breaker

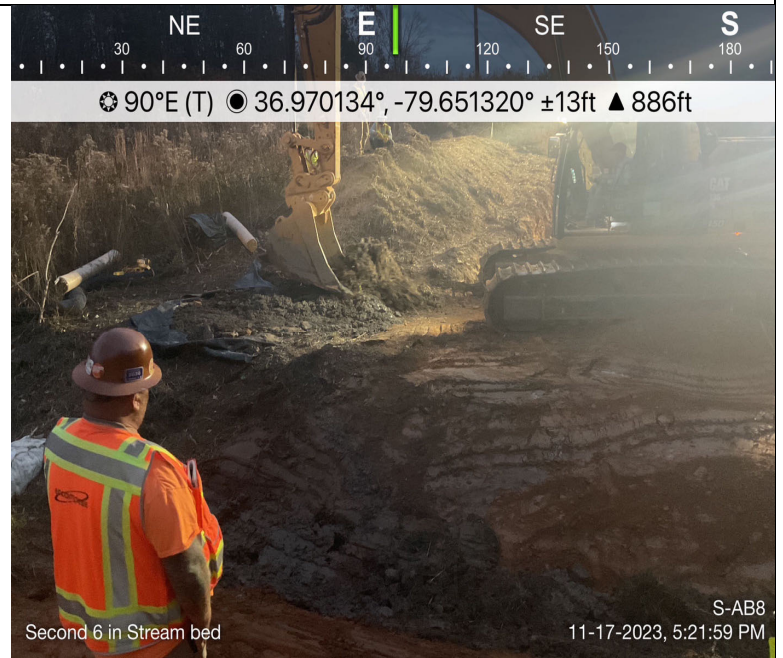
**Photo Description:** Second 6 inch of stream bed material
