STREAM BIOLOGICAL CONDITIONS ENVIRONMENTAL AUDITOR REPORT

Stream ID: S-C1	Crossing Start Date: 11/16/2023	Crossing Completion Date: 11/17/2023
Milepost: 299	Pre-Con Assessment Date: 11/13/2023	Post-Con Assessment Date: 11/18/2023
Station: 15794+77	Stream Classification: Intermittent (Perennial, Intermittent, Ephemeral)	Bankfull Width (ft.): 6
County: Pittsylvania	303(d) Impairment Listing: Not Impaired	Riffle:Pool Complexes Present? No

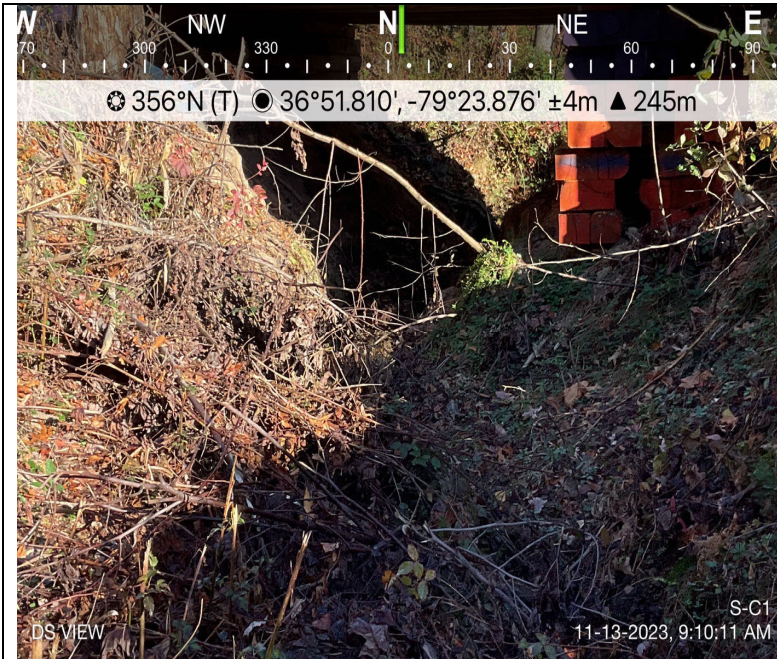
Photo Description: Downstream view of permitted impact area during pre-construction assessment.

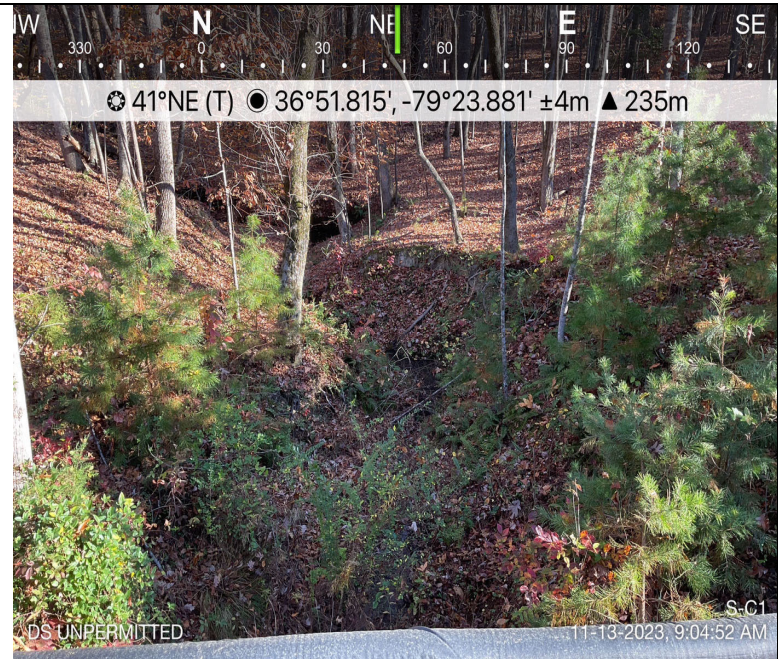
Photo Description: Conditions of the downstream area outside the ROW during pre-construction assessment.

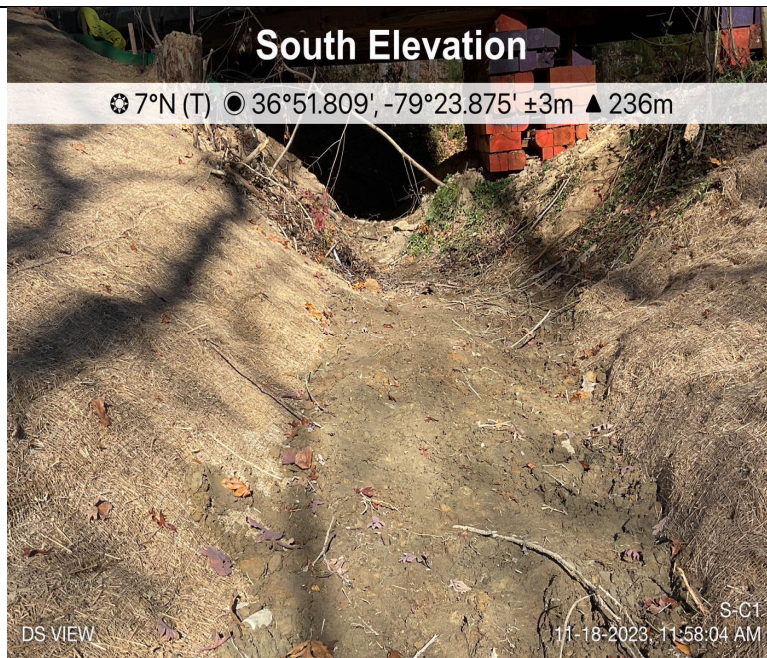
Photo Description: Downstream view of permitted impact area during post-construction assessment.

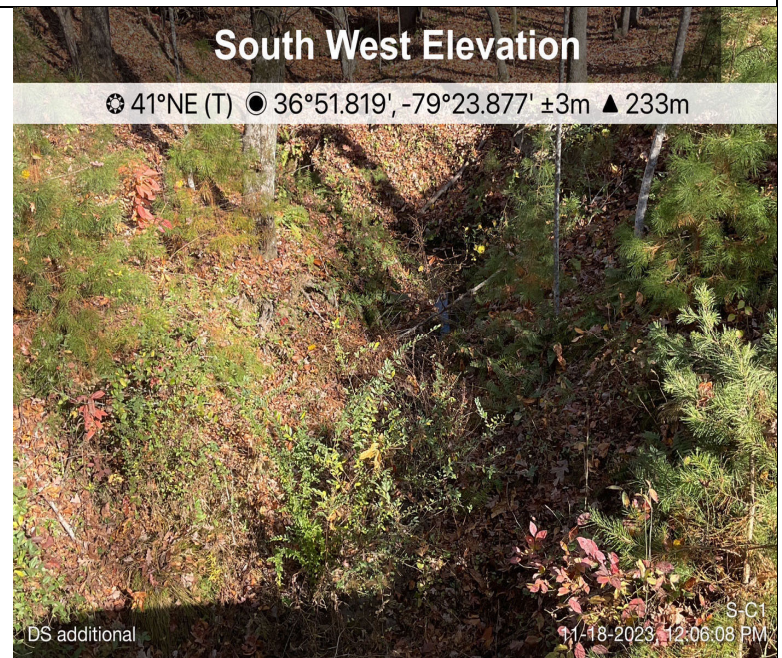
Photo Description: Conditions of the downstream area outside the ROW during post-construction assessment.

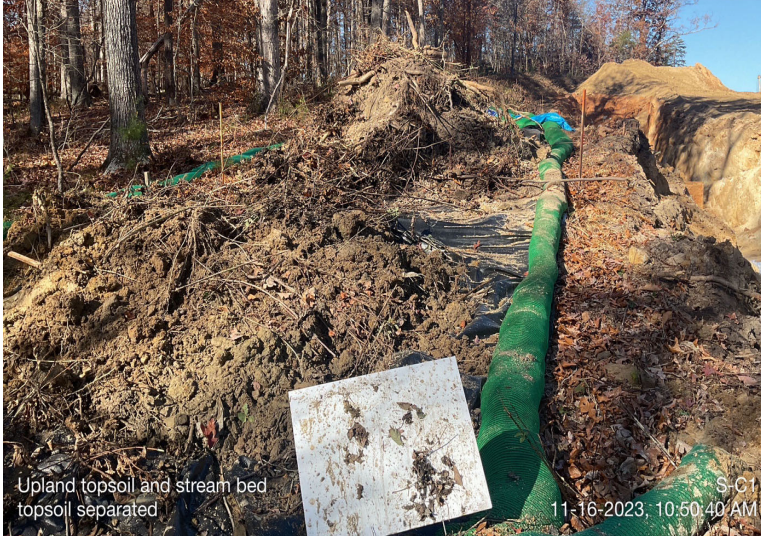
South East Elevation

Photo Description: The upland topsoil and stream substrate were removed, segregated, and stockpiled on Geotech fabric.

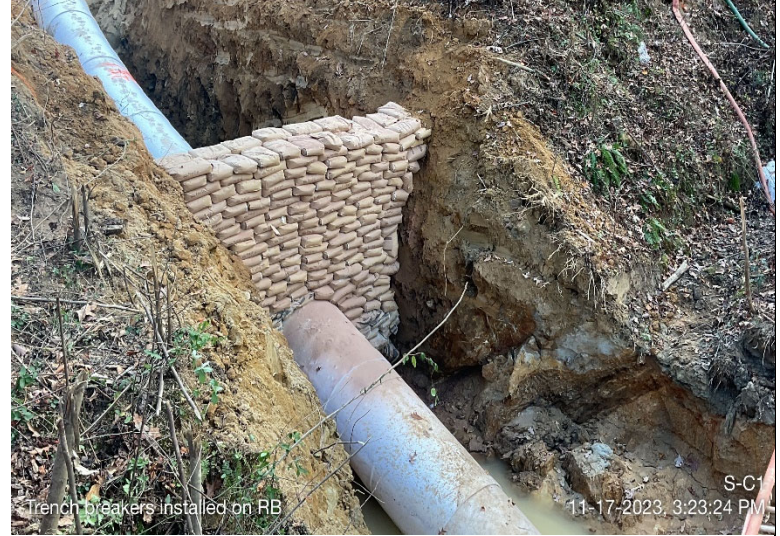
North Elevation

Photo Description: Trench breakers installed on the right bank.

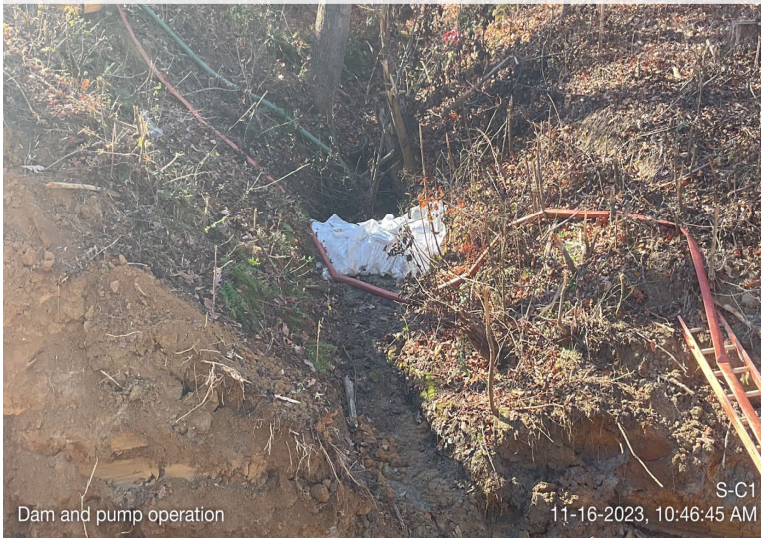
Photo Description: The Dam and pump operation.

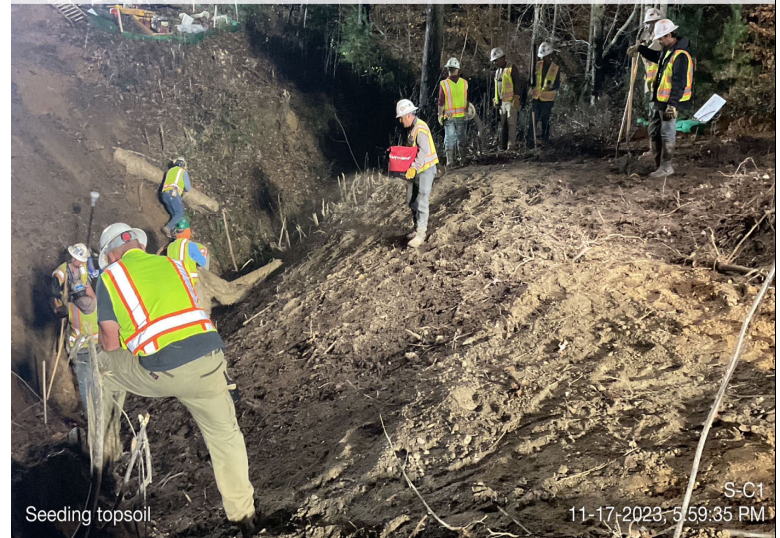
North Elevation

Photo Description: The survey team is on-site providing as-built support, while the crew begins restoration.
