STREAM BIOLOGICAL CONDITIONS ENVIRONMENTAL AUDITOR REPORT

Stream ID: S-C24	Crossing Start Date: 11/03/2023	Crossing Completion Date: 11/16/2023
Milepost: 230.2	Pre-Con Assessment Date: 11/01/2023	Post-Con Assessment Date: 11/16/2023
Station: 12166+47	Stream Classification: Intermittent (Perennial, Intermittent, Ephemeral)	Bankfull Width (ft.): 3
County: Montgomery	303(d) Impairment Listing: Not Impaired	Riffle:Pool Complexes Present? No

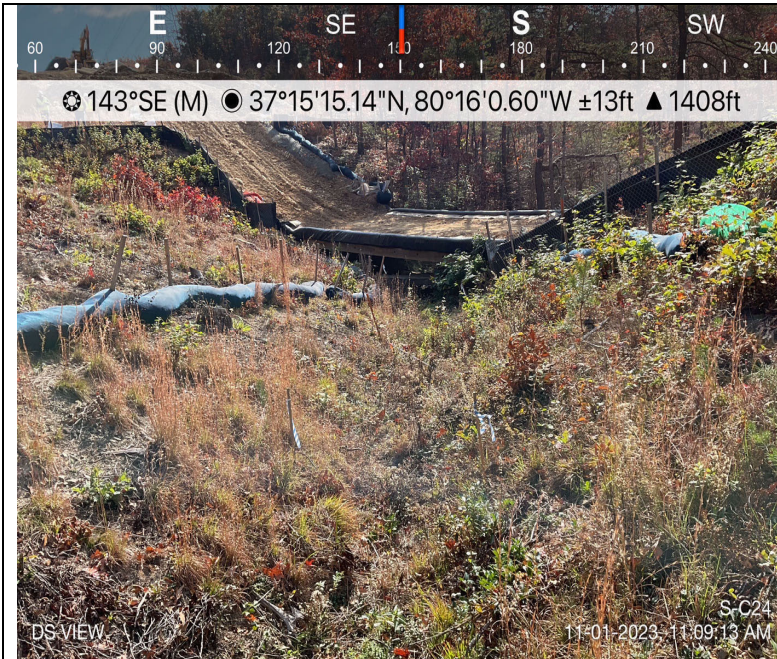
Photo Description: Downstream view of permitted impact area during pre-construction assessment.

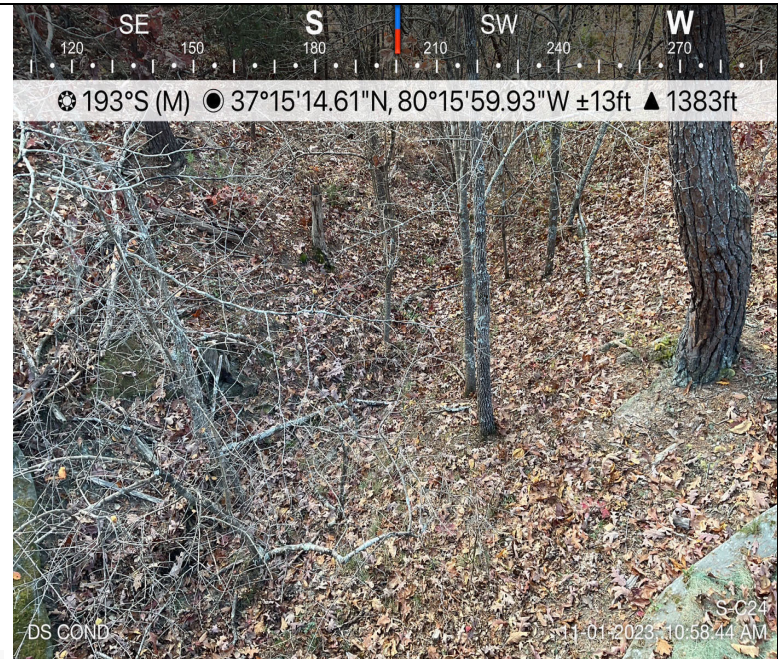
Photo Description: Conditions of the downstream area outside the ROW during pre-construction assessment.

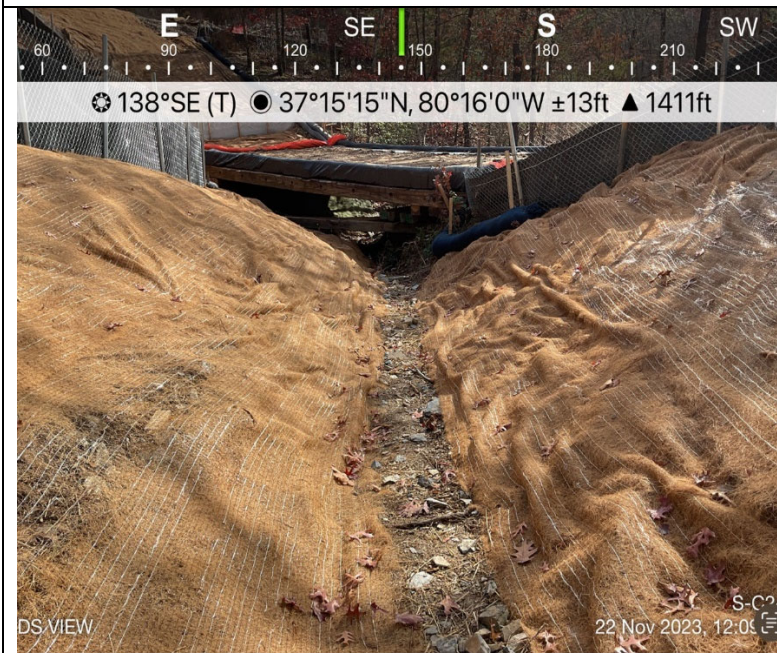
Photo Description: Downstream view of permitted impact area during post-construction assessment.

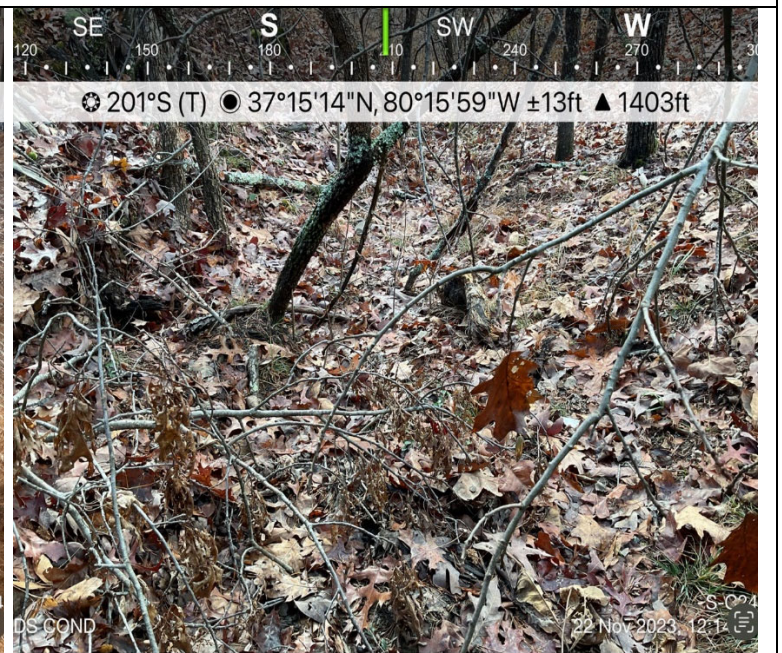
Photo Description: Conditions of the downstream area outside the ROW during post-construction assessment.

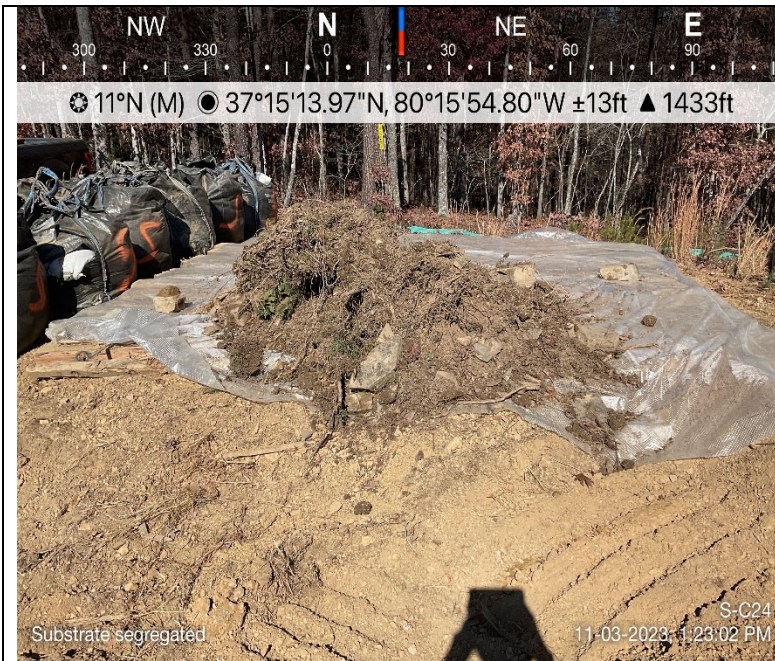
Photo Description: Streambed substrate/topsoil was stripped and segregated.

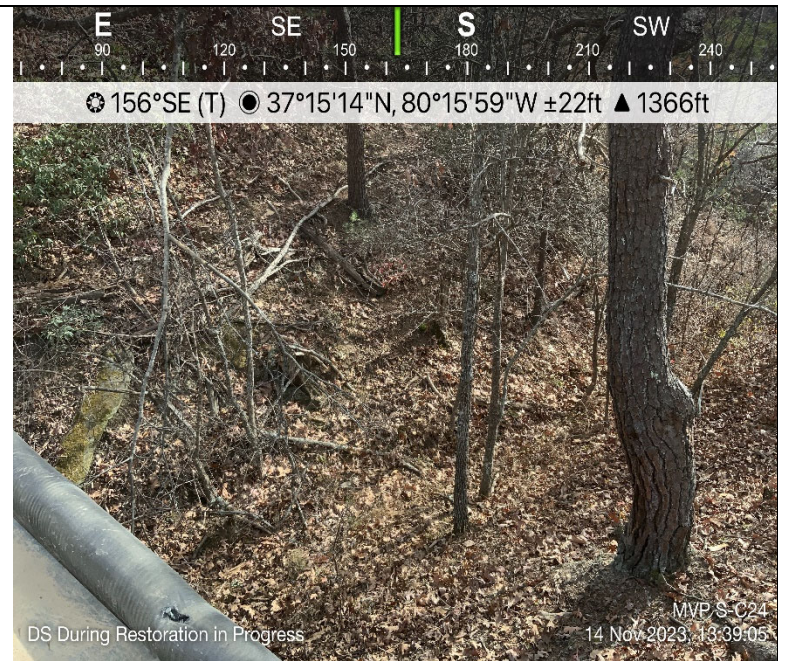
Photo Description: Conditions of resource downstream from impact area during restoration. No impacts to biological conditions or unauthorized discharges were observed during the crossing.

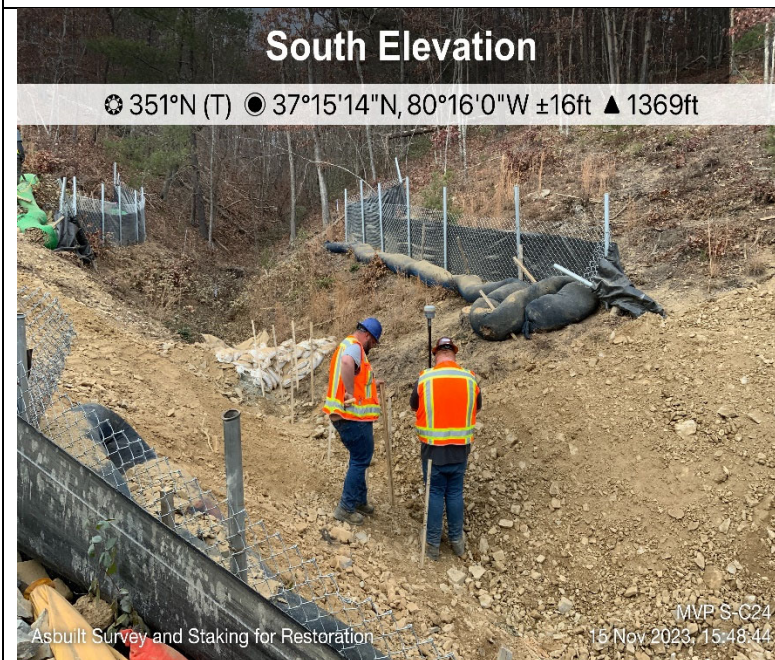
Photo Description: Survey staking out for restoration.

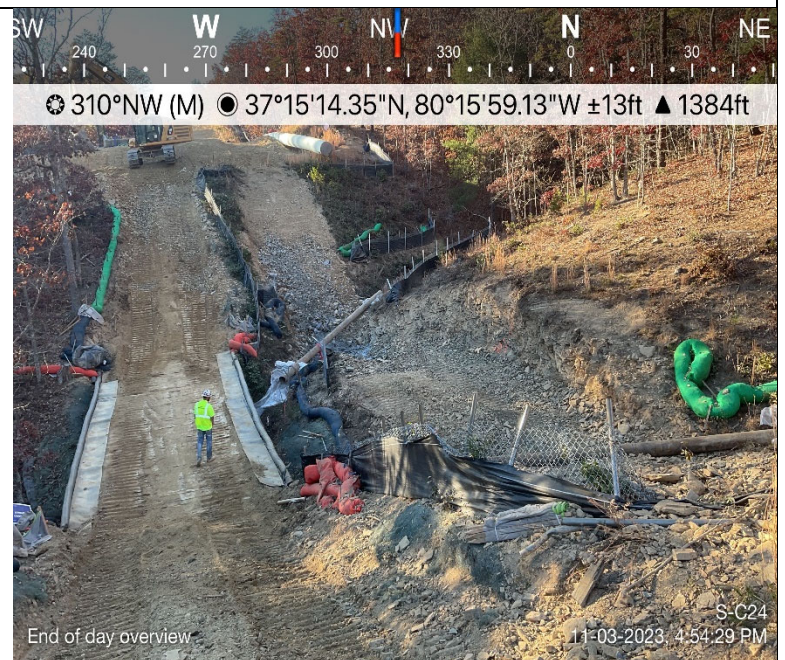
Photo Description: Conditions of the resource impact area at the end of a workday. Flume remains installed and operational.
