STREAM BIOLOGICAL CONDITIONS ENVIRONMENTAL AUDITOR REPORT

Stream ID: S-C25	Crossing Start Date: 10/27/2023	Crossing Completion Date: 11/03/2023
Milepost: 230.2	Pre-Con Assessment Date: 10/25/2023	Post-Con Assessment Date: 11/03/2023
Station: 12163+05	Stream Classification: Intermittent (Perennial, Intermittent, Ephemeral)	Bankfull Width (ft.): 3
County: Montgomery	303(d) Impairment Listing: Not Impaired	Riffle:Pool Complexes Present? No

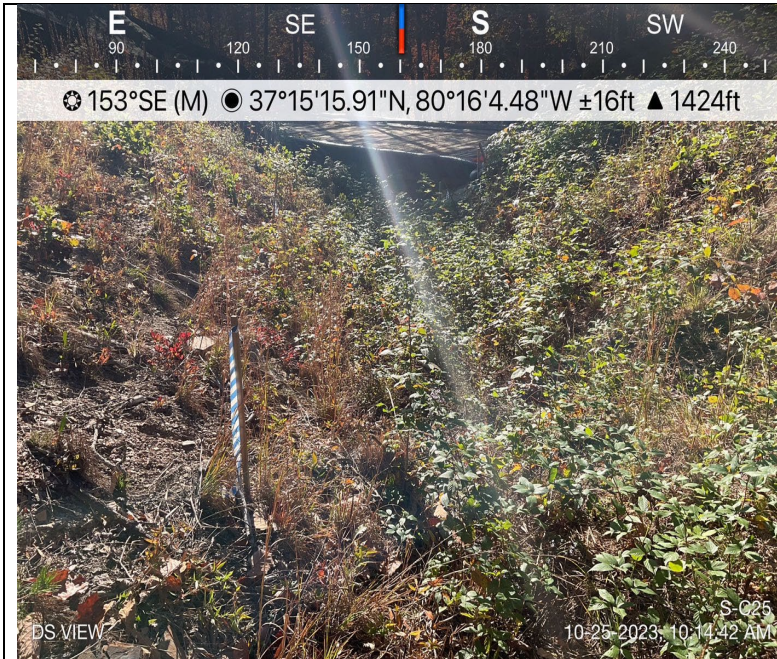
Photo Description: Downstream view of permitted impact area during pre-construction assessment.

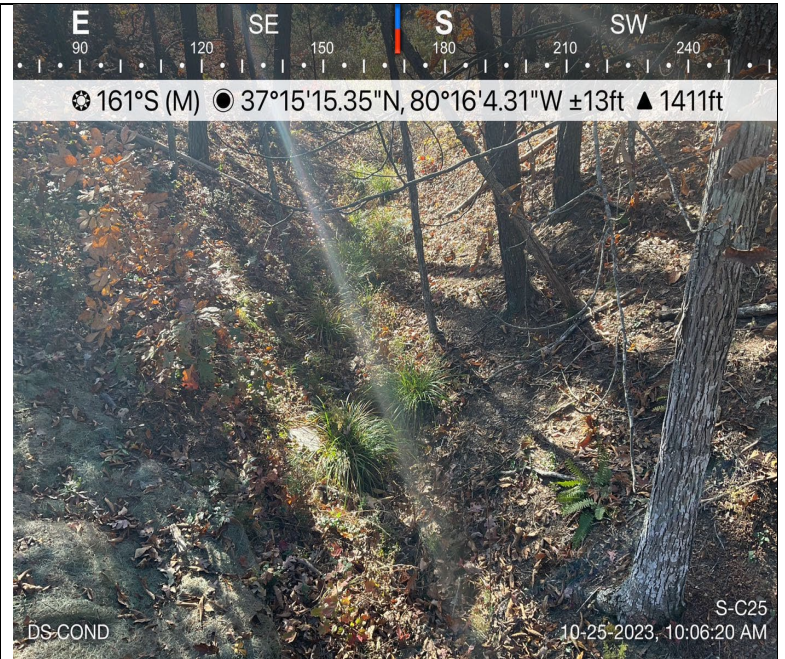
Photo Description: Conditions of the downstream area outside the ROW during pre-construction assessment.

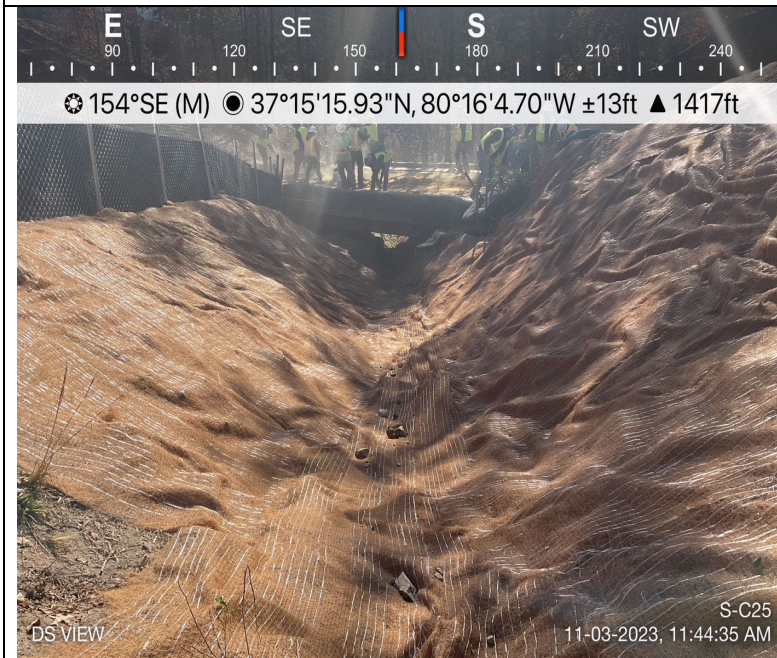
Photo Description: Downstream view of permitted impact area during post-construction assessment.

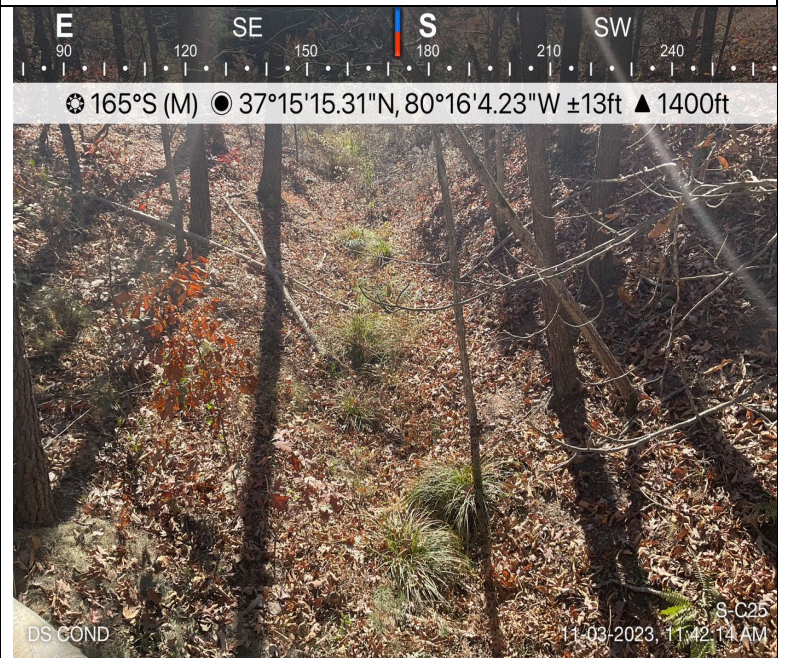
Photo Description: Conditions of the downstream area outside the ROW during post-construction assessment.

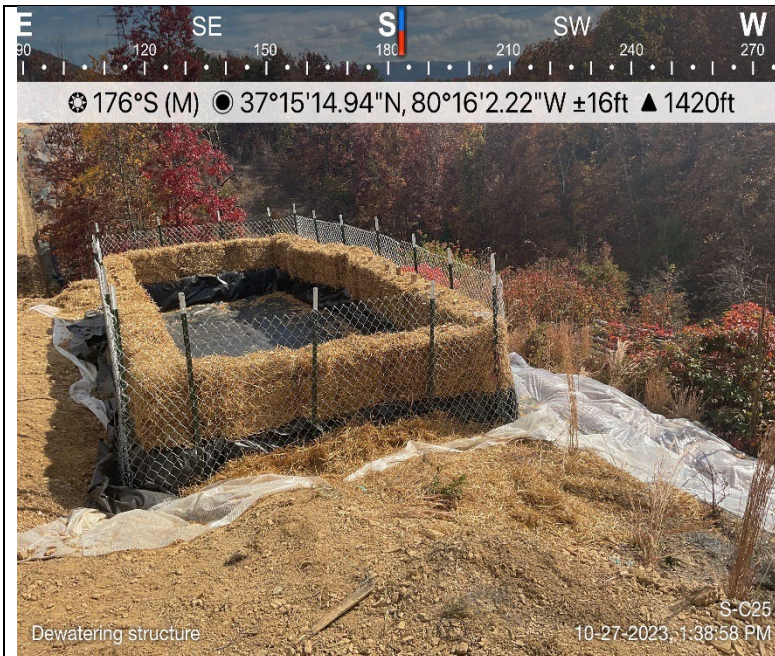
Photo Description: Dewatering structure installed and functional throughout crossing.

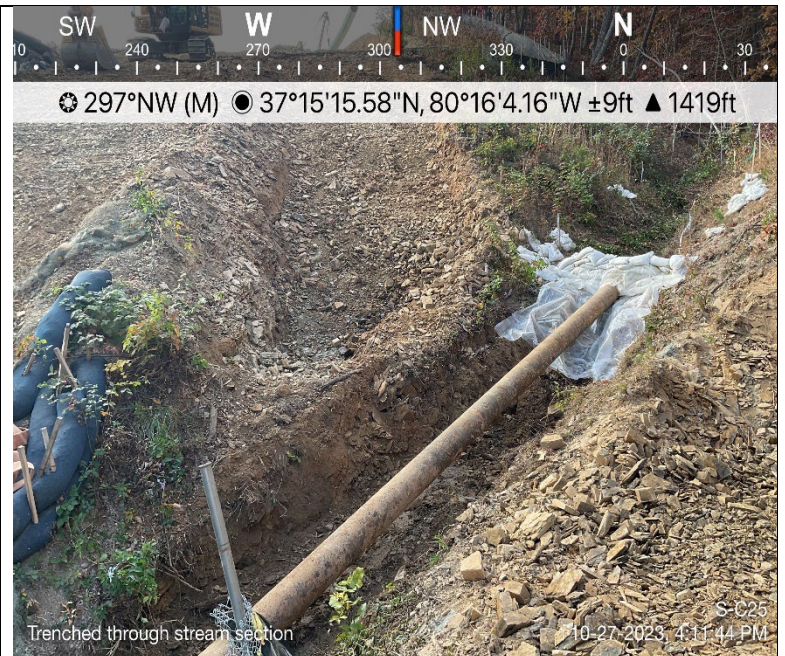
Photo Description: Flume pipe installed and operational throughout crossing.

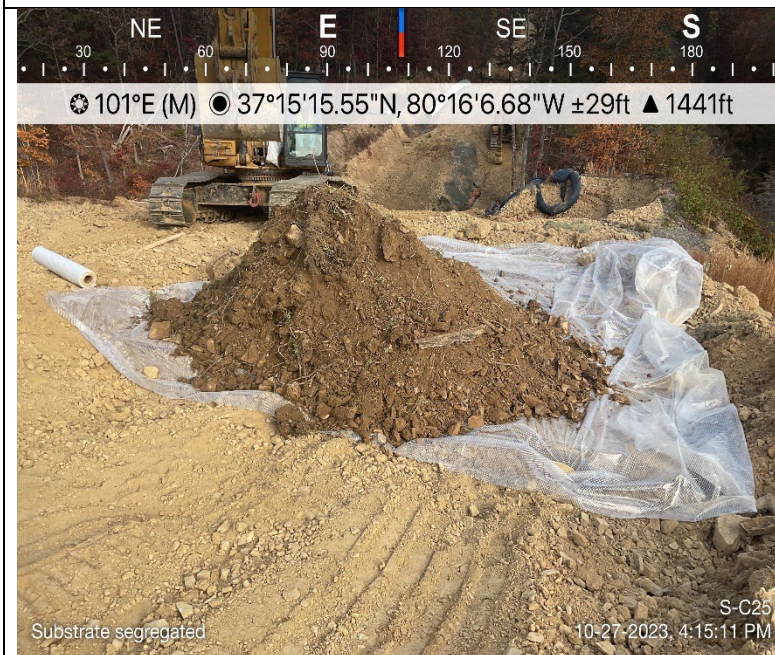
Photo Description: Streambed substrate stockpiled separately from subsoil.

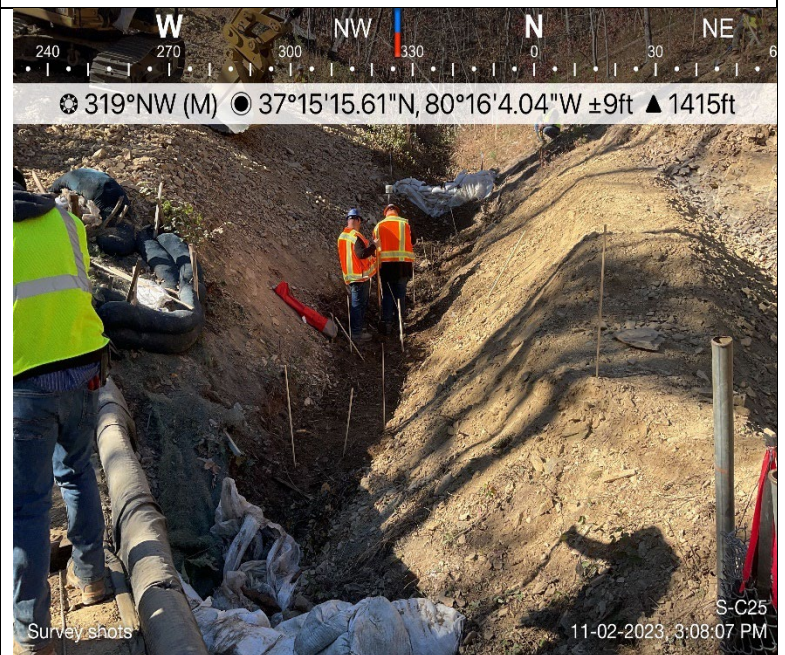
Photo Description: Survey team on site assisting with restoration of pre-construction conditions and contours.
