STREAM BIOLOGICAL CONDITIONS ENVIRONMENTAL AUDITOR REPORT

Stream ID: S-CC10	Crossing Start Date: 11/16/2023	Crossing Completion Date: 11/24/2023
Milepost: 294.6	Pre-Con Assessment Date: 11/04/2023	Post-Con Assessment Date: 11/25/2023
Station: 15563+59	Stream Classification: Intermittent (Perennial, Intermittent, Ephemeral)	Bankfull Width (ft.): 9
County: Pittsylvania	303(d) Impairment Listing: Not Impaired	Riffle:Pool Complexes Present? No

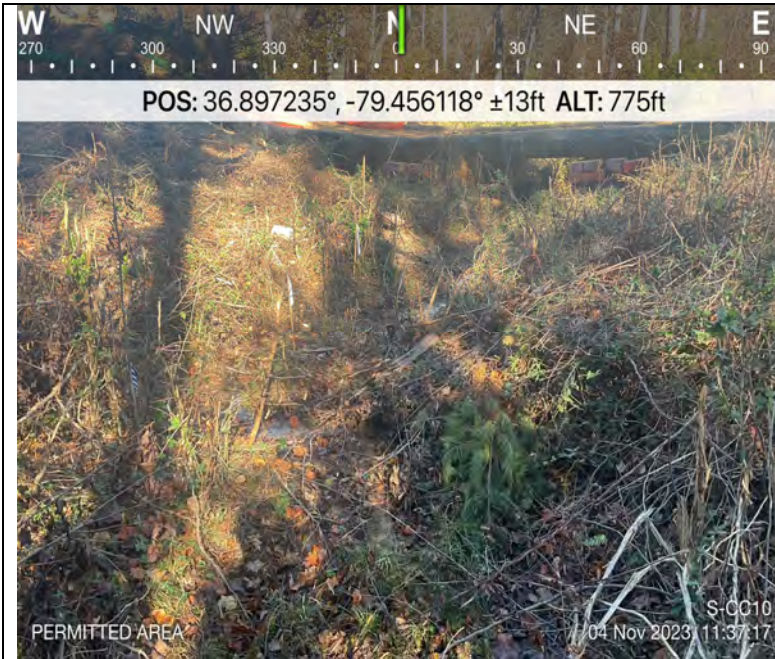
Photo Description: Downstream view of permitted impact area during pre-construction assessment.

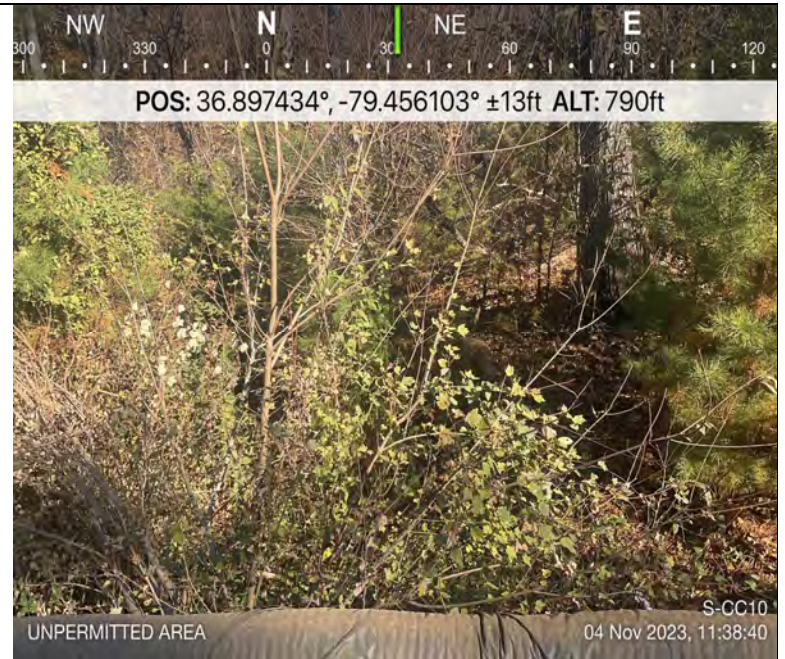
Photo Description: Conditions of the downstream area outside the ROW during pre-construction assessment.

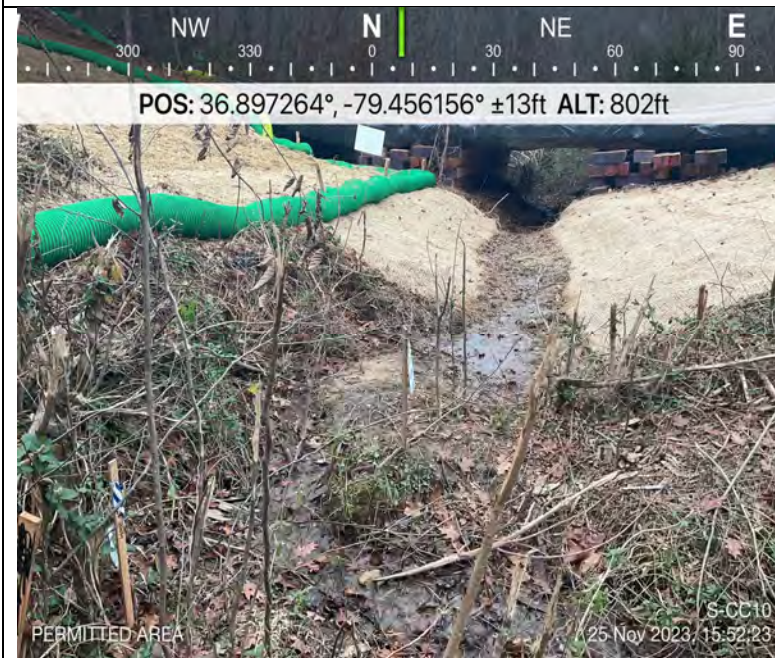
Photo Description: Downstream view of permitted impact area during post-construction assessment.

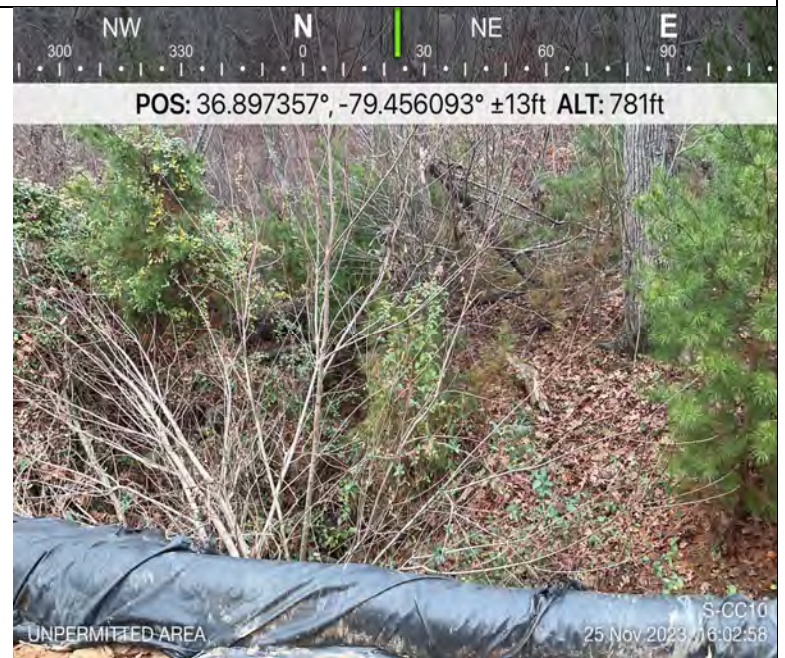
Photo Description: Conditions of the downstream area outside the ROW during post-construction assessment.

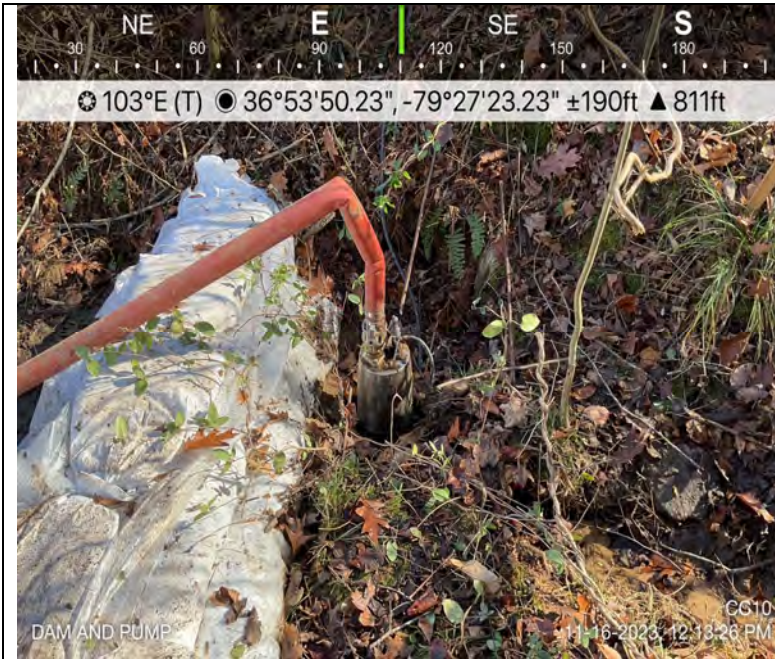
Photo Description: The dam and pump installed and functioning.

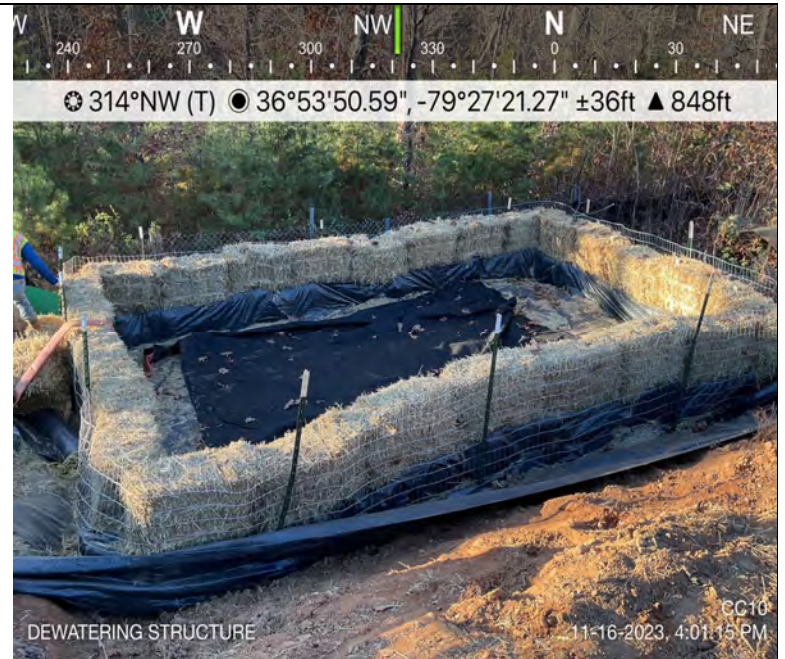
Photo Description: An overview of the dewatering structure.

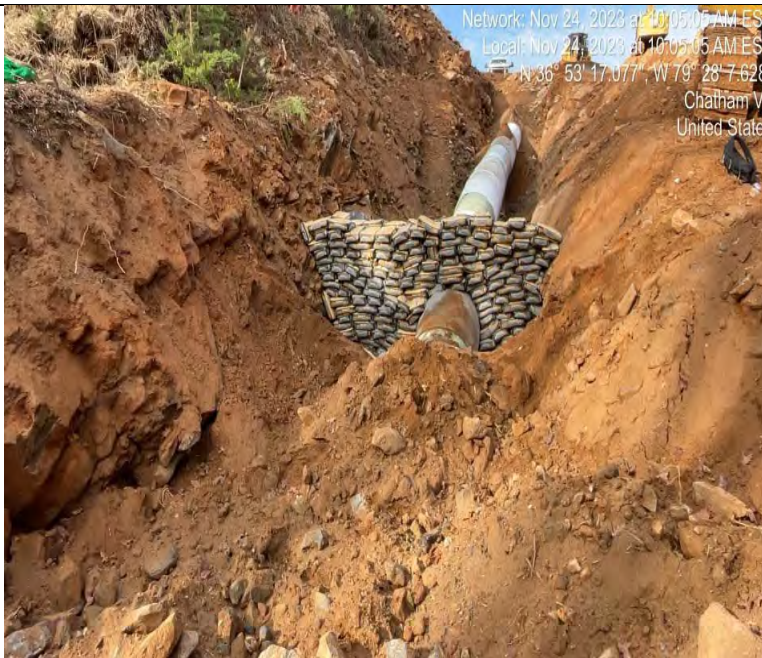
Photo Description: The CIS trench breaker after installation.

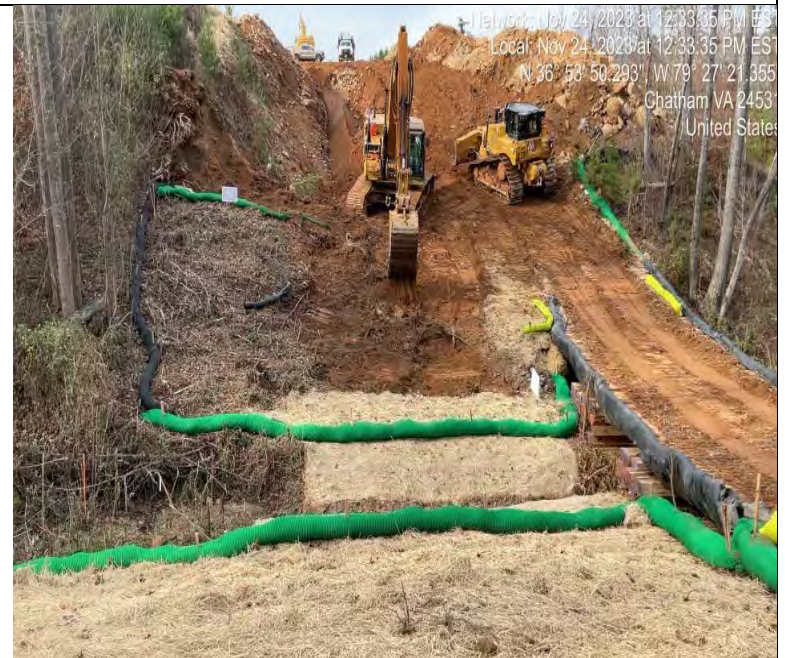
Photo Description: Restoration of the 50-foot buffer on the CIS.
